CONSTRUCTION MONITORING REPORT
NOVEMBER 2021 TO APRIL 2022

Sydney Metro City & Southwest

Package 5 & 6

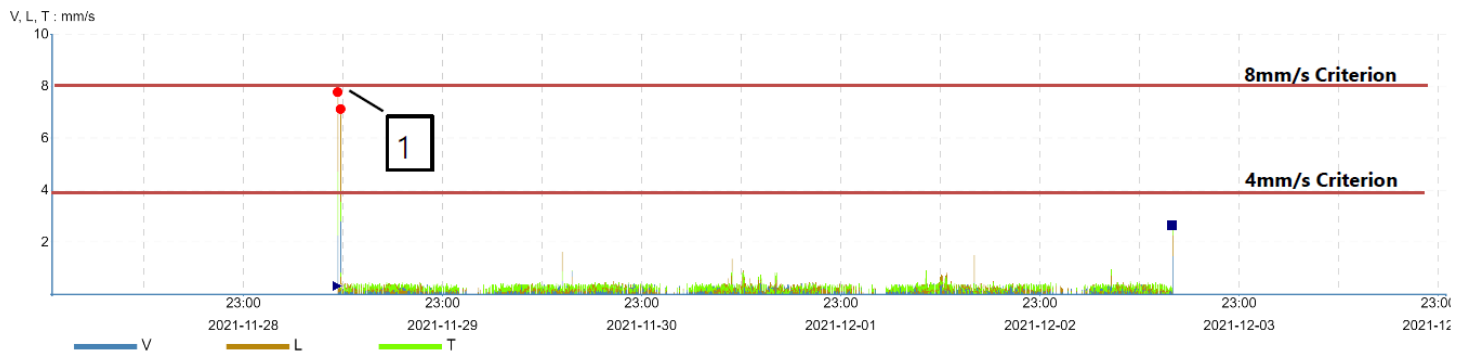
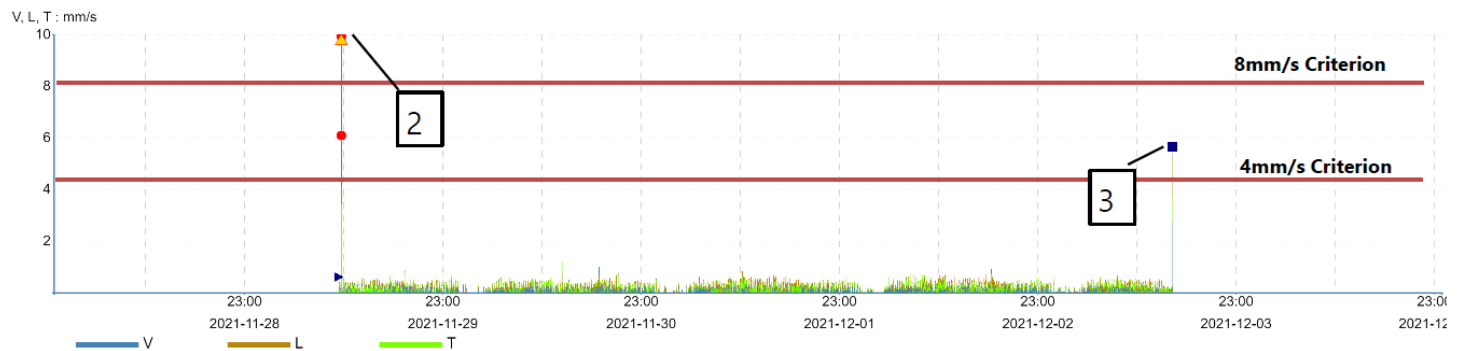
Fig. 1 – Unattended vibration monitoring location 1 results (residential property on Commons Street, 29th November – 03rd December 2021)

Fig. 2 – Unattended vibration monitoring location 2 results (residential property on Commons Street, 29th November – 03rd December 2021)

It can be seen in Figure 1 and Figure 2 that the vibration levels produced from the vibration intensive works in the vicinity of the affected garage structure is below 4 mm/s. Note that there were events that resulted in an instantaneous vibration level of above 4 mm/s which are justified in the table below.

Exceedance ID	Date and Time	Cause of exceedance
1	29.11.2021, 10:30am	At this time, the vibration monitor was mounted on the ground spike to commence monitoring. Exceedance was not caused by the nearby construction activities. The exceedance was the result of the monitor instillation process
2	29.11.2021, 11:00am	At this time, the vibration monitor was mounted on the ground spike to commence monitoring. Exceedance was not caused by the nearby construction activities. The exceedance was the result of the monitor instillation process.
3	03.12.2021, 03:00pm	At this time, the vibration monitor was removed from the ground spike at the completion of monitoring. Exceedance was not caused by the nearby construction activities. The exceedance was the result of the monitor instillation process

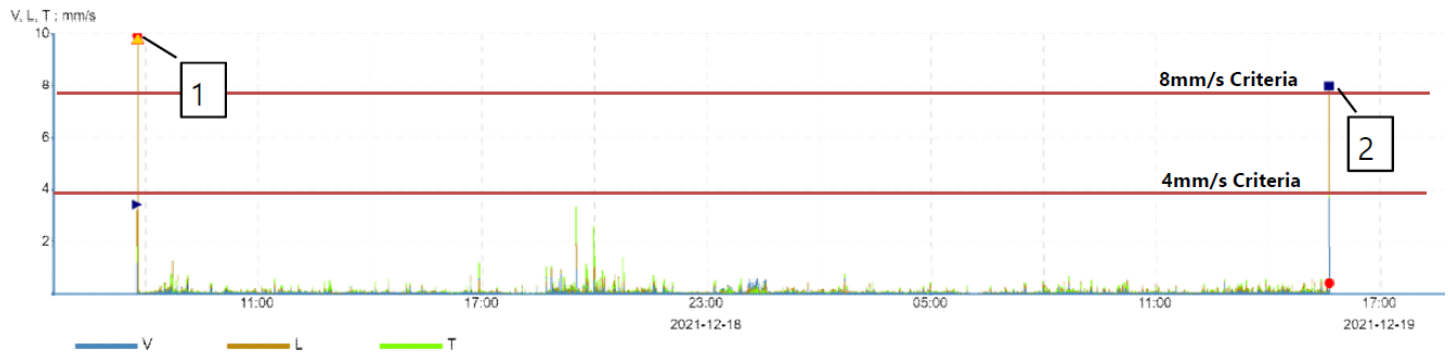
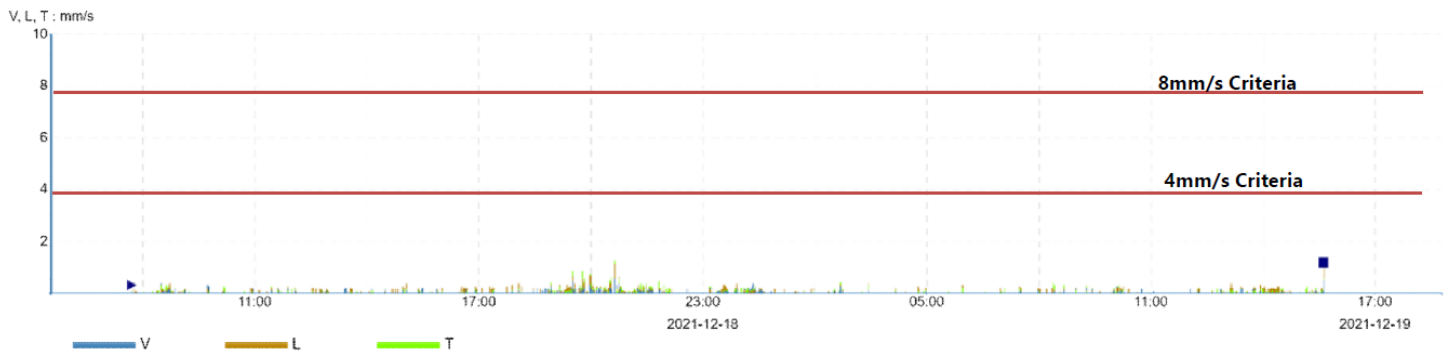
Fig. 3 – Unattended vibration monitoring location 1 results (residential property on Commons Street, 18th December – 19th December 2021)

Fig. 4 – Unattended vibration monitoring location 2 results (residential property on Commons Street, 18th December – 19th December 2021)

Exceedance ID	Date and Time	Cause of exceedance
1	18.12.2021 07:47am	At this time, the vibration monitor was mounted on the ground spike to commence monitoring. Exceedance was not caused by the nearby construction activities. The exceedance was the result of the monitor instillation process
2	19.12.2021 03:41pm	At this time, the vibration monitor was removed from the ground spike to complete the monitoring. Exceedance was not caused by the nearby construction activities. The exceedance was the result of the monitor instillation process

It can be seen in Figure 3 and Figure 4 that the vibration levels produced from the vibration intensive works in the vicinity of the affected garage structure is below 4 mm/s. Note that there were events that resulted in an instantaneous vibration level of above 4 mm/s, however these were not caused by the nearby construction activities, as justified in the table above.

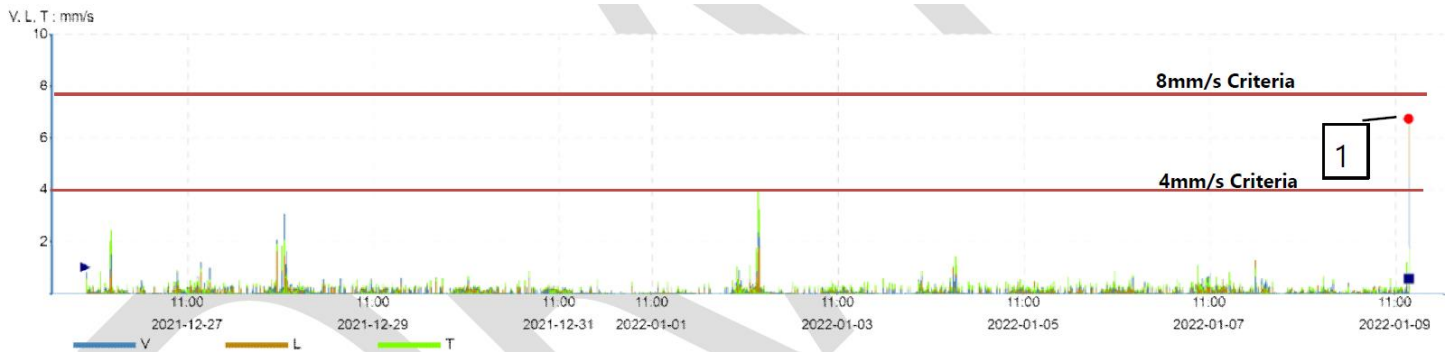
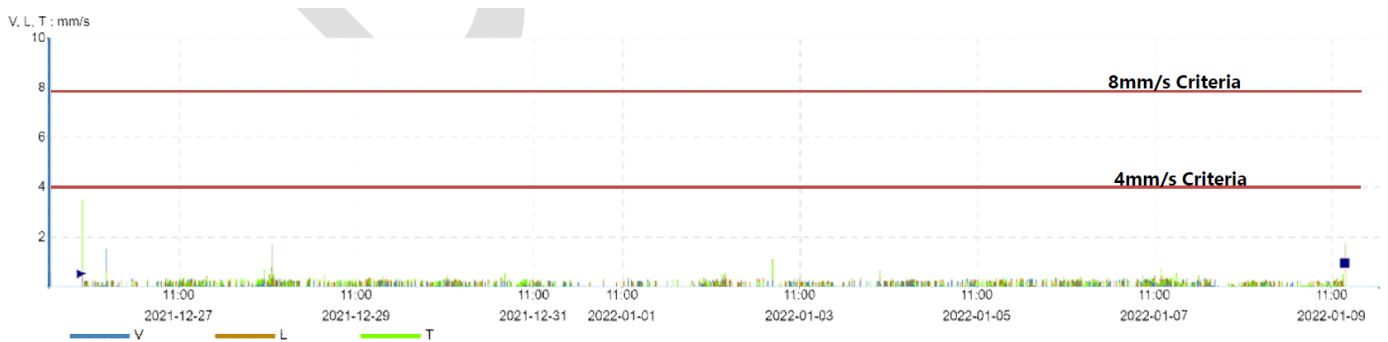
Fig. 5 – Unattended vibration monitoring location 1 results (residential property on Commons Street, 26th December 2021 – 9th January 2022)

Fig. 6 – Unattended vibration monitoring location 2 results (residential property on Commons Street, 26th December 2021 – 9th January 2022)

Exceedance ID	Date and Time	Cause of exceedance
1	09.01.2022 02:25pm	At this time, the vibration monitor was removed from the ground spike to complete the monitoring. Exceedance was not caused by the nearby construction activities. The exceedance was the result of the monitor instillation process.

It can be seen in Figure 5 and 6 that the vibration levels produced from the vibration intensive works in the vicinity of the affected garage structure is below 4 mm/s. Note that there was an event that resulted in an instantaneous vibration level of above 4 mm/s, however this event was not caused by the nearby construction activities, as justified in the table above.

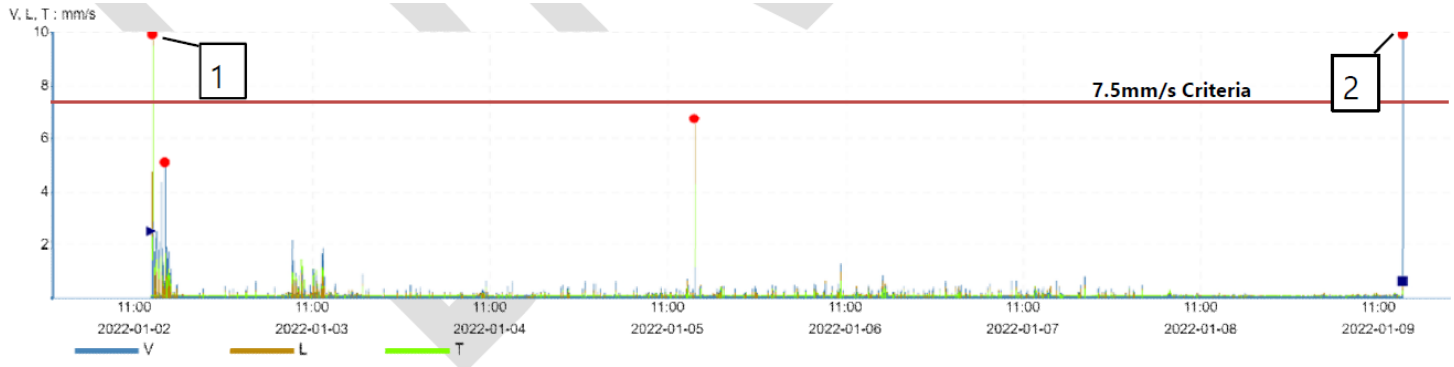
Fig. 6 – Unattended vibration monitoring at platform 1 results (2nd – 9th January 2022)

It can be seen in Figure 6 that the vibration levels produced from the jackhammering works in the vicinity of the station building on platform 1 is below 7.5 mm/s. Note that there were events that resulted in an instantaneous vibration level of above 7.5 mm/s, however these were not caused by the nearby construction activities, as justified in the table below.

Exceedance ID	Date and Time	Cause of exceedance
1	09.01.2022 02:25pm	At this time, the vibration monitor was mounted inside the station building to commence monitoring. Exceedance was not caused by the nearby construction activities. The exceedance was the result of the monitor instillation process.
2	09.01.2022 02:12pm	At this time, the vibration monitor was removed from the station building to complete the monitoring. Exceedance was not caused by the nearby construction activities. The exceedance was the result of the monitor instillation process.

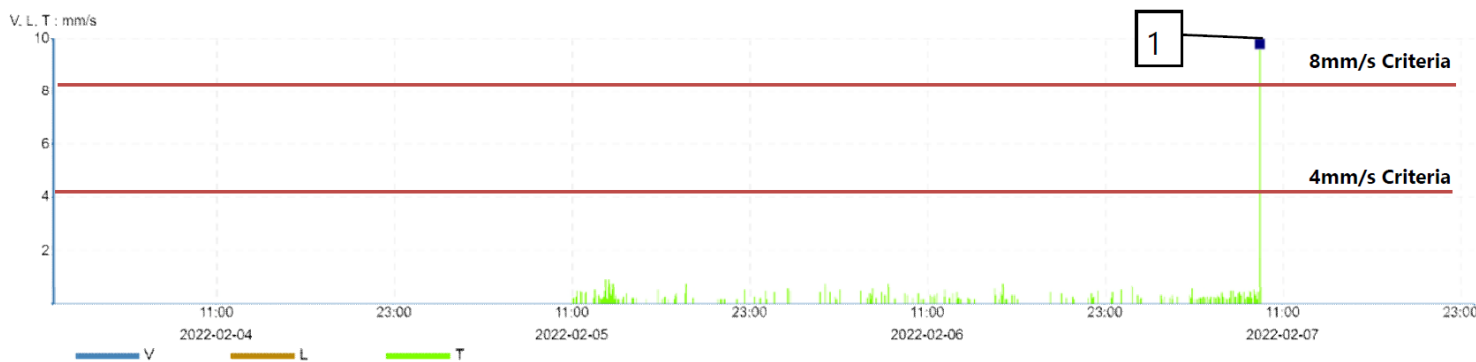
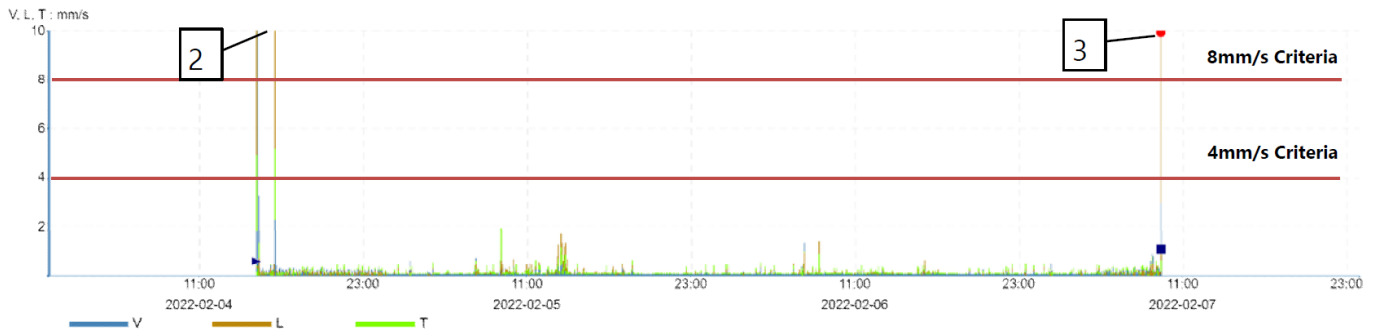
Fig. 7 – Unattended vibration monitoring location 1 results (residential property on Commons Street, 7th February 2022)

Fig. 8 – Unattended vibration monitoring location 2 results (residential property on Commons Street, 7th February 2022)

The results of the noise measurements were below the predicted $LA_{eq\ 15minutes}$ levels presented in the Gatewave model prepared for the works. The results of the unattended vibration measurements were typically below the established vibration criteria established for the location. There were events that resulted in an instantaneous vibration level of above the established vibration criteria, however, the cause of these events was not related to construction activity, as outlined in the table below.

Exceedance ID	Date and Time	Cause of exceedance
1	07.02.2022 09:24am	At this time, the vibration monitor was removed from the ground spike to complete the monitoring. Exceedance was not caused by the nearby construction activities. The exceedance was the result of the monitor instillation process.
2	04.02.2022 03:10pm	At this time, the vibration monitor was installed on the ground spike to start the monitoring. Exceedance was not caused by the nearby construction activities. The exceedance was the result of the monitor instillation process.
3	07.02.2022 09:20am	At this time, the vibration monitor was re moved from the ground spike to complete the monitoring. Exceedance was not caused by the nearby construction activities. The exceedance was the result of the monitor instillation process.
