Tree Impact Assessment Report

City and Southwest Metro Station Upgrade Works Package 5 & 6

P5 Document No. SMCSWSW5-DEW-WEC-EM-REP-000542

P6 Document No. SMCSWSW6-DEW-WEC-EM-REP-000632

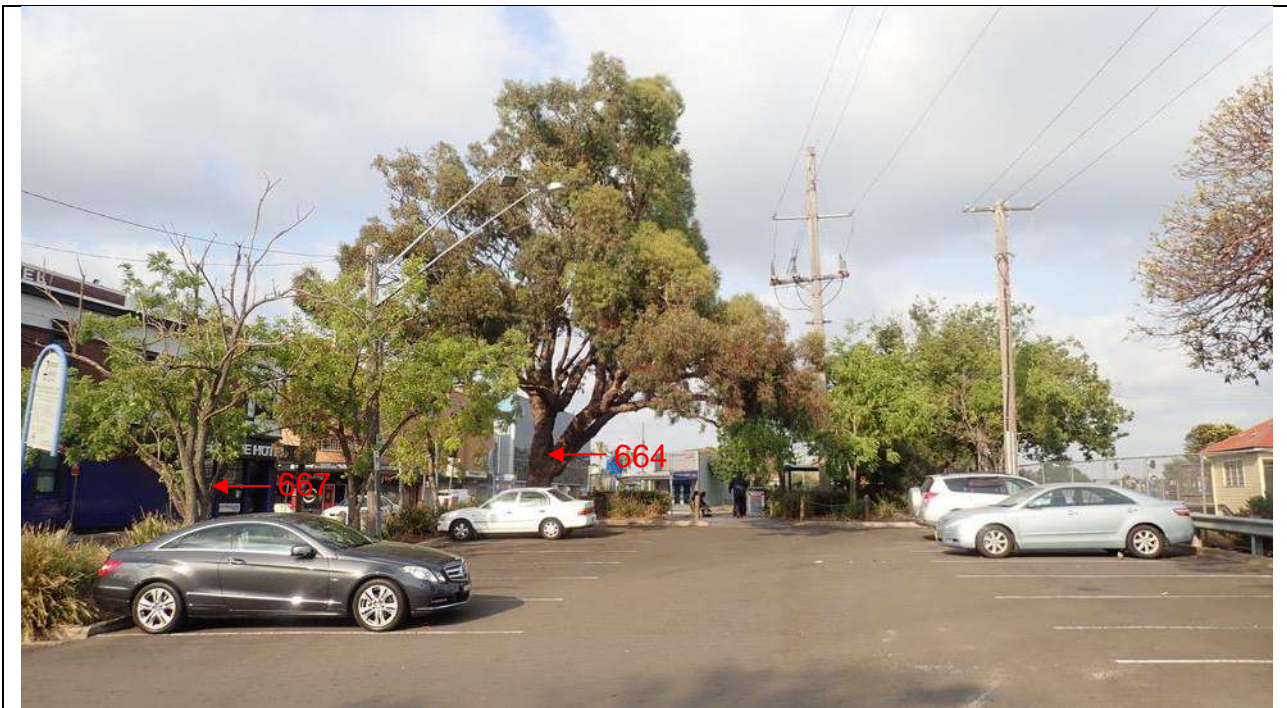
Image 1: Looking West towards tree 664 and 667. The proposed construction must be completed in accordance with section 9.2 to ensure tree 664 is not significantly impacted by the proposed works. Tree 667 is in poor health/advanced stages of decline and is recommended for removal due to its current condition and impacts from the proposed development.

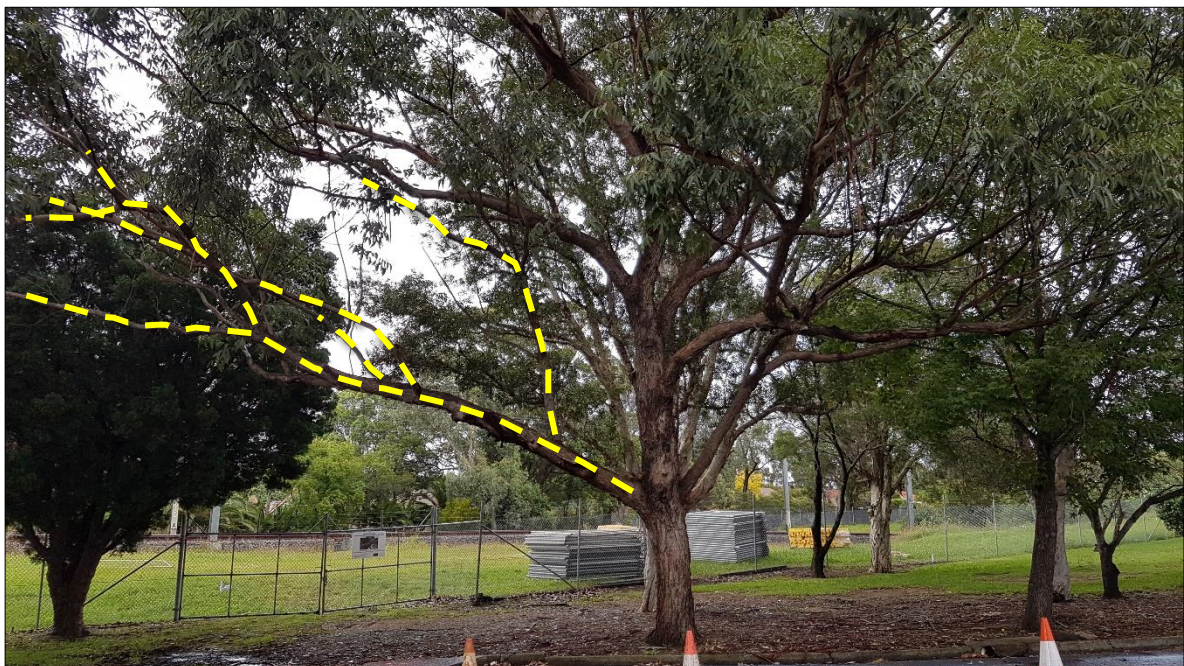
Tree 14 *Eucalyptus robusta* (Swamp Mahogany) identified pruning involves the removal of one first order branch at 2m height. The branch is approximately 300mm in diameter and constitutes 30% of the total canopy volume of the tree. A reduction in tree growth and physiological function can be expected as a result of the pruning works. Exposure of internal woody tissues at the site of the final pruning cut shall be susceptible to infection by decay causing fungi. The removal of the branch is not considered to significantly affect vocal amenity.

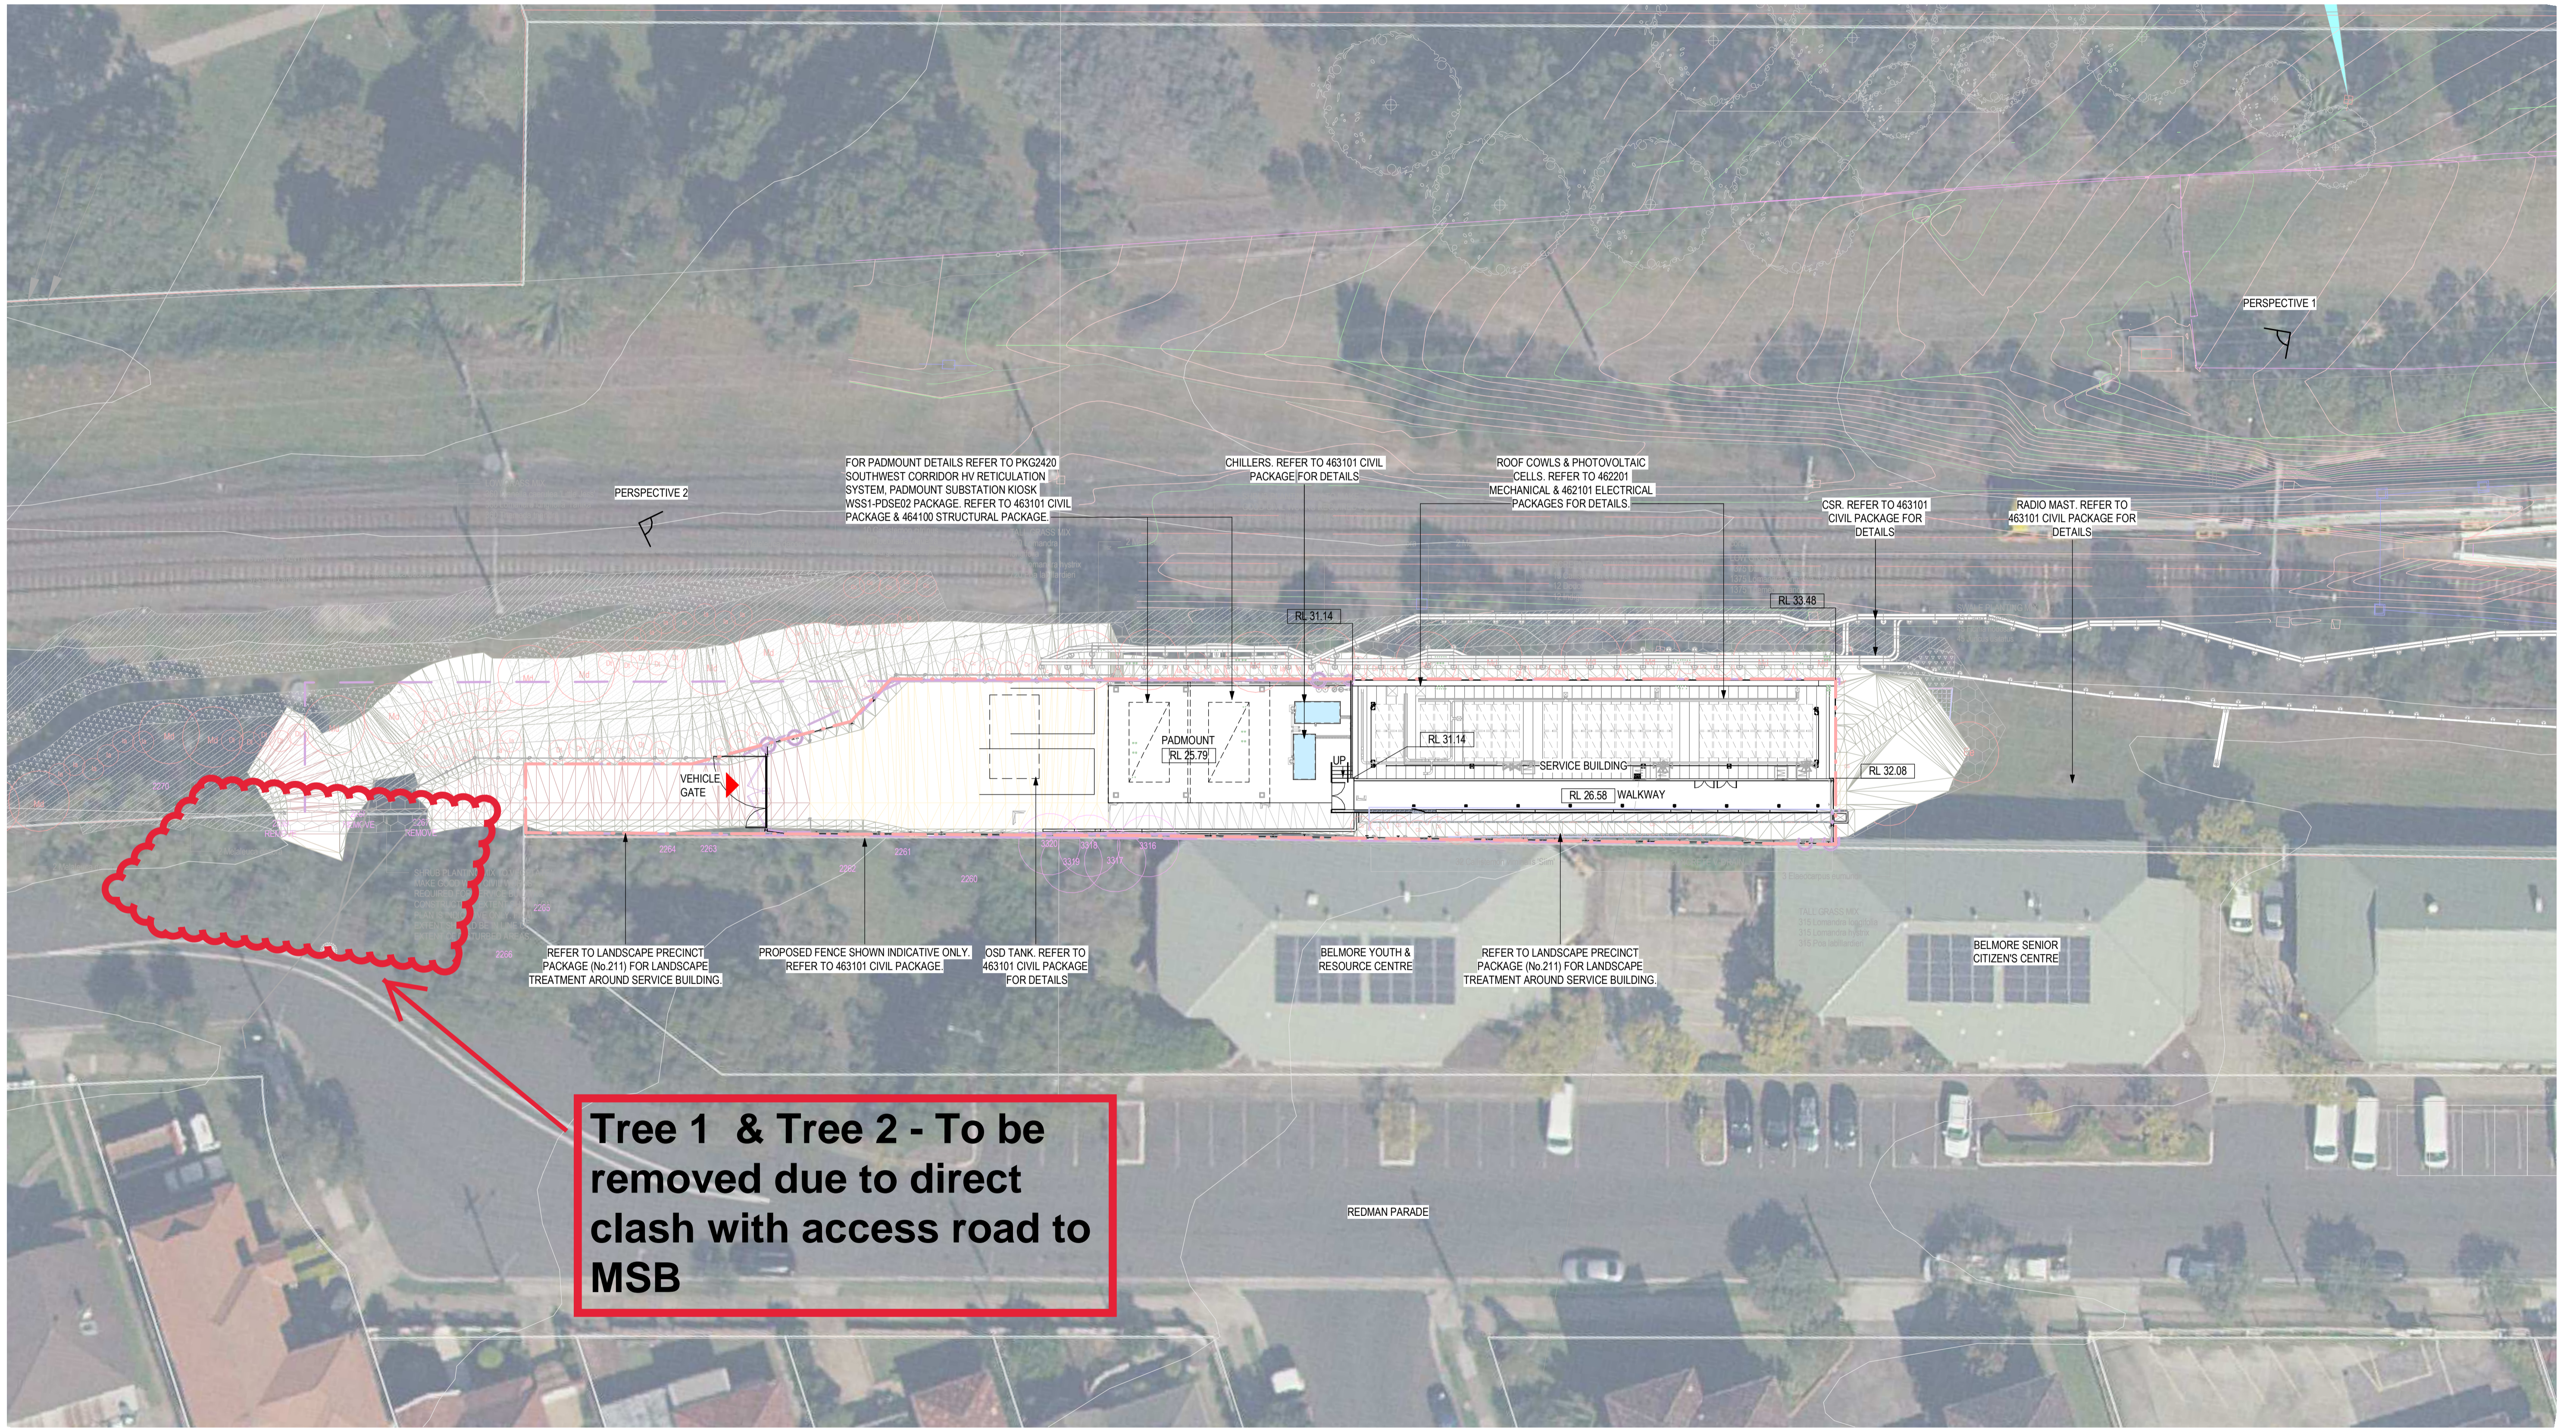
Tree 1 & Tree 2 - To be removed due to direct clash with access road to MSB

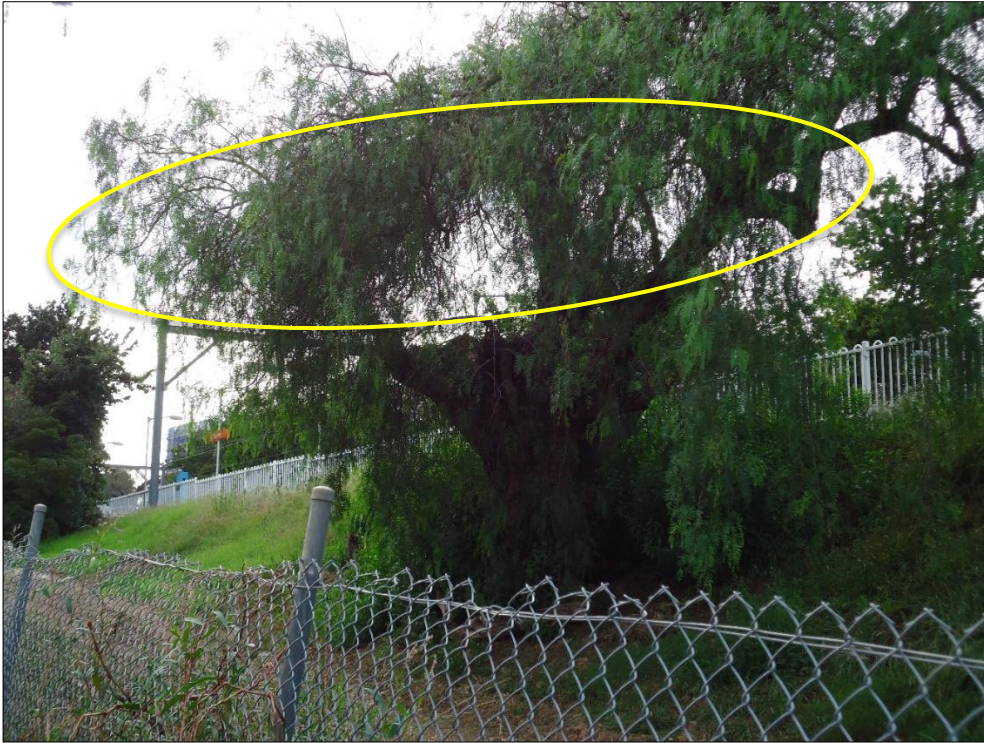
Pruning works were identified to be undertaken on tree 692 *Schinus molle* (Peppercorn Tree) to provide clearance along the rail corridor access track for plant and equipment. It is envisioned that pruning works shall involve the reduction and removal of selected branches up to 100mm in diameter and constitute approximately 25-30% of the total live canopy volume of the tree. Based upon the current health and condition of the tree these pruning works are considered to be significant and shall likely result in a reduction of tree growth and physiological function. All pruning works are to be undertaken by suitably qualified tree workers and meet the requirements of *AS4373-2007 Pruning of Amenity Trees*. Image 2 shows the tree and branches that overhang the access road.

Image 2: Yellow outline indicates branches from Tree 692, *Schinus molle* (Peppercorn Tree), that shall require selective removal to provide clearances along the rail corridor access track.

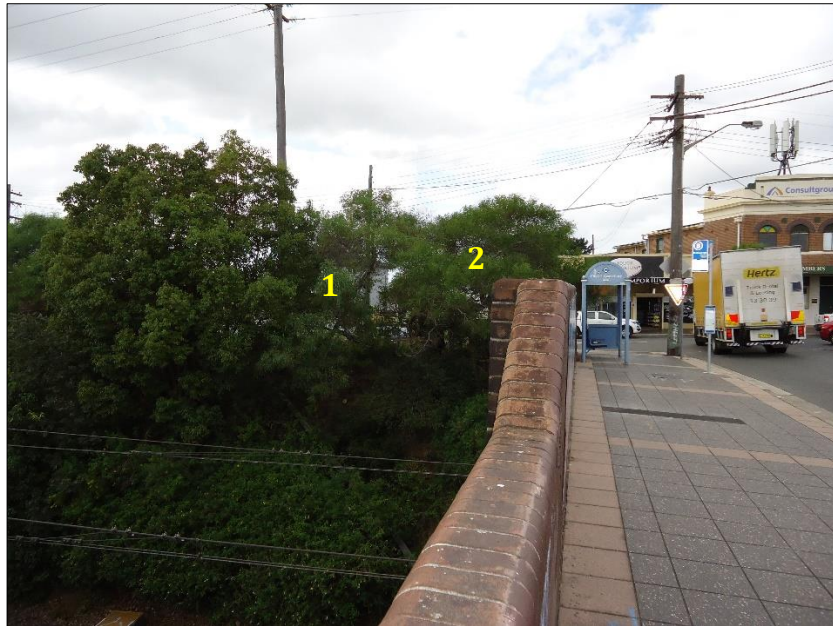
The two Wattles were identified for removal to accommodate soil nailing works. Image 2 shows the subject trees. The trees were found to have a short useful life expectancy given their species type and medium landscape significance. The trees provide some screening from the rail corridor and its associated infrastructure.

Image 2: Trees 1 and 2, Wattles require removal to accommodate soil pinning works adjacent the bridge.

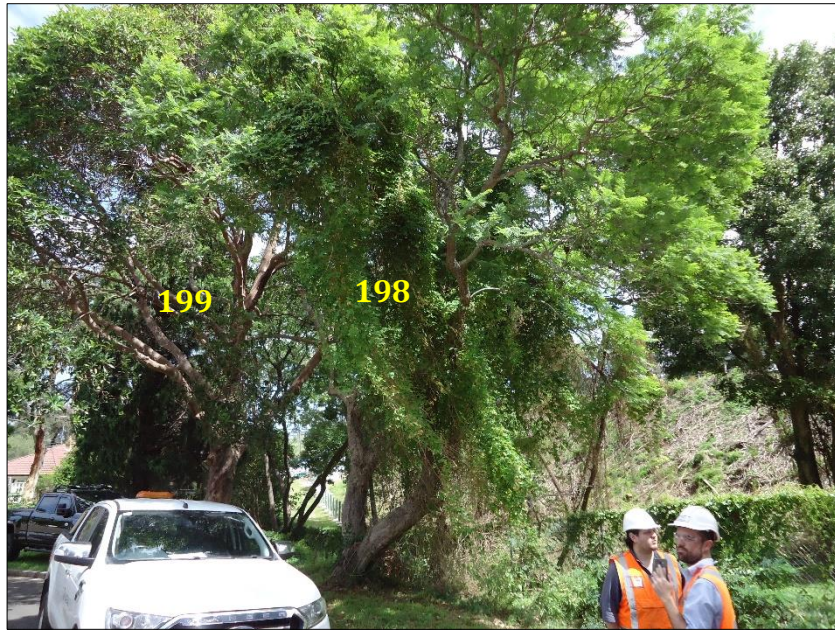
Image 5: Trees 198 and 199 as identified within the AIA report shall require removal for the Metro Services Building access road.

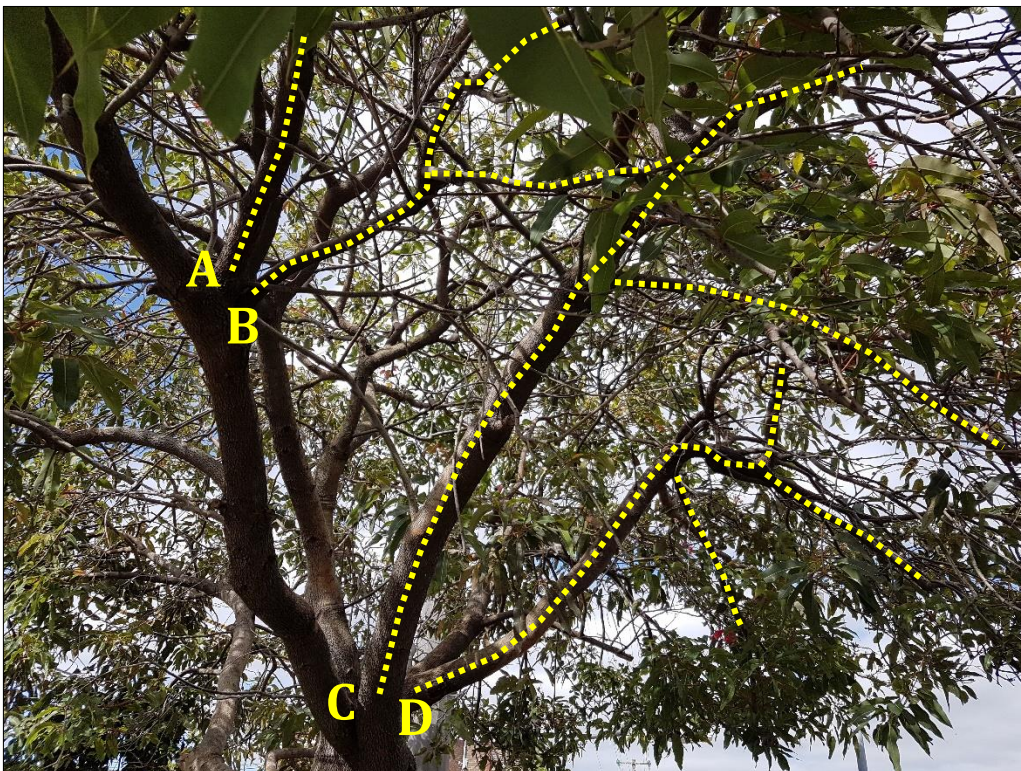
Photograph 3: Branches identified for removal from tree 591 to provide clearance for the proposed concourse roof structure. Branch A is 40mm in diameter at 2.7m height, branch B is 20mm in diameter at 2.7m height, branch C is 120mm in diameter at 2.1m height, branch D is 120mm in diameter at 2.2m height. The removal of identified branches constitutes approximately 35% of the total live canopy volume of the tree.

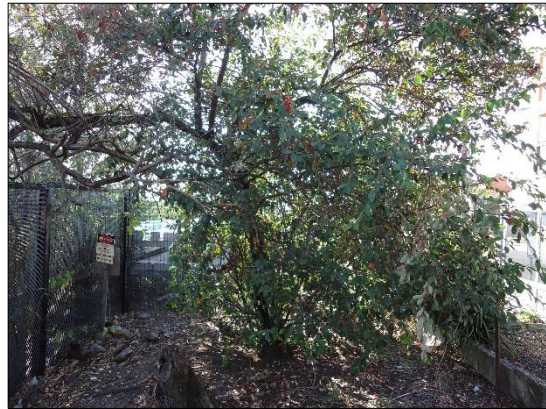
Photograph 2: Tree 516 *Leptosporum petersonii* (Lemon-scented Teatree) was found to be dead.

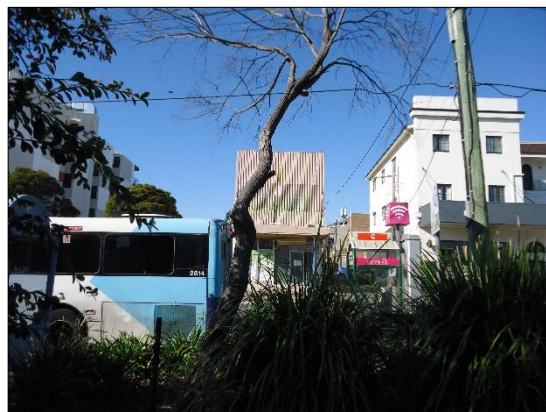
Photograph 3: Tree 517 *Pittosporum undulatum* (Sweet Pittosporum) was found to be dead.

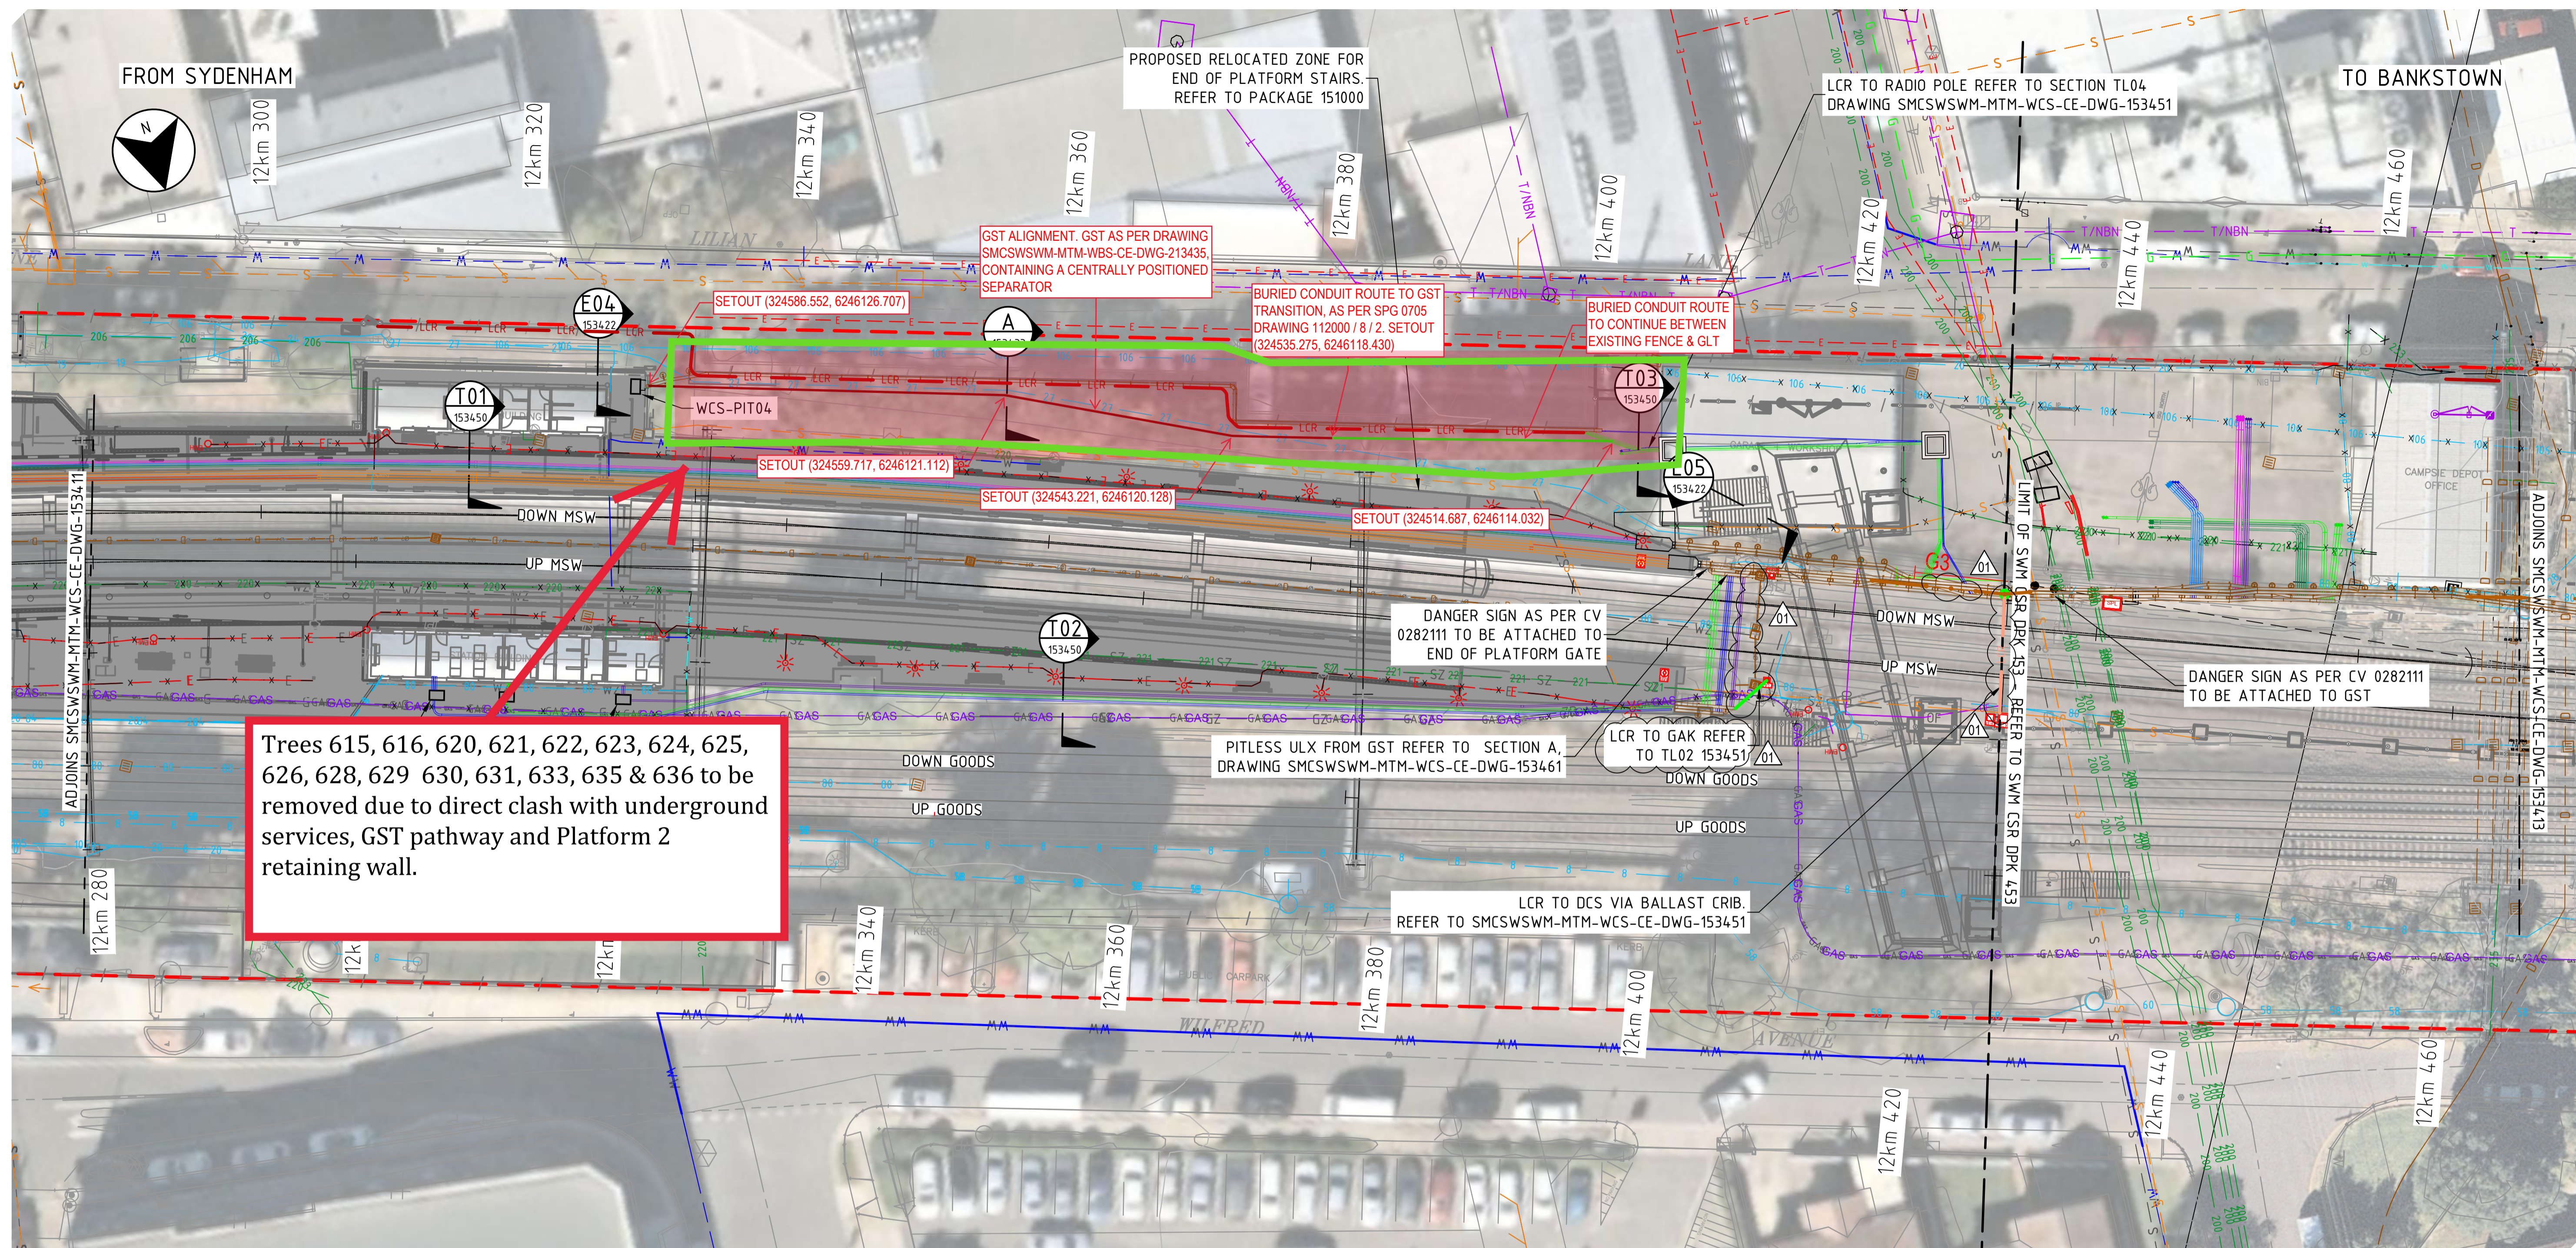
Trees 615, 616, 620, 621, 622, 623, 624, 625, 626, 628, 629 630, 631, 633, 635 & 636 to be removed due to direct clash with underground services, GST pathway and Platform 2 retaining wall.

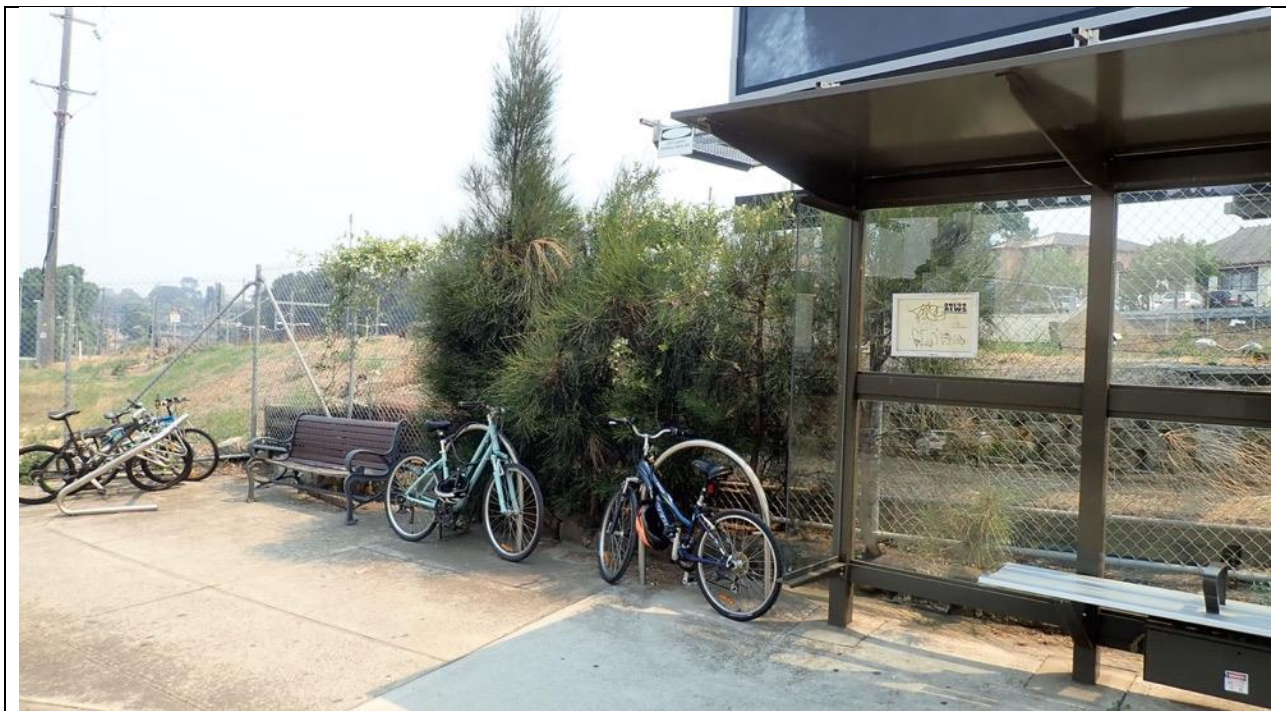
Image 2: Looking North towards trees 586, 587, 588, 589 and 590. The trees have been recommended for removal due to construction impacts from the proposed hard surfacing excavations.

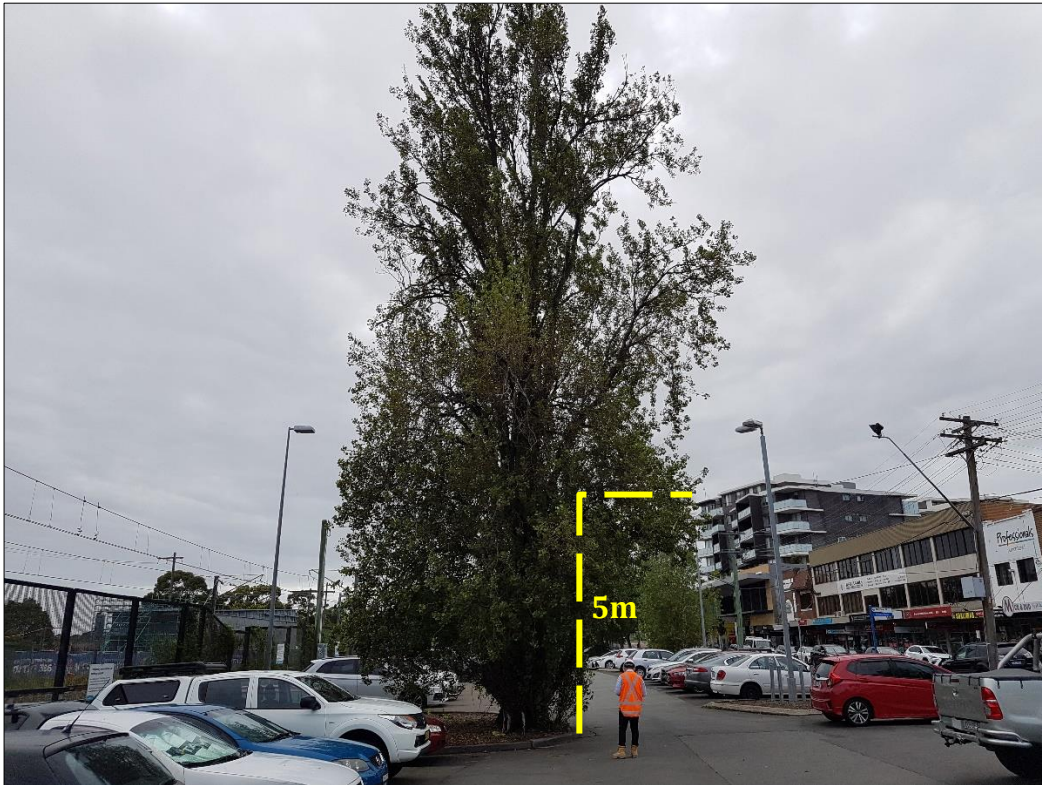
Photograph 1: Tree 1 *Populus nigra* 'Italica' (Lombardy Poplar as seen from the carpark area adjacent The Boulevard. 5m of vertical clearance is required from the outside edge of kerb adjacent the base of the tree.
