Tree Impact Assessment Report

City and Southwest Metro Station Upgrade Works Package 5 & 6

P5 Document No. SMCSWSW5-DEW-WEC-EM-REP-000542

P6 Document No. SMCSWSW6-DEW-WEC-EM-REP-000632

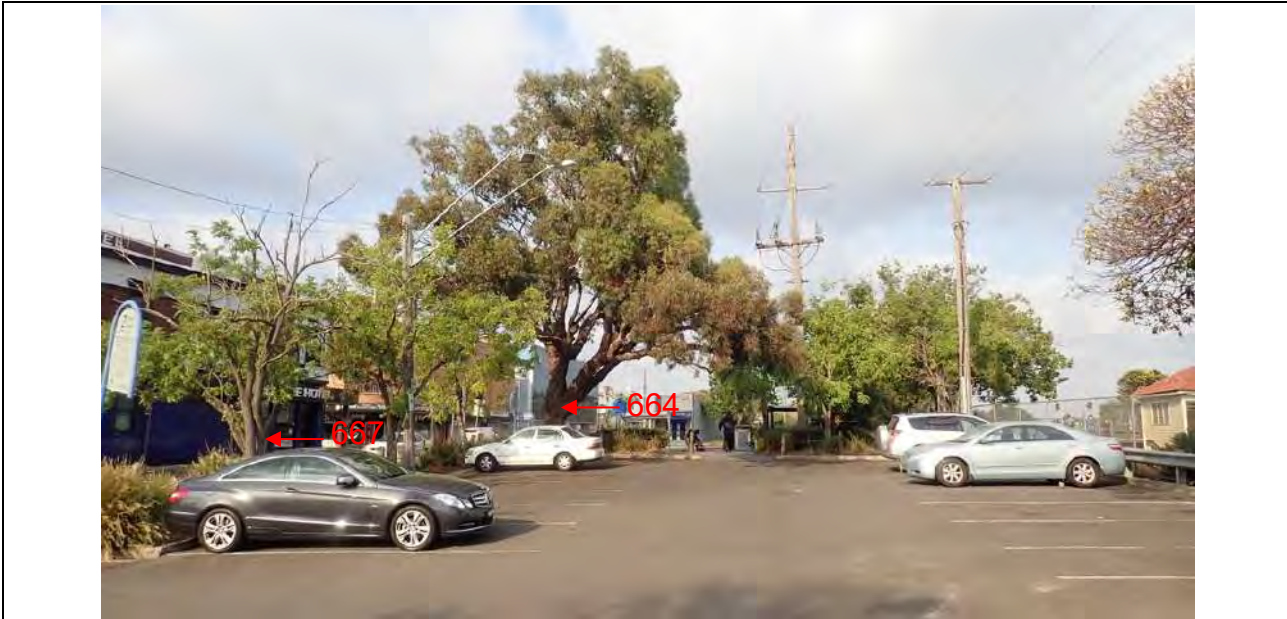
Image 1: Looking West towards tree 664 and 667. The proposed construction must be completed in accordance with section 9.2 to ensure tree 664 is not significantly impacted by the proposed works. Tree 667 is in poor health/advanced stages of decline and is recommended for removal due to its current condition and impacts from the proposed development.

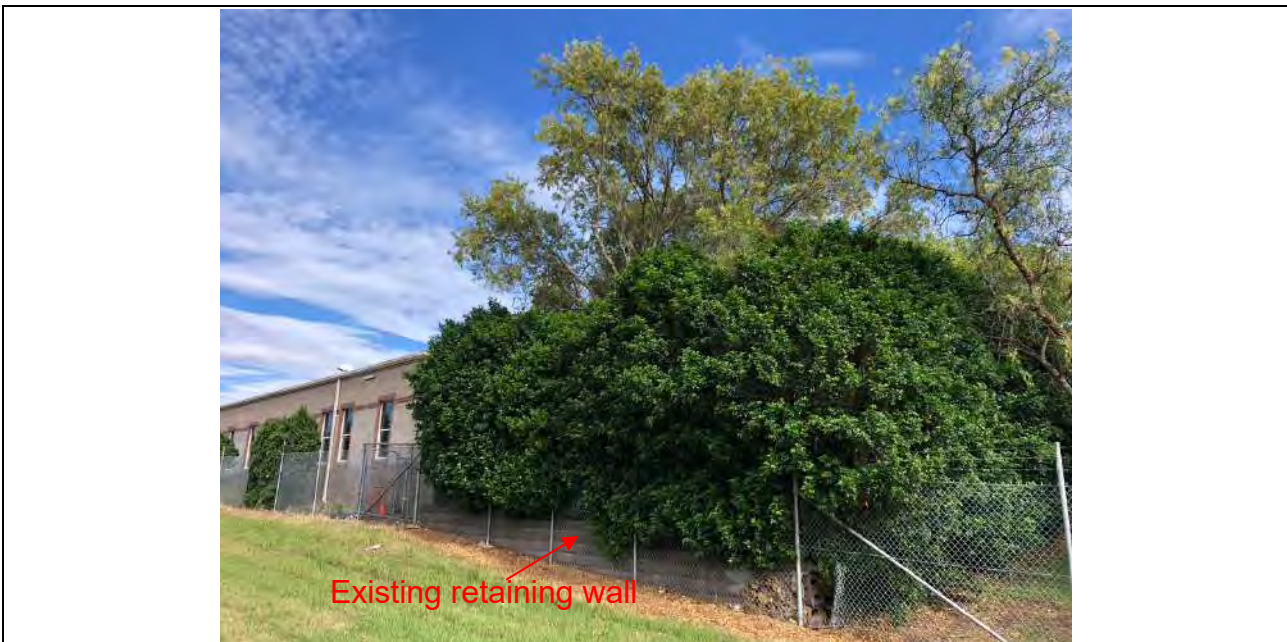
Image 2: Looking towards tree 3316, 3317, 3318, 3319 and 3320, showing the existing boundary retaining wall. The existing boundary retaining wall appears to be restricting root growth into the corridor, therefore, the proposed works within the corridor will not impact the trees. Minor canopy pruning may be required for tree 3316, 3317, 3319 and 3320. The proposed canopy pruning will result in the removal of less than 10% of the live foliage area of the trees and will not significantly impact the trees.

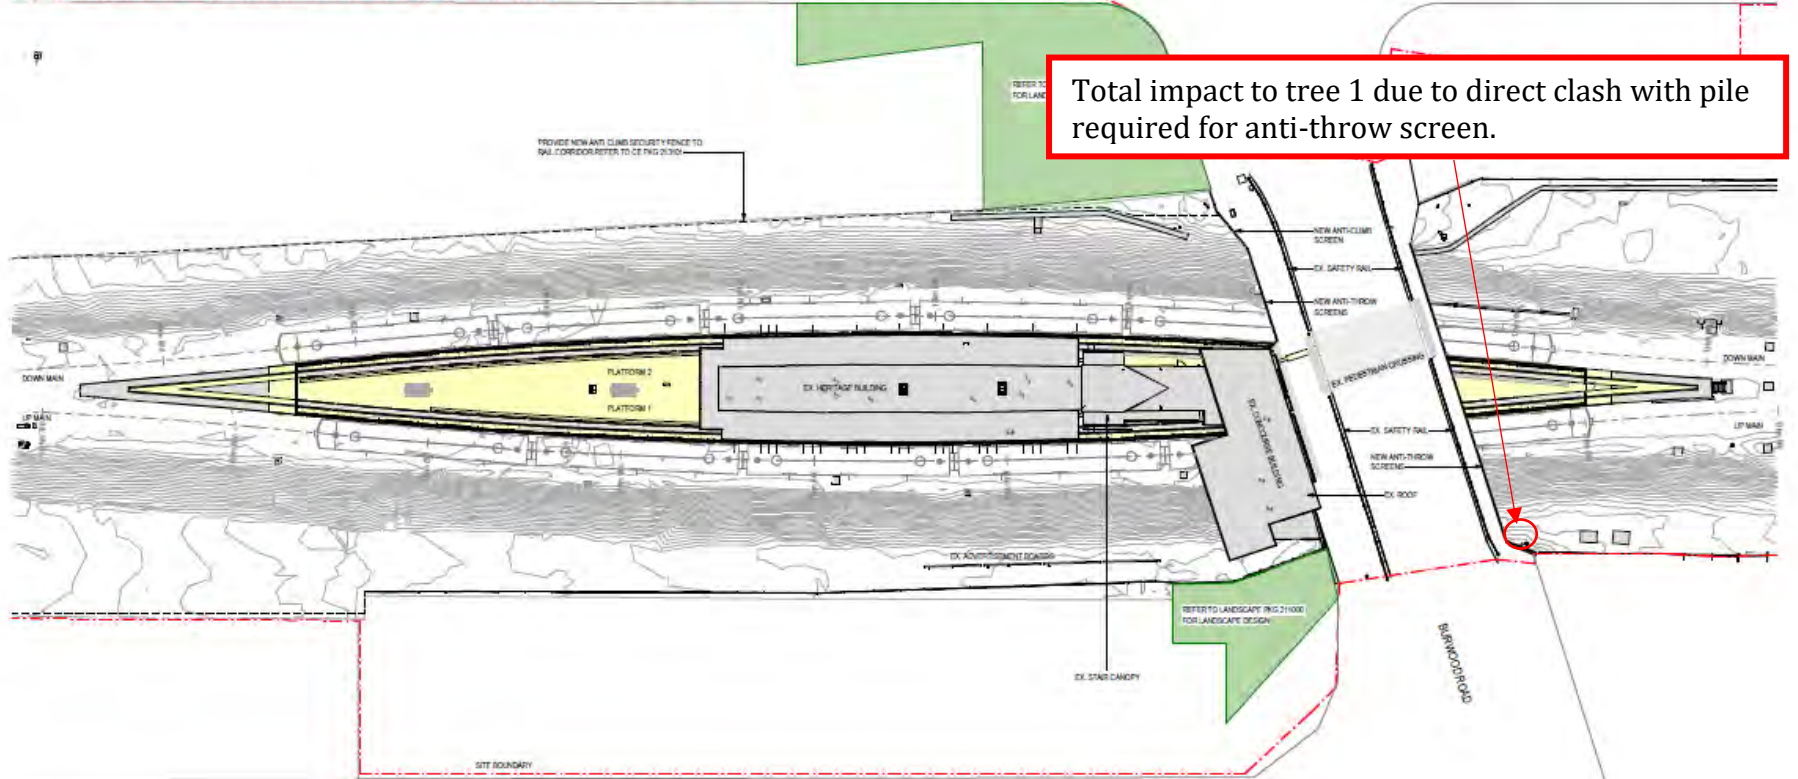
Total impact to tree 1 due to direct clash with pile required for anti-throw screen.

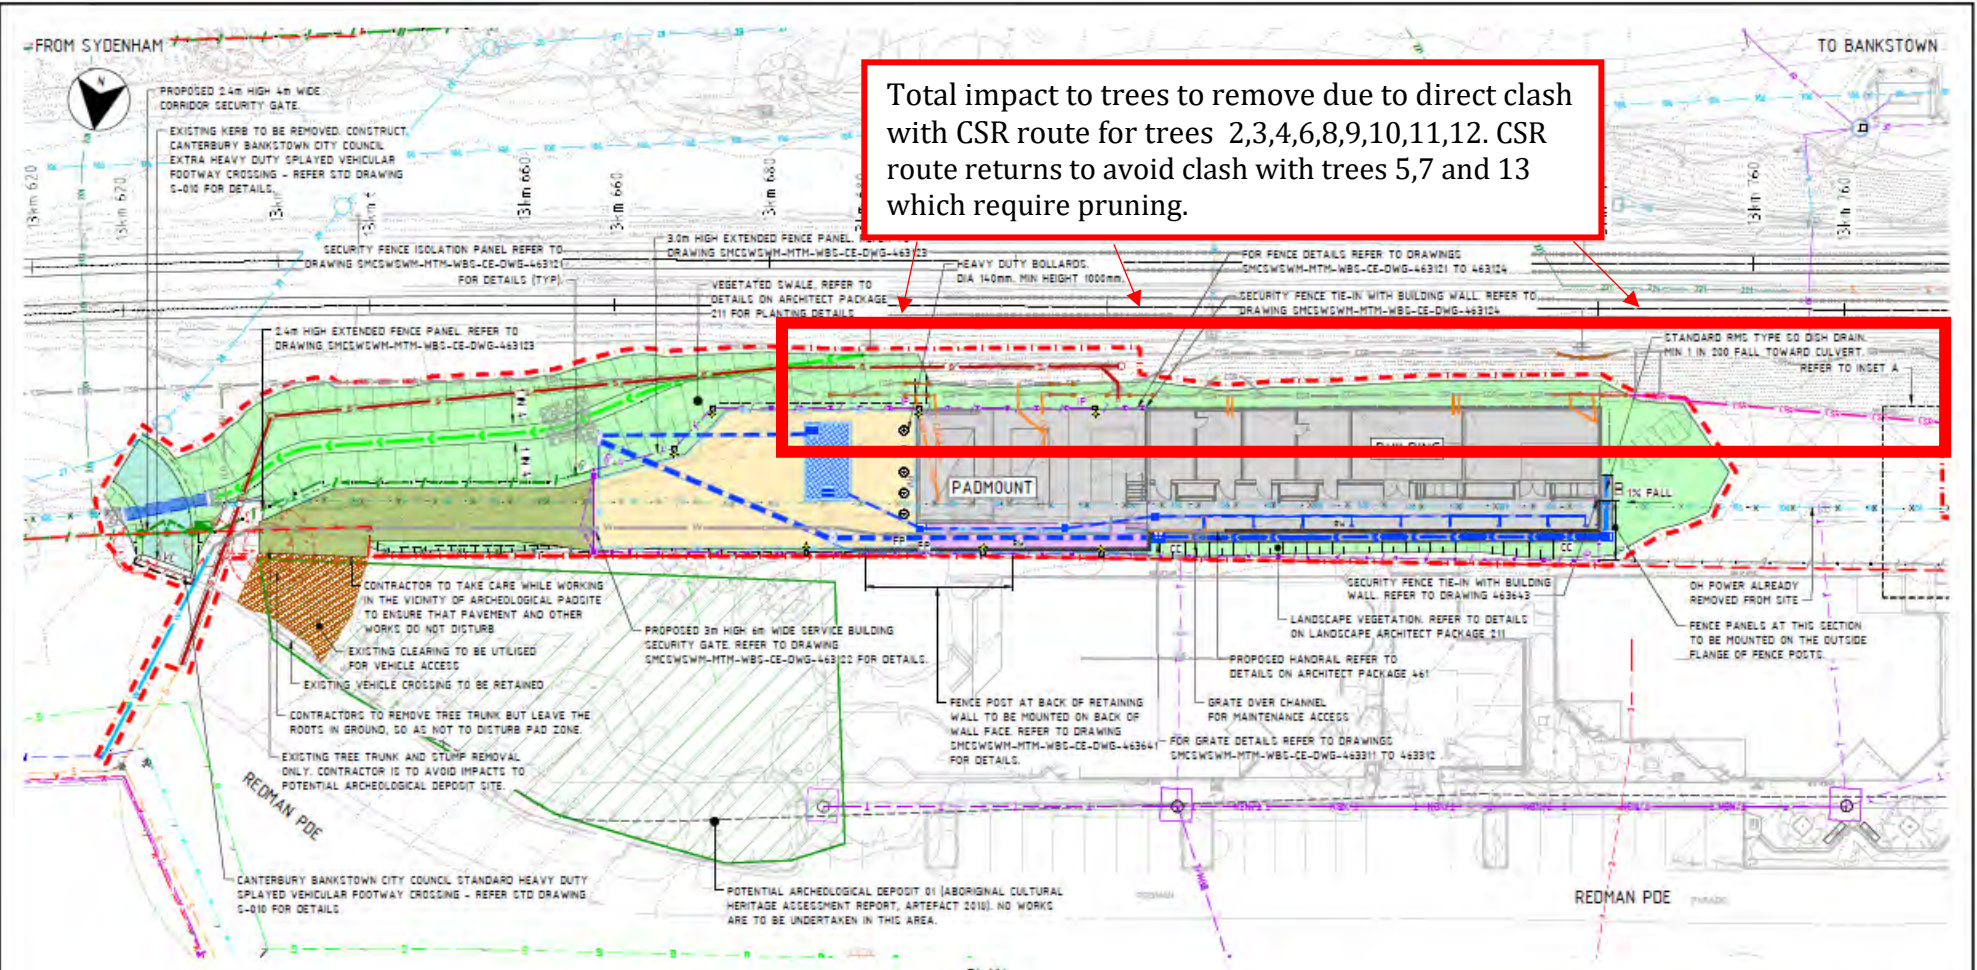
Total impact to trees to remove due to direct clash with CSR route for trees 2,3,4,6,8,9,10,11,12. CSR route returns to avoid clash with trees 5,7 and 13 which require pruning.

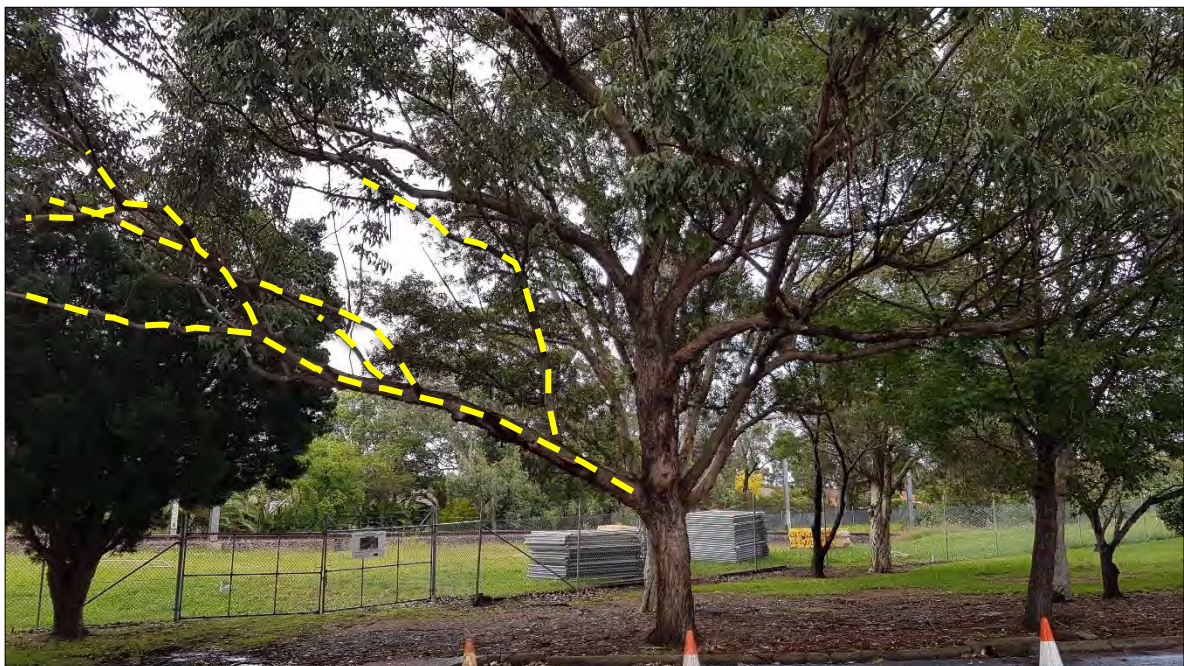
Tree 14 *Eucalyptus robusta* (Swamp Mahogany) identified pruning involves the removal of one first order branch at 2m height. The branch is approximately 300mm in diameter and constitutes 30% of the total canopy volume of the tree. A reduction in tree growth and physiological function can be expected as a result of the pruning works. Exposure of internal woody tissues at the site of the final pruning cut shall be susceptible to infection by decay causing fungi. The removal of the branch is not considered to significantly affect vocal amenity.

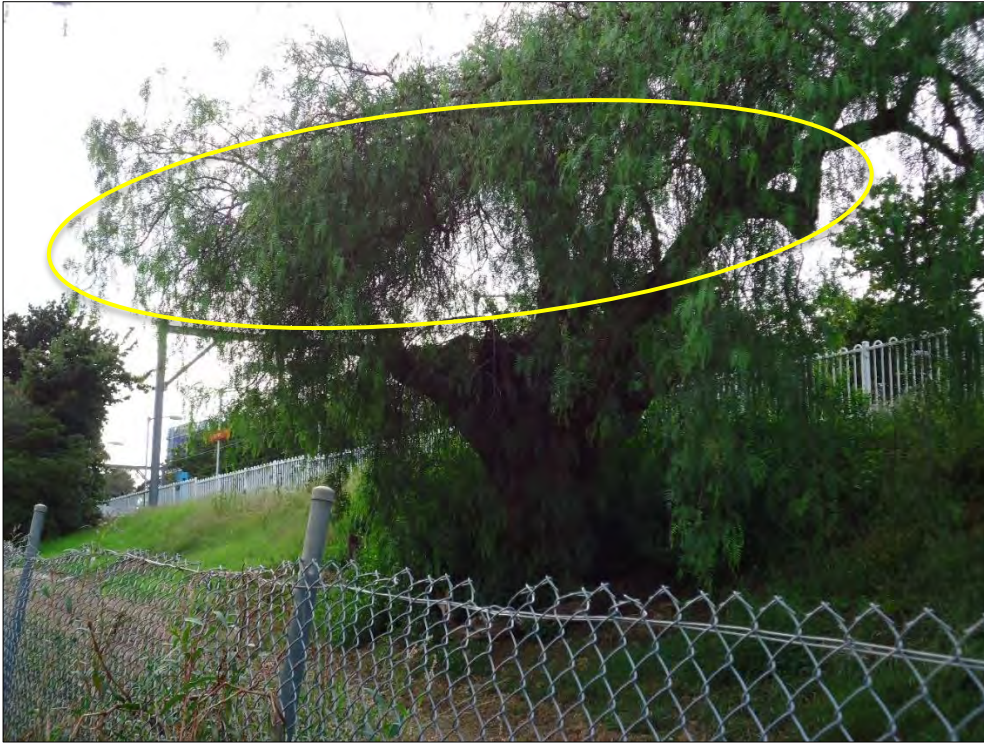
Image 2: Yellow outline indicates branches from Tree 692, *Schinus molle* (Peppercorn Tree), that shall require selective removal to provide clearances along the rail corridor access track.

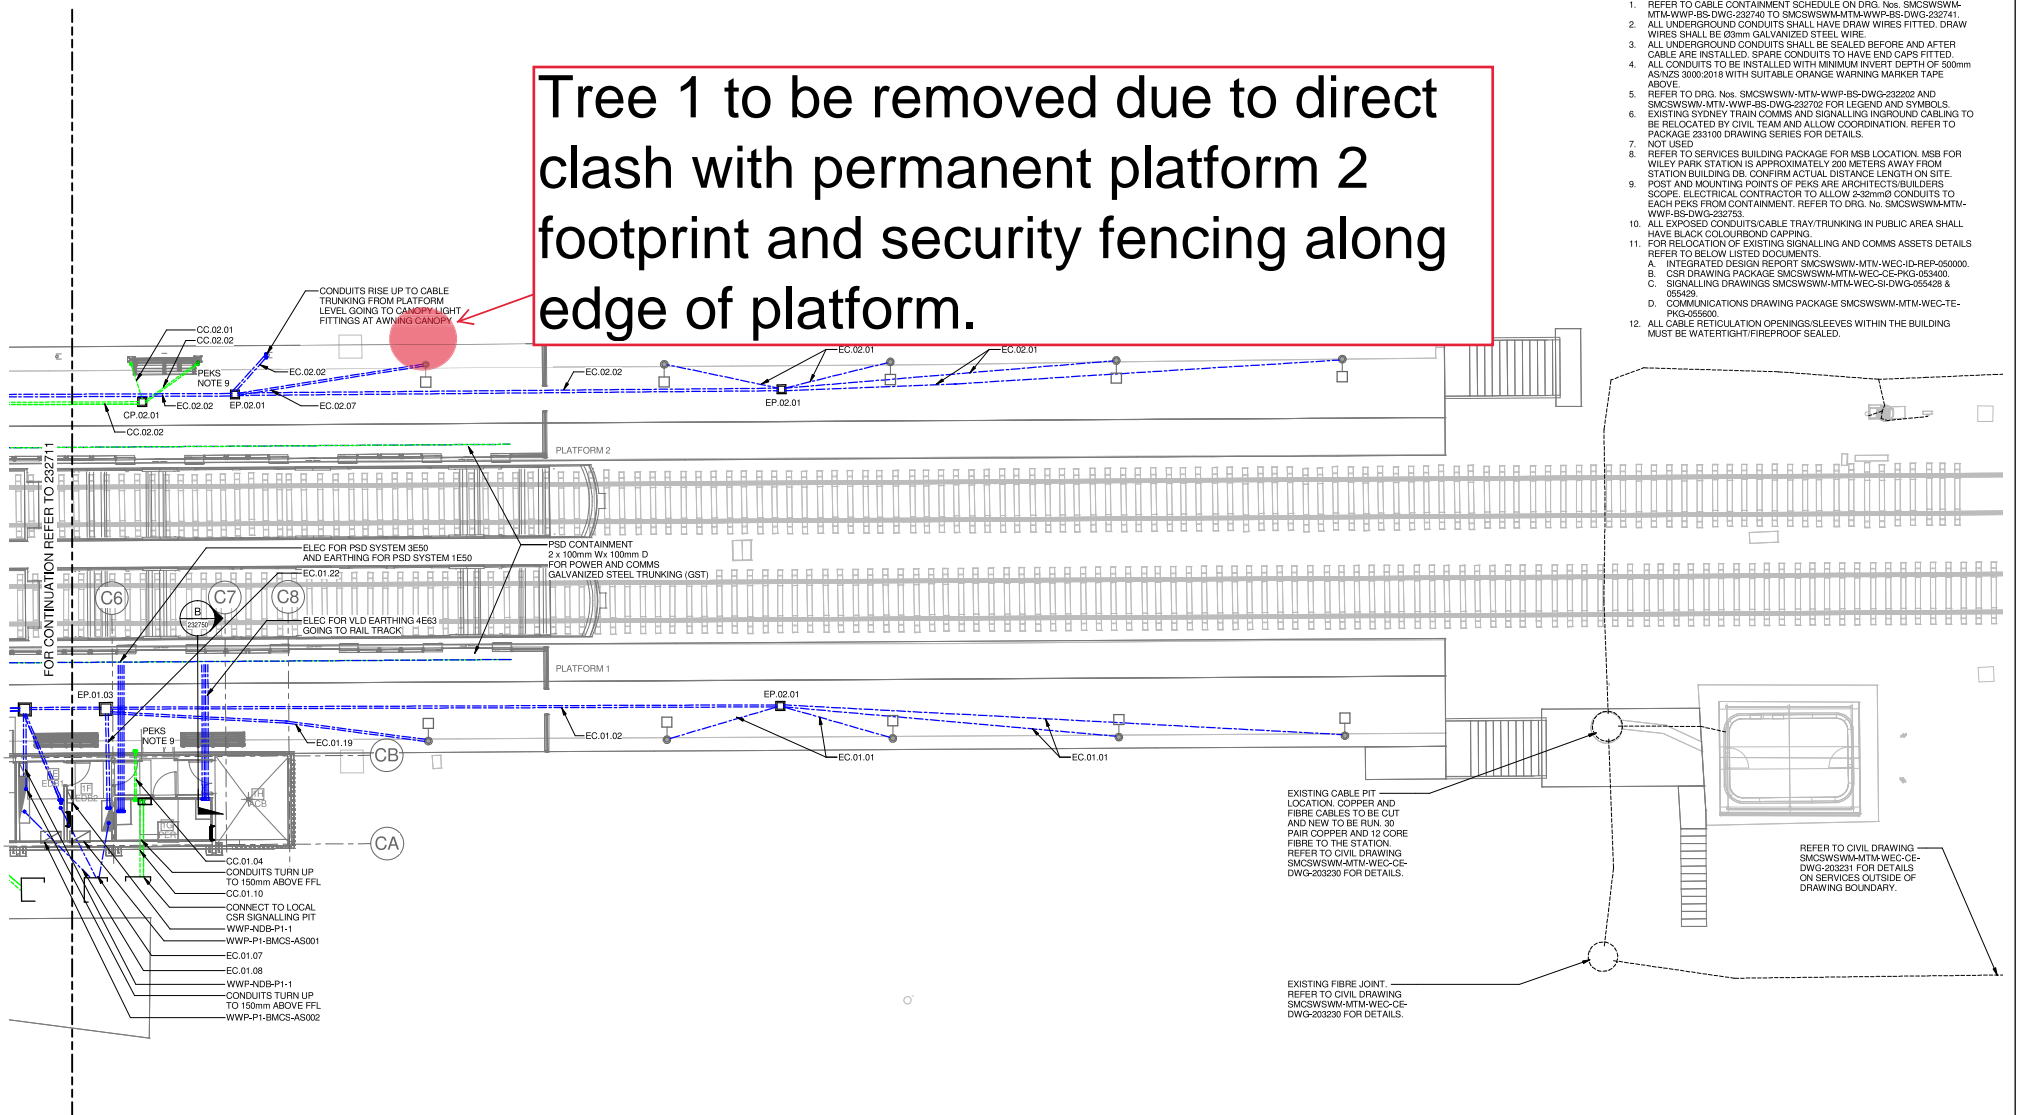
Tree 1 to be removed due to direct clash with permanent platform 2 footprint and security fencing along edge of platform.

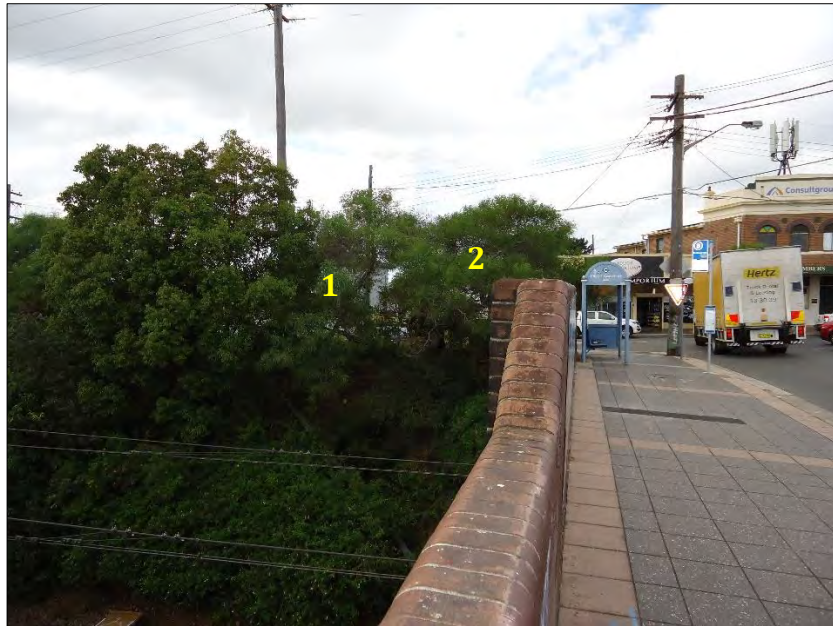
Image 2: Trees 1 and 2, Wattles require removal to accommodate soil pinning works adjacent the bridge.

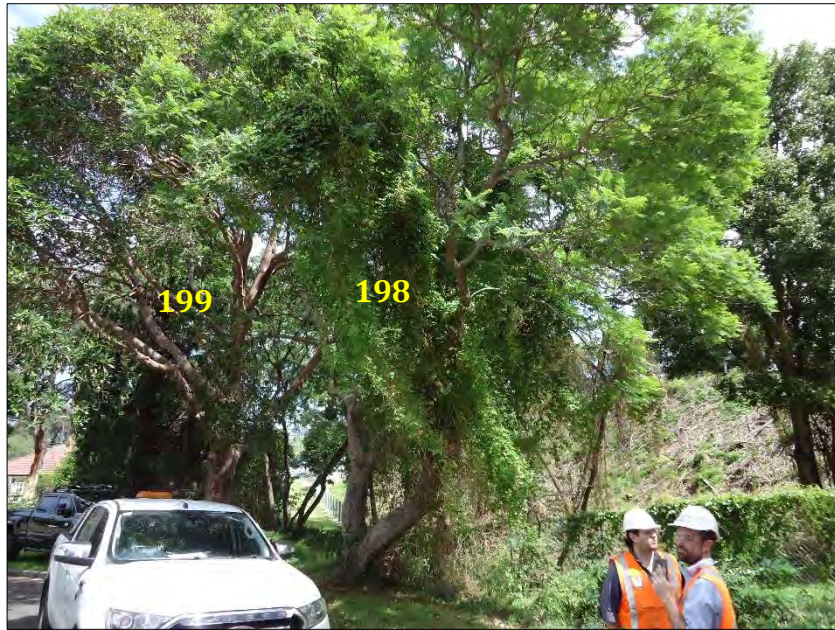
Image 5: Trees 198 and 199 as identified within the AIA report shall require removal for the Metro Services Building access road.

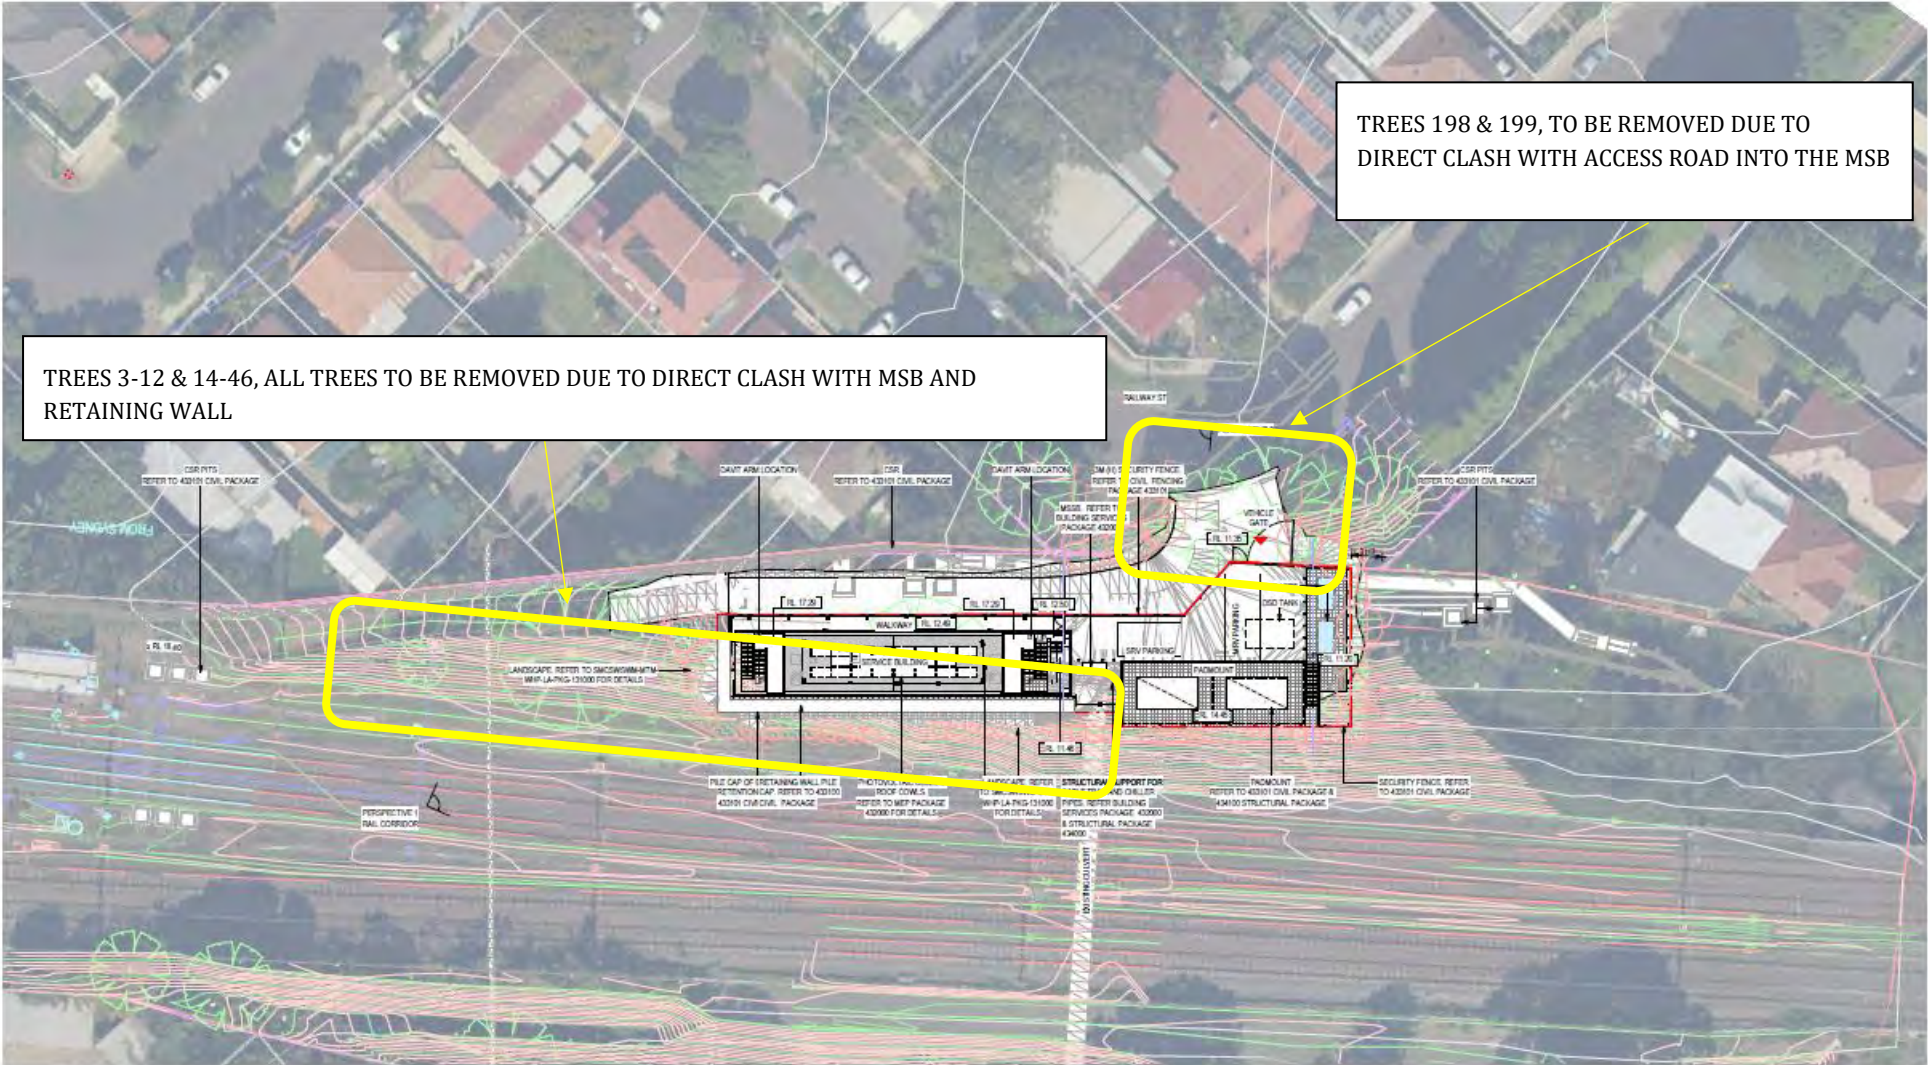
TREES 3-12 & 14-46, ALL TREES TO BE REMOVED DUE TO DIRECT CLASH WITH MSB AND RETAINING WALL

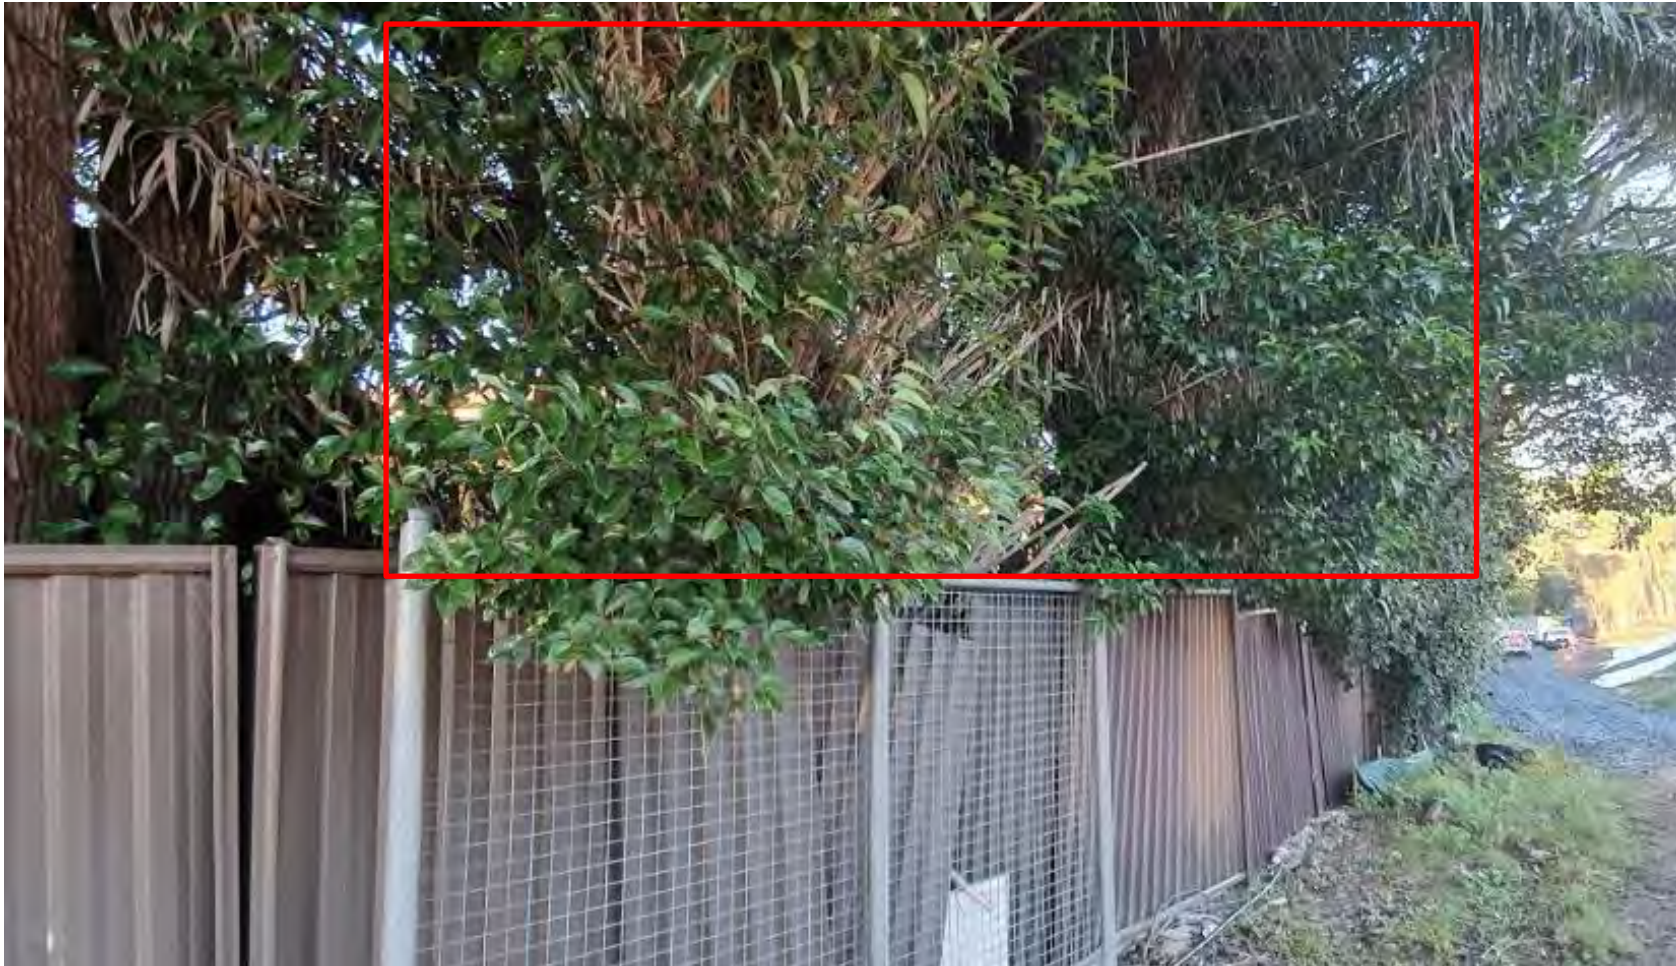
This area of foliage is minor regrowth from weed species and is requested to be pruned back to the fence line.

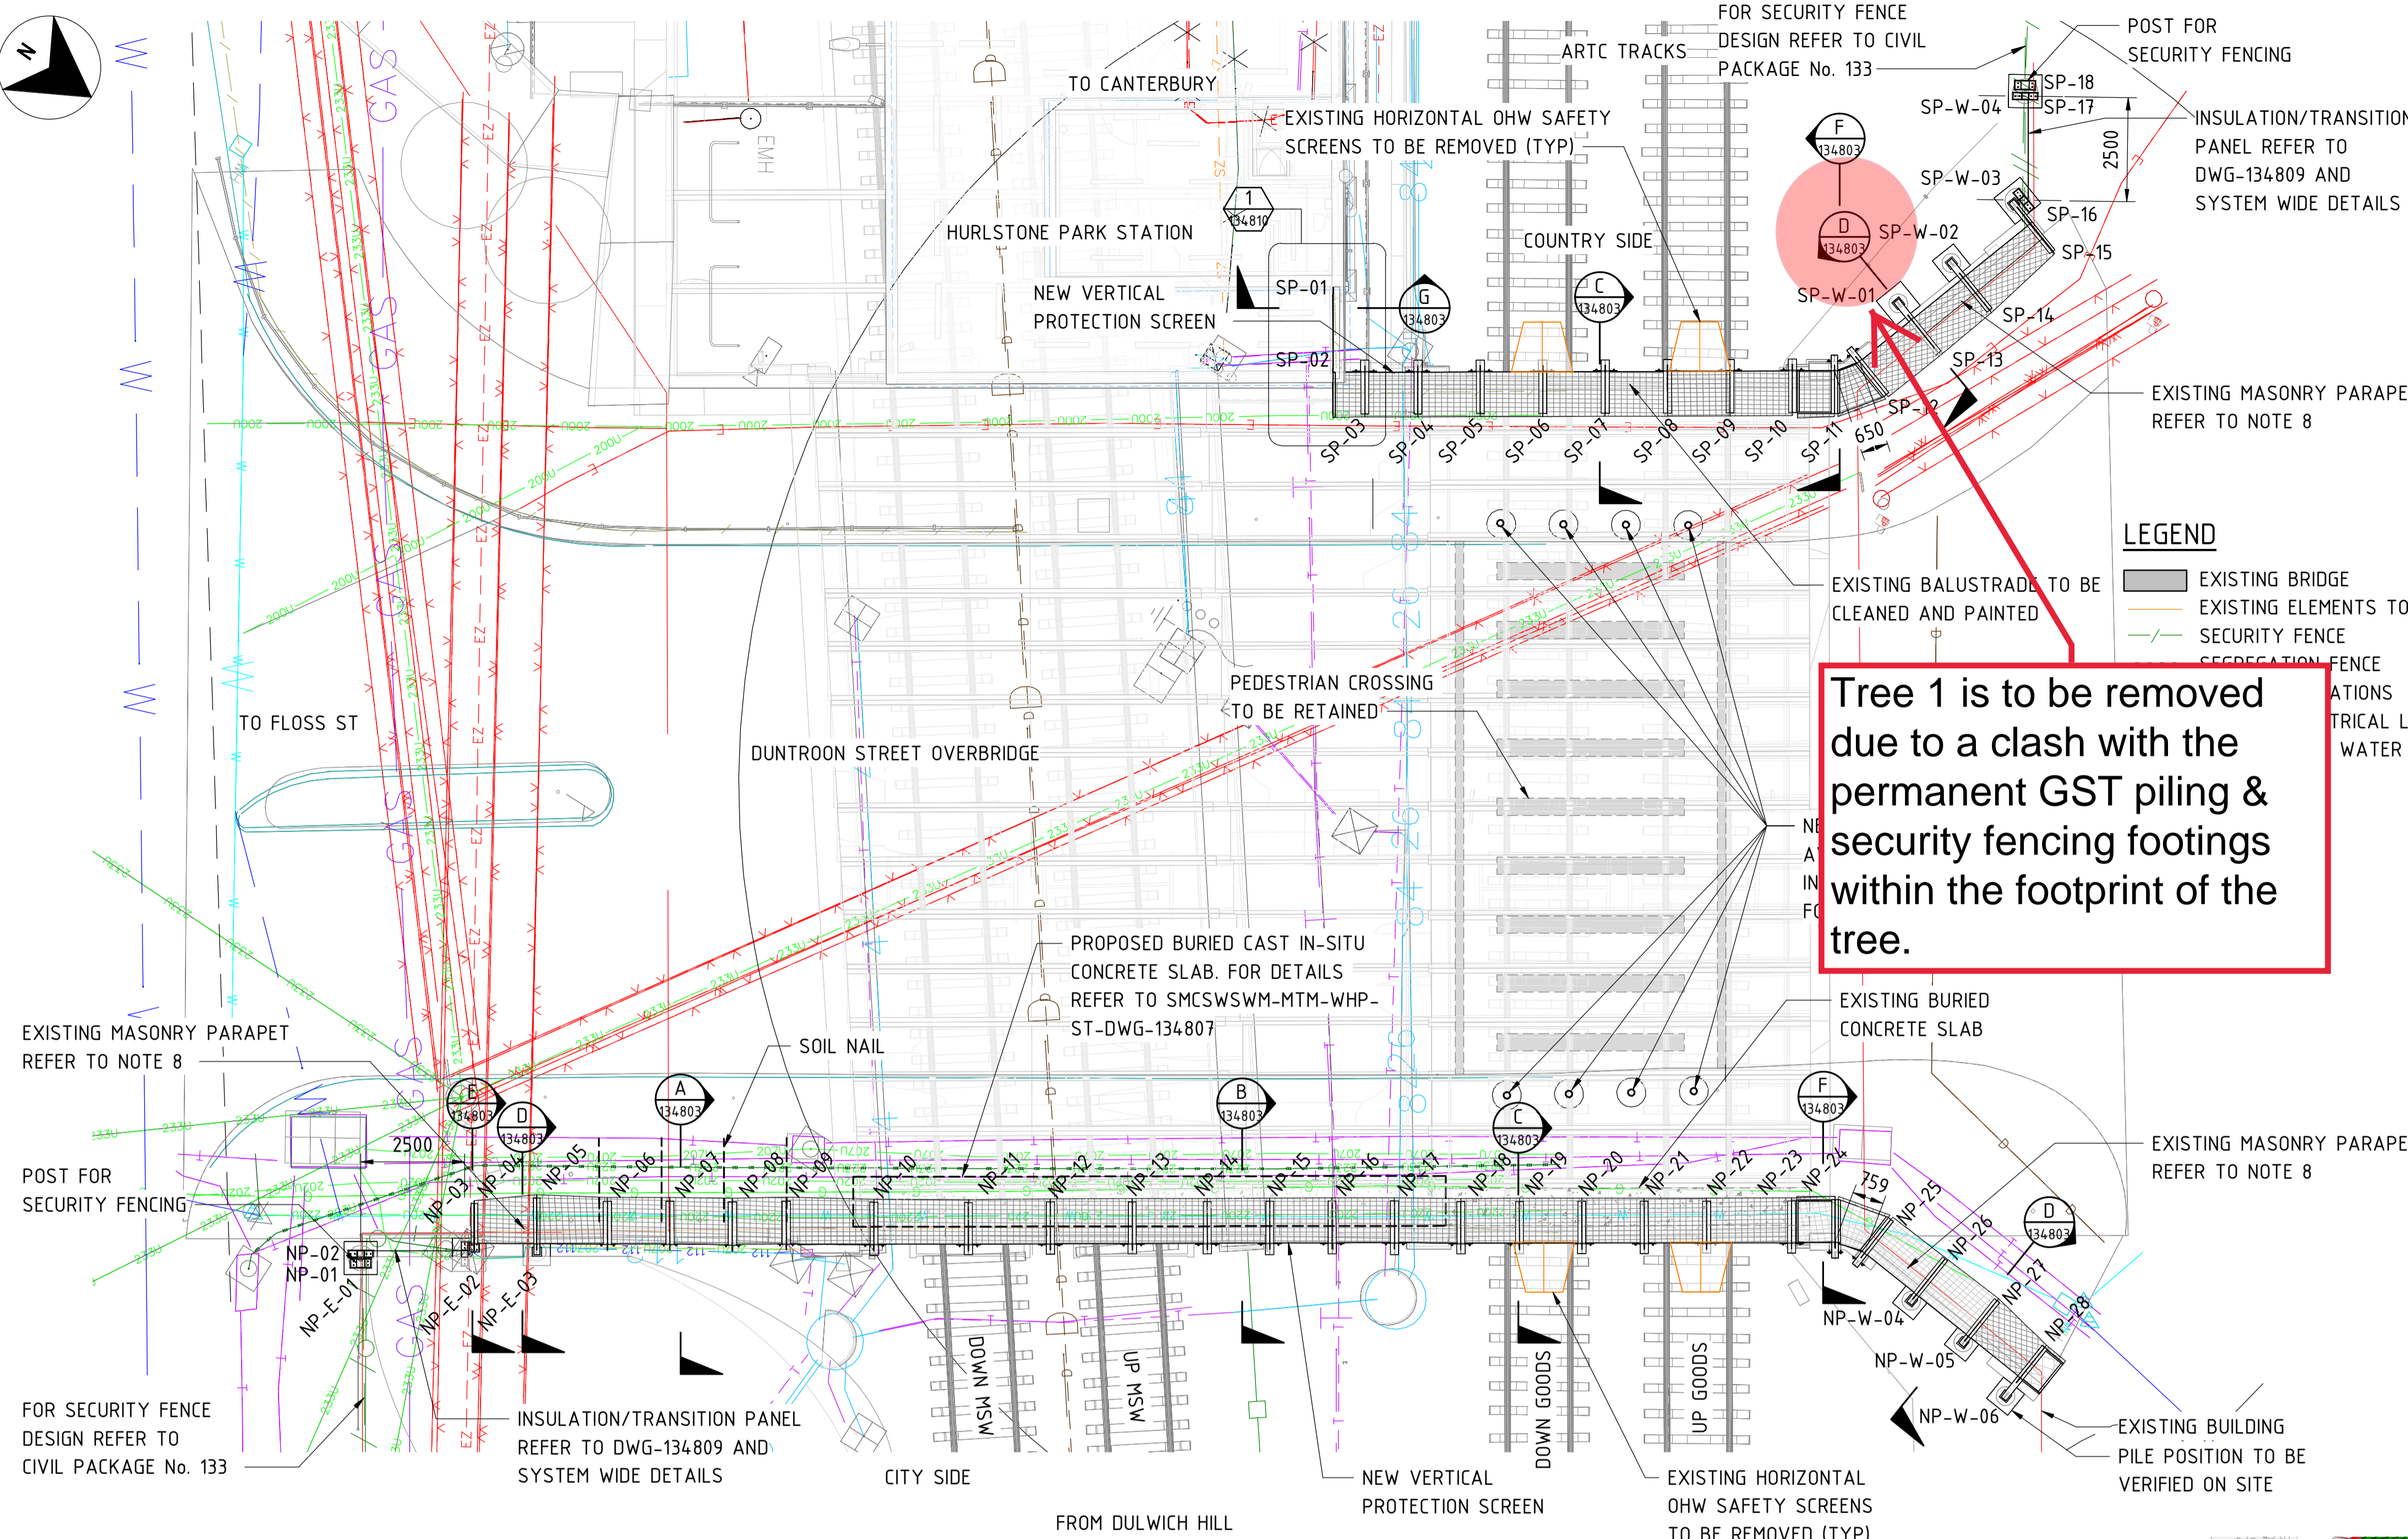
Tree 1 is to be removed due to a clash with the permanent GST piling & security fencing footings within the footprint of the tree.

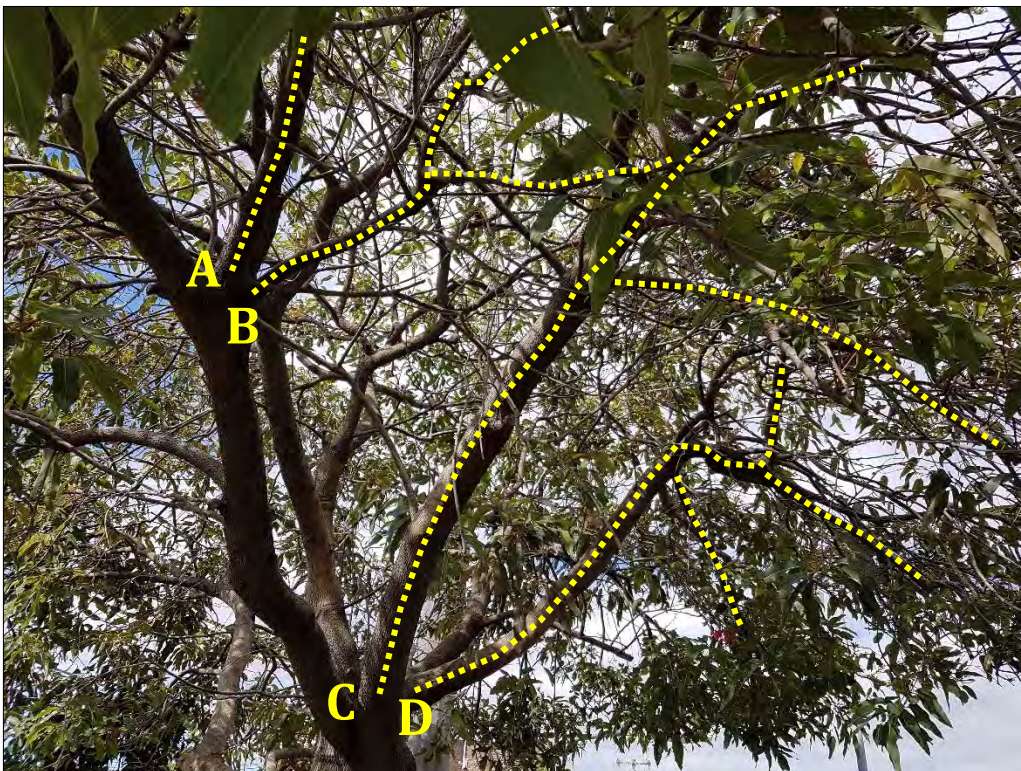
Photograph 3: Branches identified for removal from tree 591 to provide clearance for the proposed concourse roof structure. Branch A is 40mm in diameter at 2.7m height, branch B is 20mm in diameter at 2.7m height, branch C is 120mm in diameter at 2.1m height, branch D is 120mm in diameter at 2.2m height. The removal of identified branches constitutes approximately 35% of the total live canopy volume of the tree.
