Tree Impact Assessment Report

City and Southwest Metro Station Upgrade Works Package 5 & 6

**Project wide: Hurlstone Park, Wiley Park, Belmore,
Campsie, Dulwich Hill and Punchbowl**

P5 Document No. SMCSWSW5-DEW-WEC-EM-REP-000542

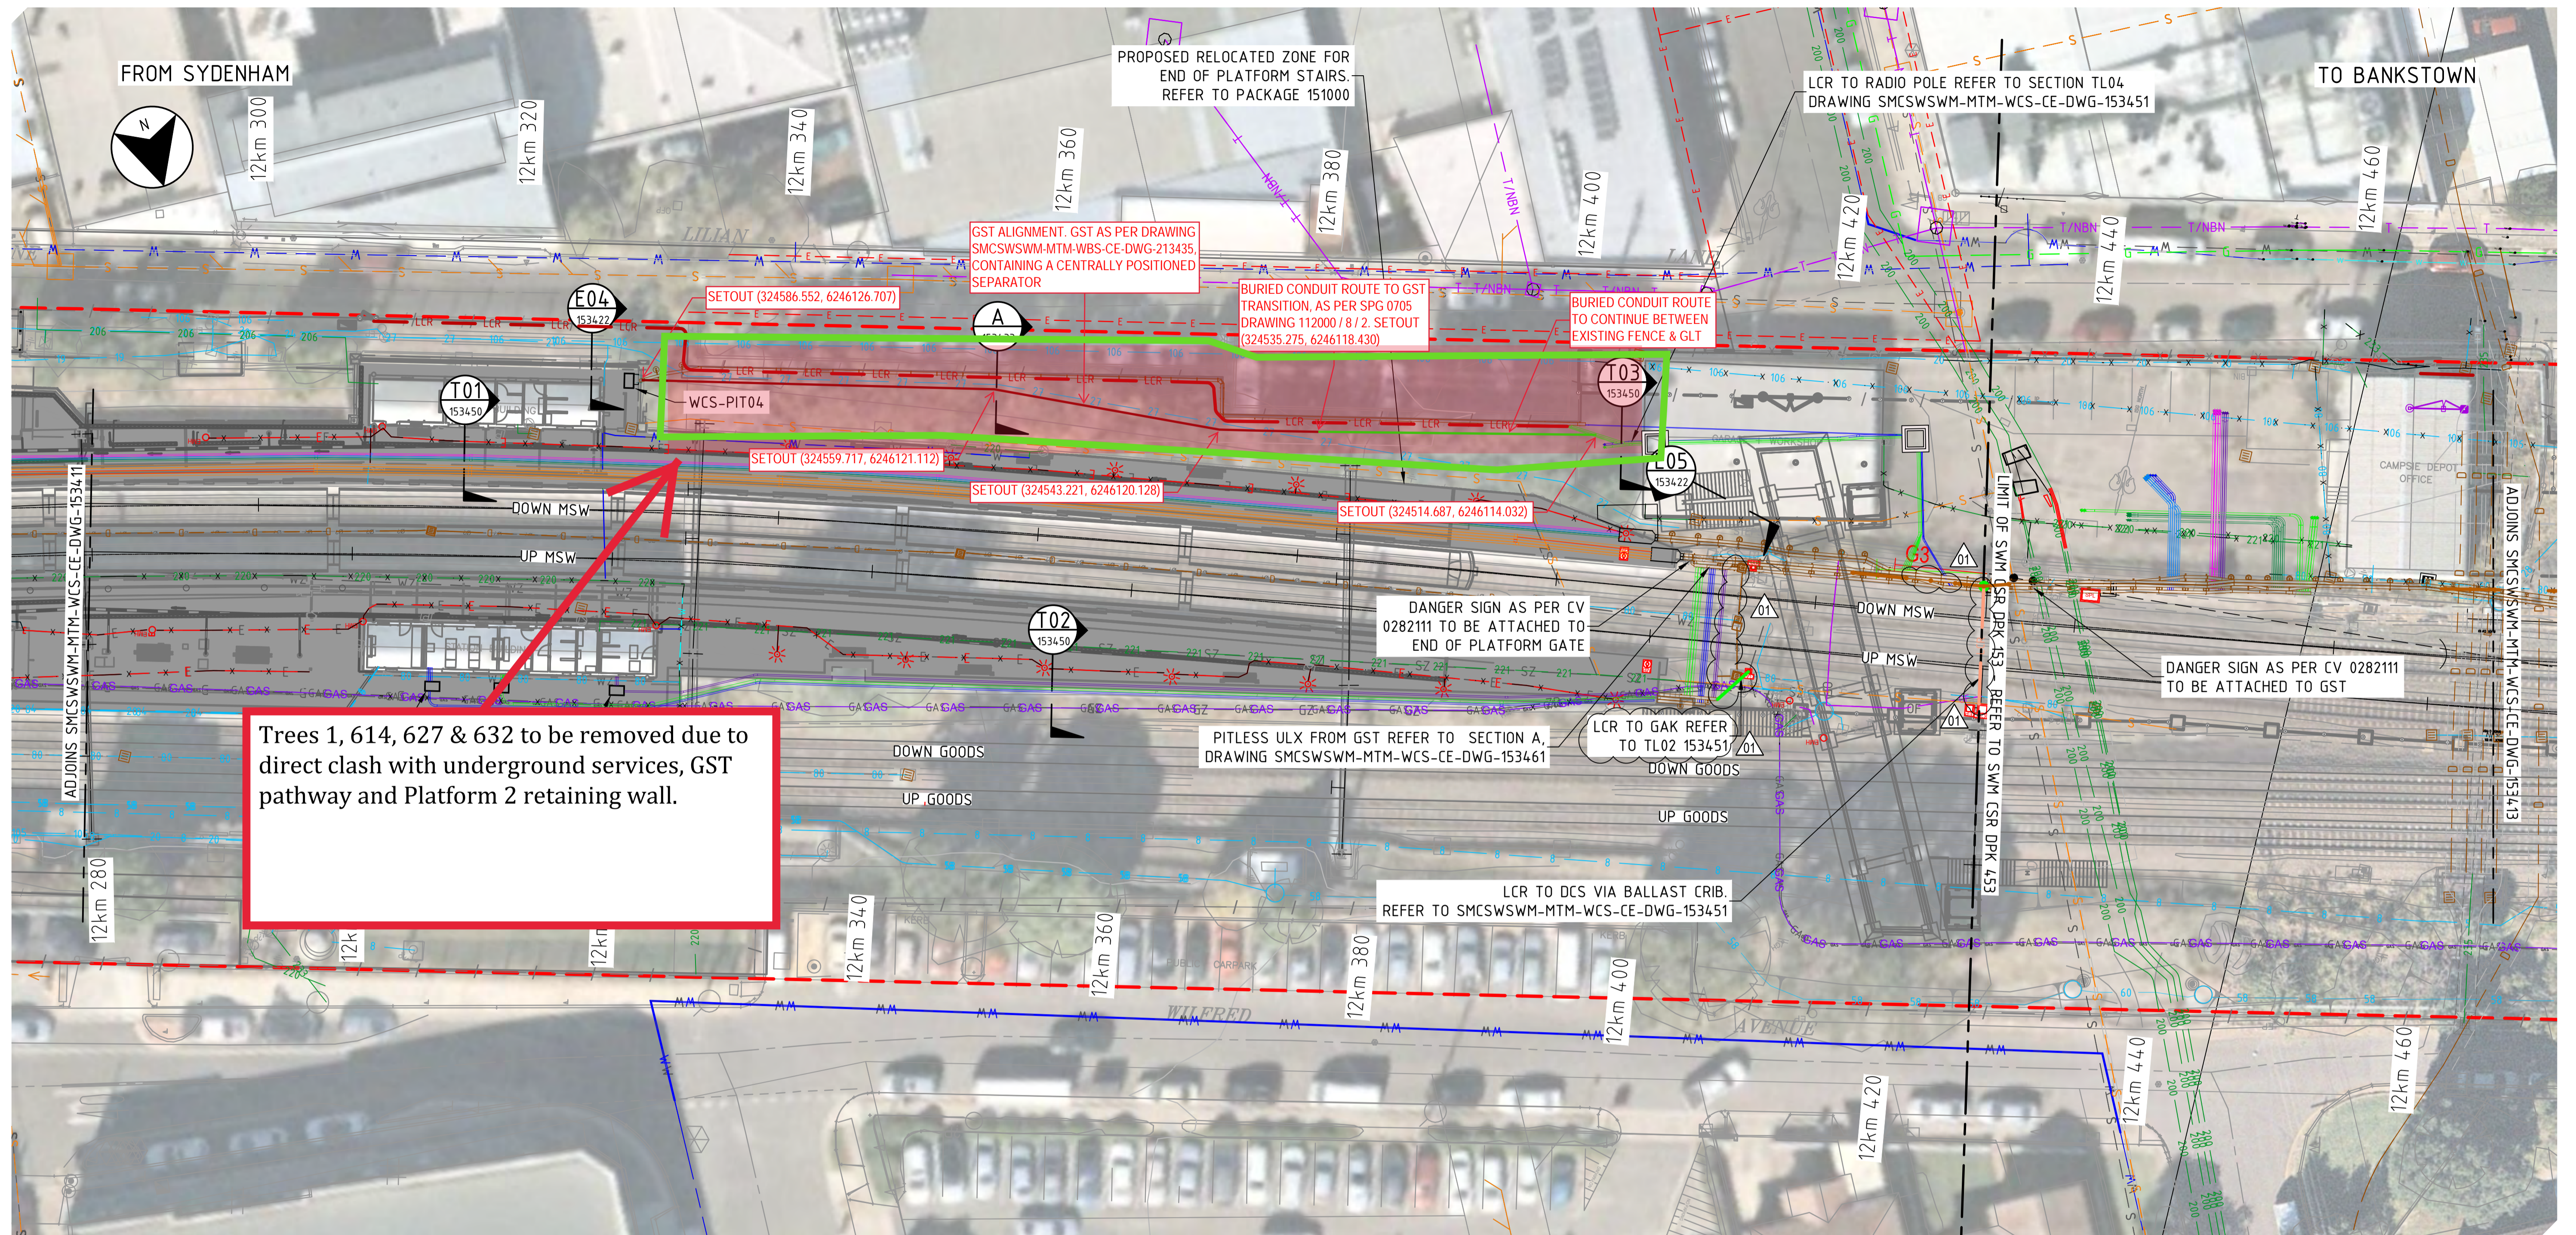
Trees 1, 614, 627 & 632 to be removed due to direct clash with underground services, GST pathway and Platform 2 retaining wall.

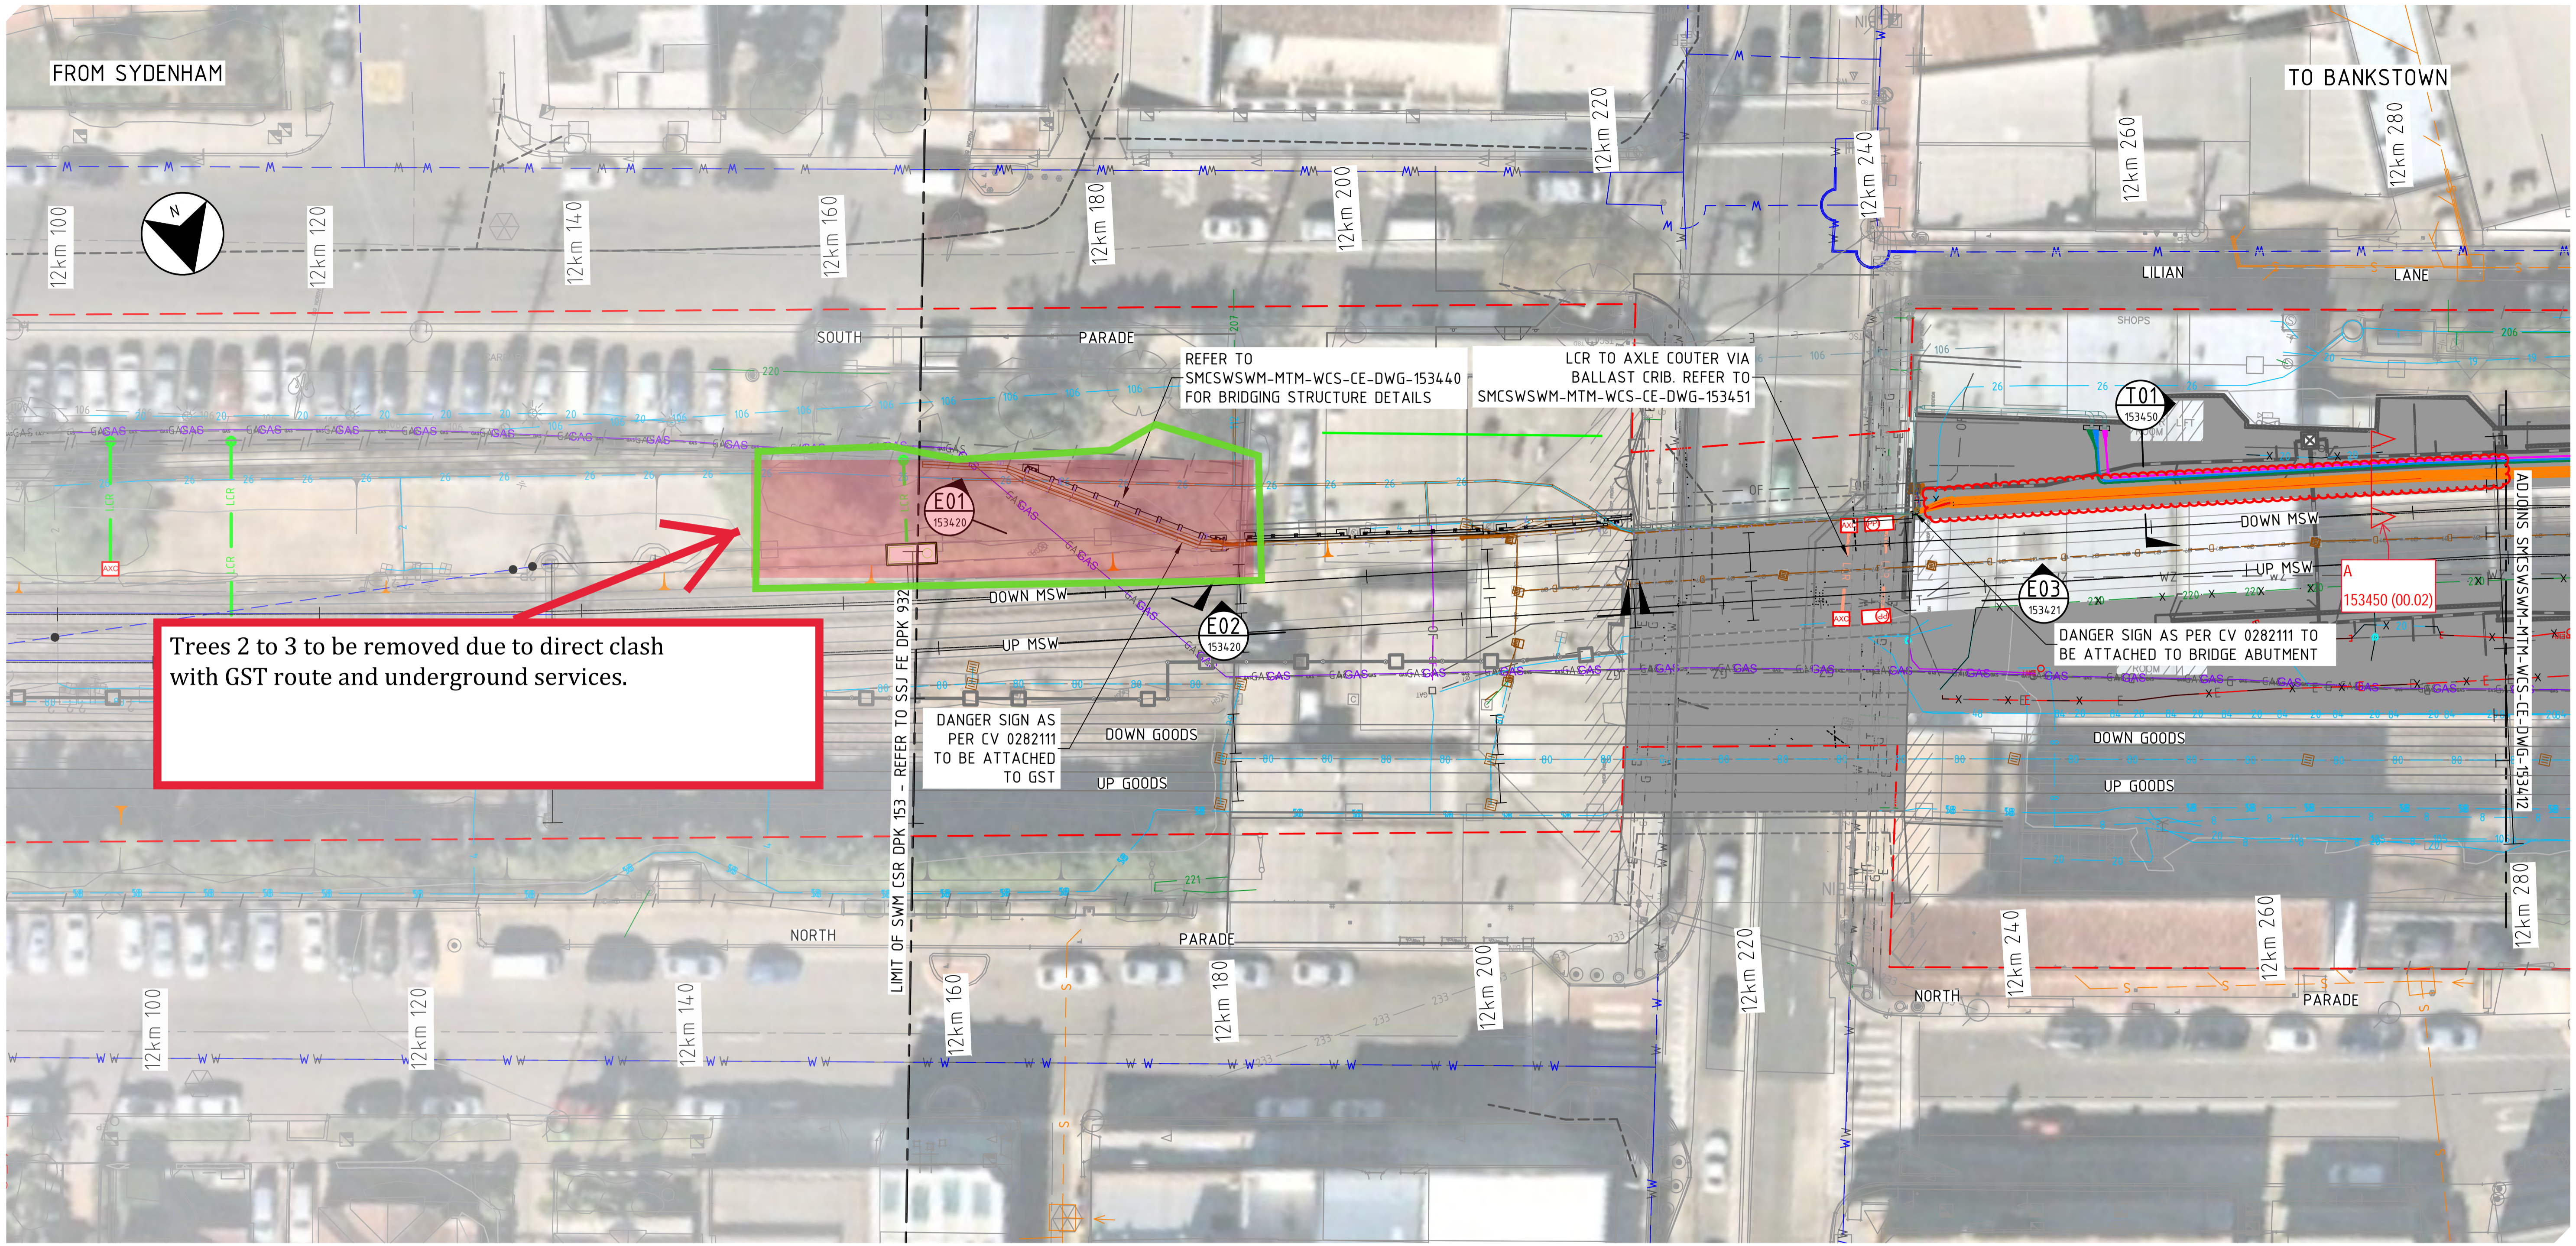
Trees 2 to 3 to be removed due to direct clash with GST route and underground services.

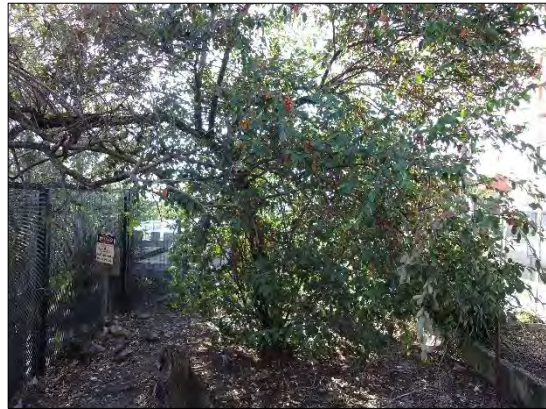
Photograph 2: Tree 516 *Leptosporum petersonii* (Lemon-scented Teatree) was found to be dead.

Trees 515, 516, 517 & 519 must be cleared to provide adequate construction access to the GST route on the Sydney Trains rail corridor embankment. The GST route can't be constructed from the track due to the topographical restrictions preventing the safe construction of the permanent asset

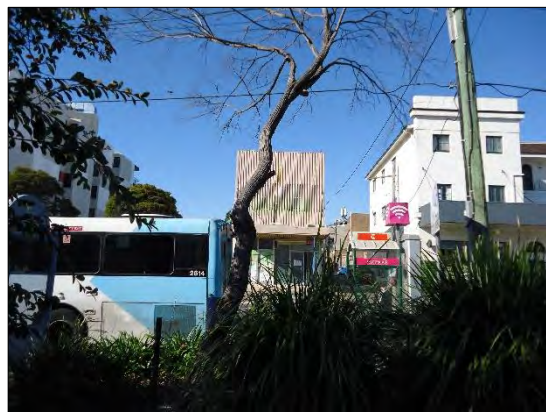
Photograph 3: Tree 517 *Pittosporum undulatum* (Sweet Pittosporum) was found to be dead.

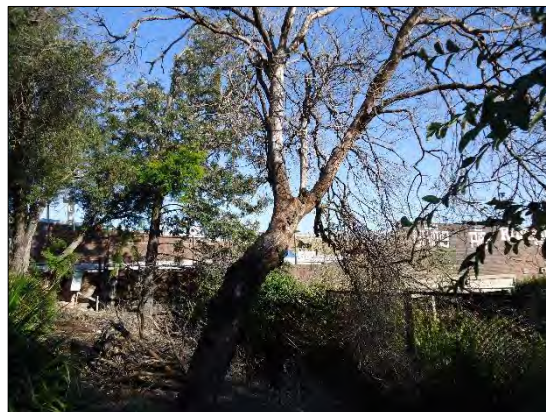
Photograph 4: Tree 519 *Callistemon viminalis* (Weeping Bottlebrush) located adjacent the northern side of South Parade.

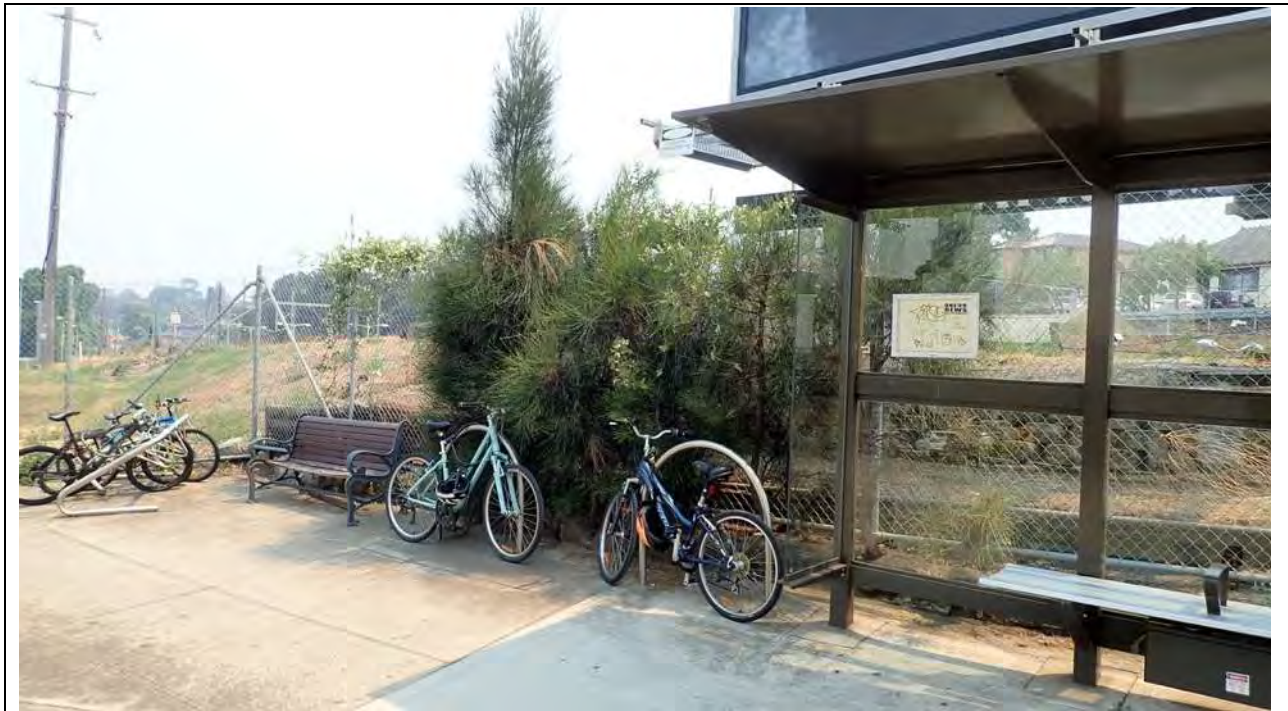
Image 1: Looking North towards trees 586, 587, 588, 589 and 590. The trees have been recommended for removal due to impacts from the proposed hard surfacing excavations.

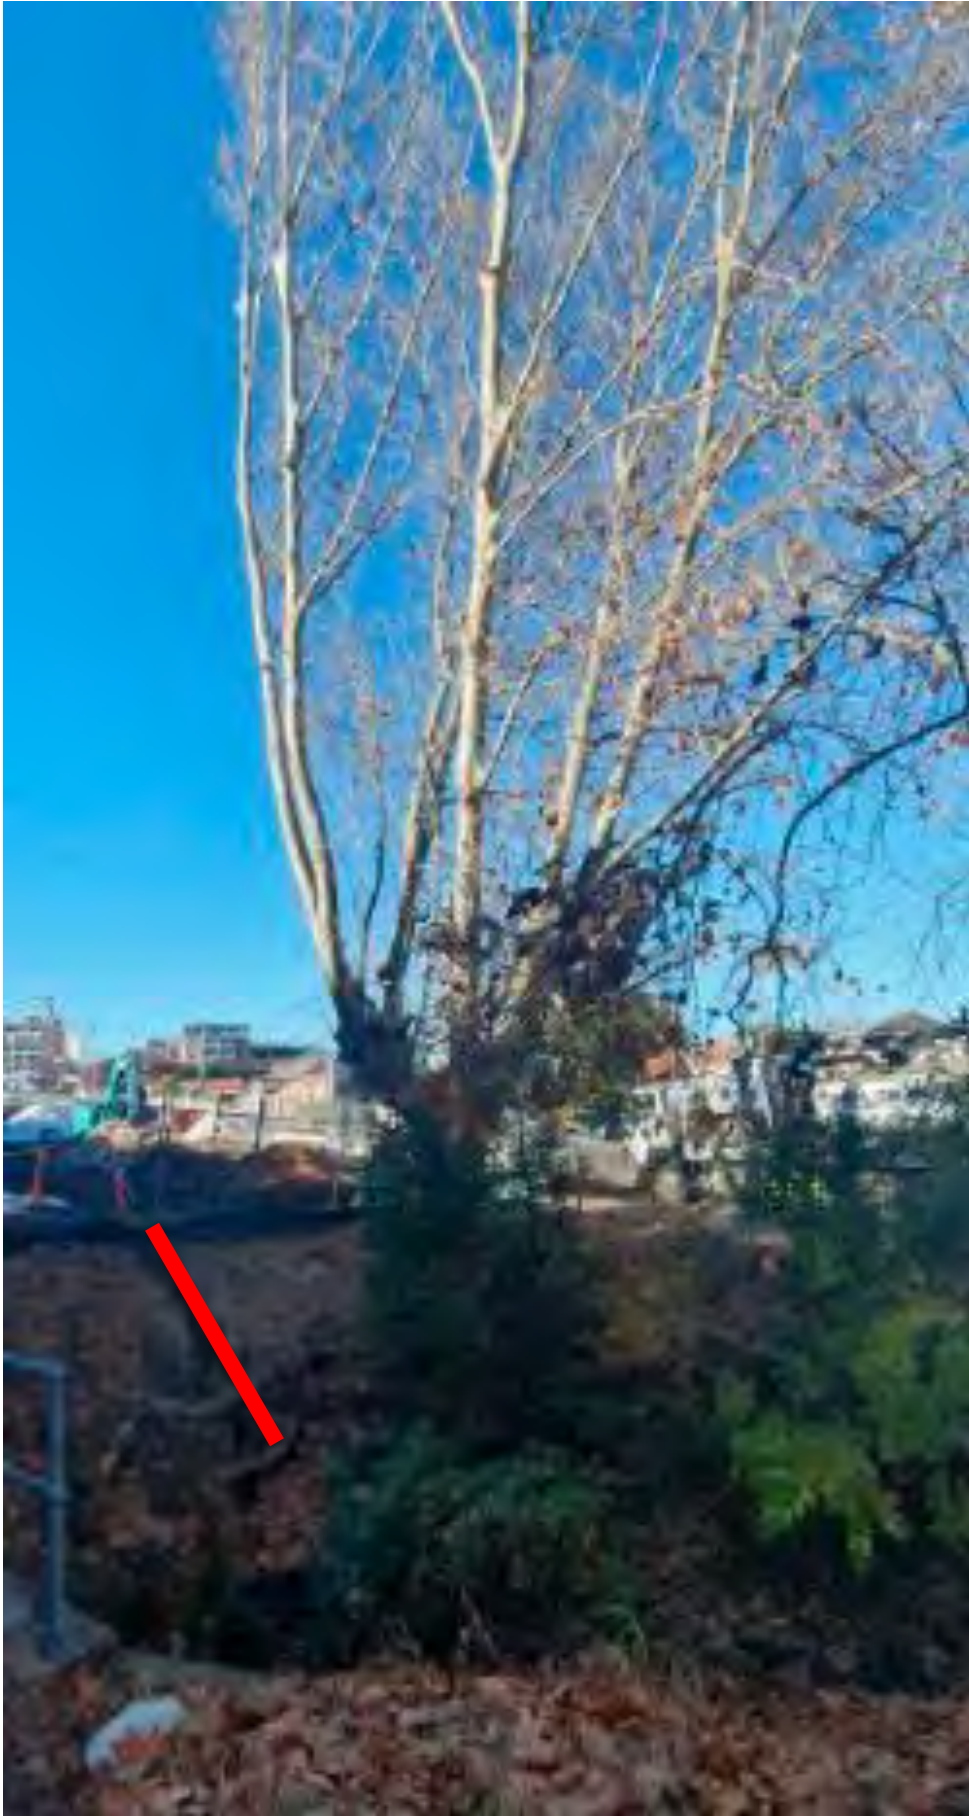
Image of the subject tree (Tree 94) taken on the 15th June 2021 (red line shows approximate location of required excavations).

Tree number	Tree name	Tree dimensions				Vigour	Condition	Age class	ULE	Amenity and Visual Value	Native or Exotic	TPZ (m)	SRZ (m)	Comments	Remove or Retain
	<i>Botanical name</i> Common name	Height (m)	Spread (m)	DBH (cm)	DAB (cm)										
94	<i>Platanus x Hybrida</i> London Plane	20	12	100	120	NV	F	M	M	M	E	15	3.57	To be removed due to a clash with the permanent drainage design.	Remove

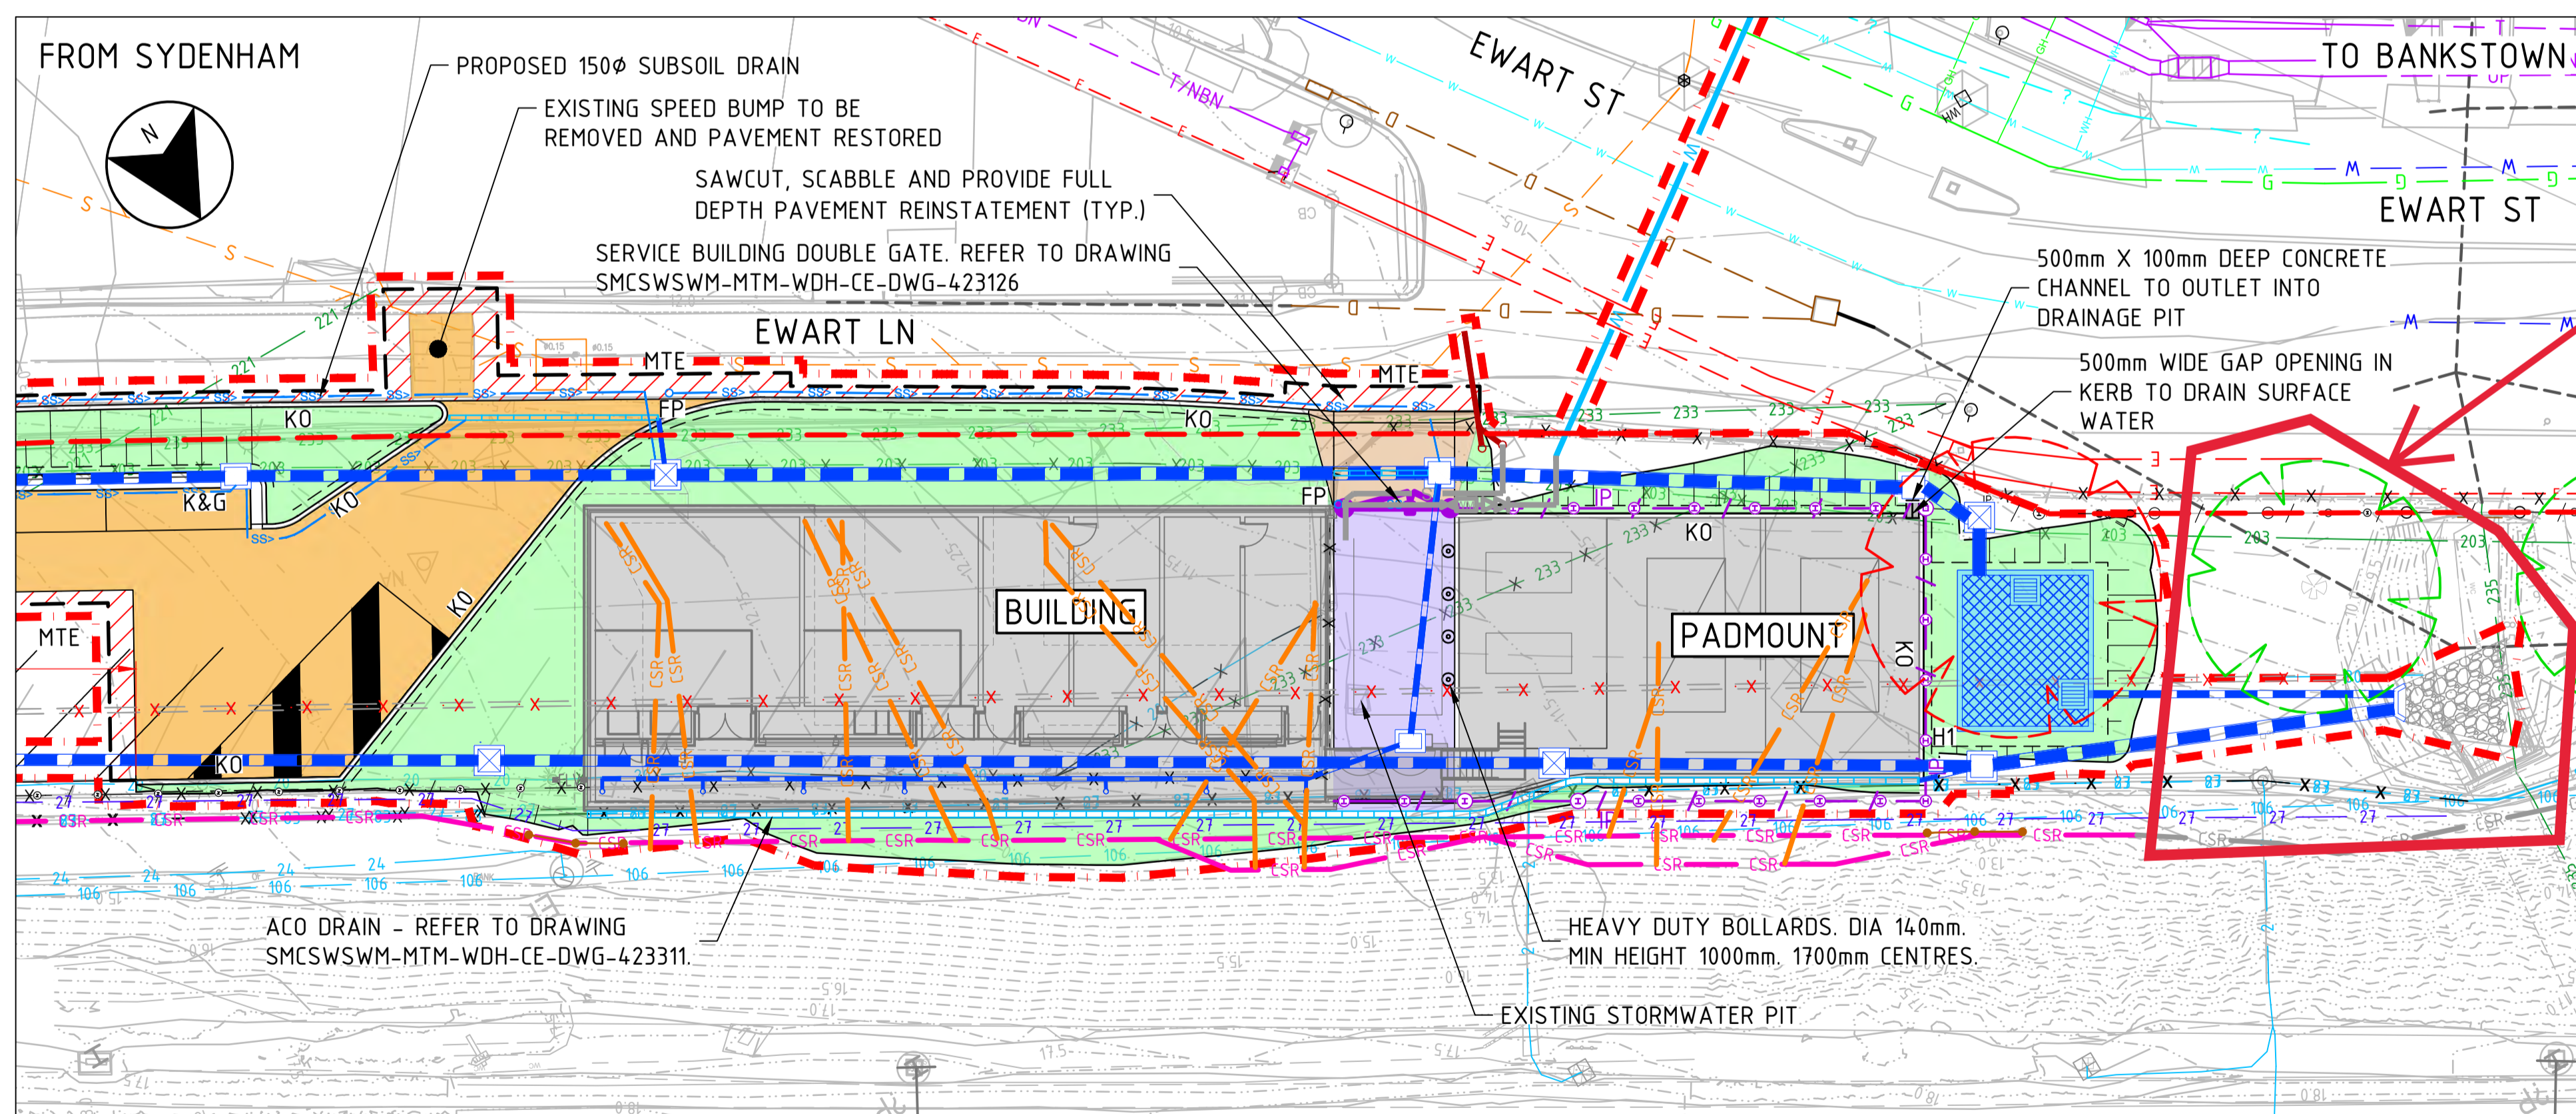
PLAN
SCALE 1:200

To be cleared due to clash with permanent drainage design. Drainage design indicated by blue and white dotted line.

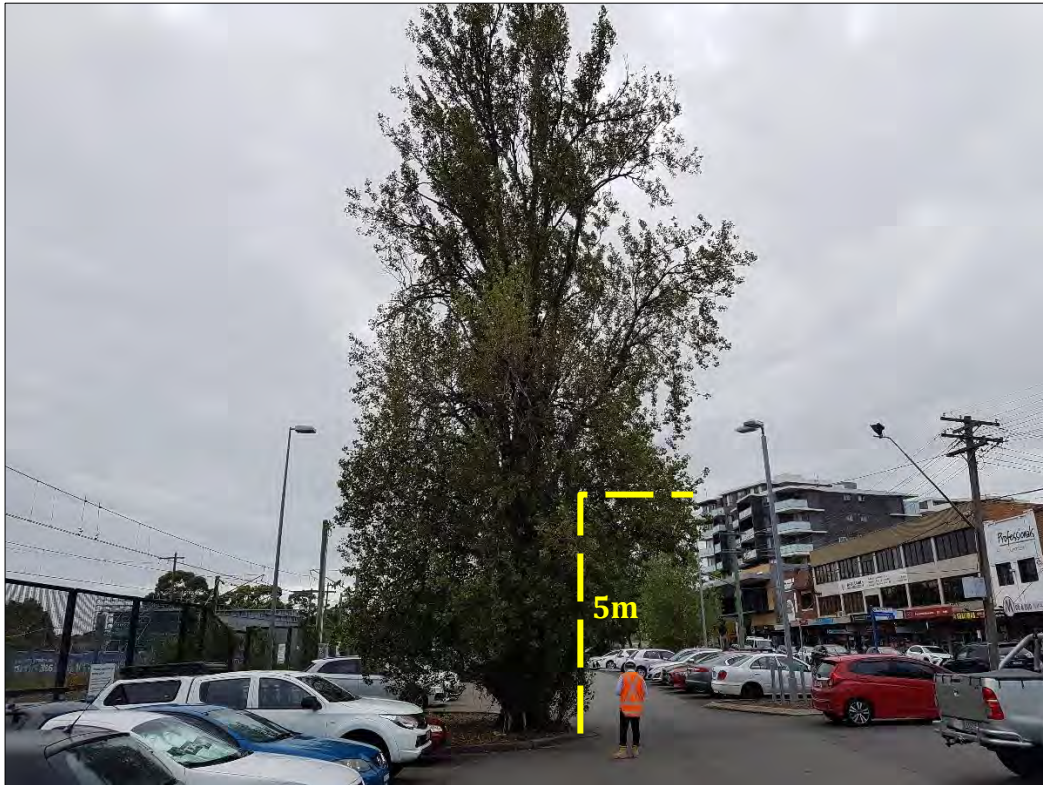
Photograph 1: Tree 1 *Populus nigra* 'Italica' (Lombardy Poplar as seen from the carpark area adjacent The Boulevard. 5m of vertical clearance is required from the outside edge of kerb adjacent the base of the tree.
