Tree Impact Assessment Report

City and Southwest Metro Station Upgrade Works Package 5 & 6

**Project wide: Hurlstone Park, Wiley Park, Belmore,
Campsie, Dulwich Hill and Punchbowl**

P5 Document No. SMCSWSW5-DEW-WEC-EM-REP-000542

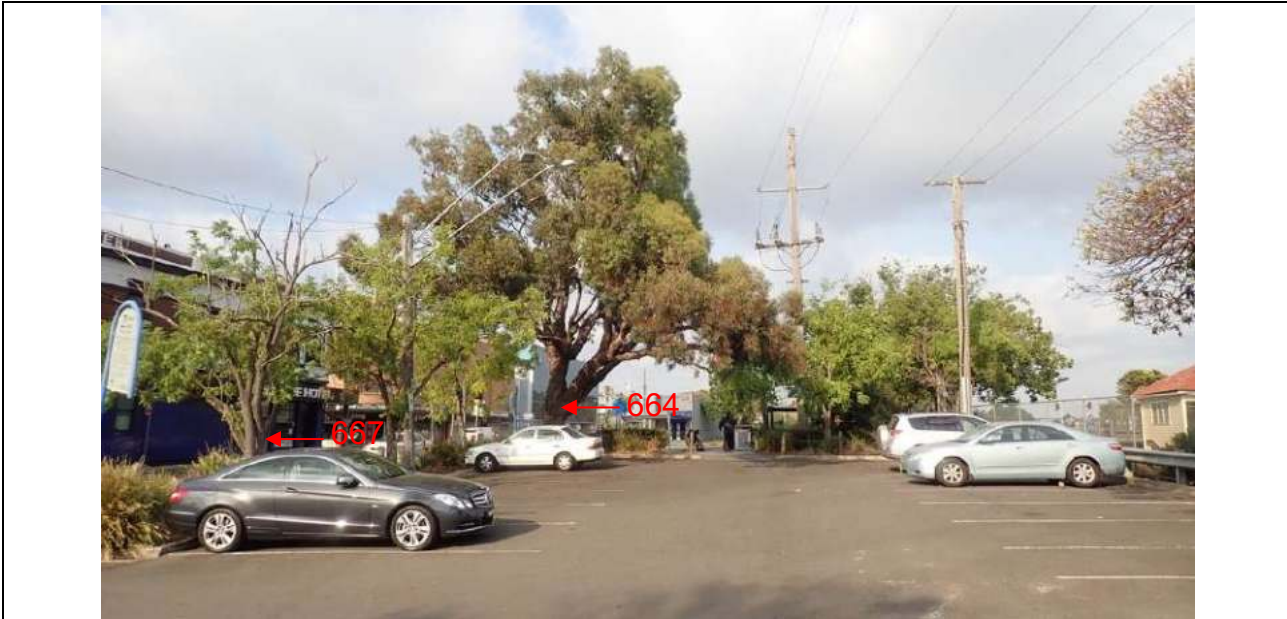
Image 1: Looking West towards tree 664 and 667. The proposed construction must be completed in accordance with section 9.2 to ensure tree 664 is not significantly impacted by the proposed works. Tree 667 is in poor health/advanced stages of decline and is recommended for removal due to its current condition and impacts from the proposed development.

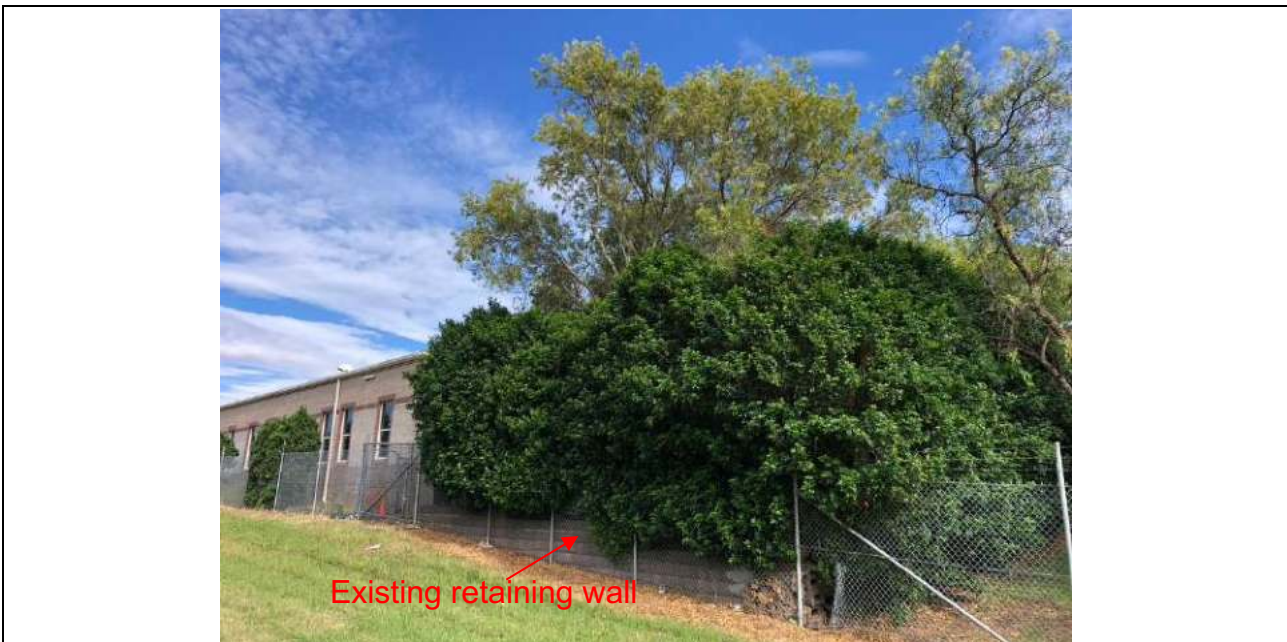
Image 2: Looking towards tree 3316, 3317, 3318, 3319 and 3320, showing the existing boundary retaining wall. The existing boundary retaining wall appears to be restricting root growth into the corridor, therefore, the proposed works within the corridor will not impact the trees. Minor canopy pruning may be required for tree 3316, 3317, 3319 and 3320. The proposed canopy pruning will result in the removal of less than 10% of the live foliage area of the trees and will not significantly impact the trees.

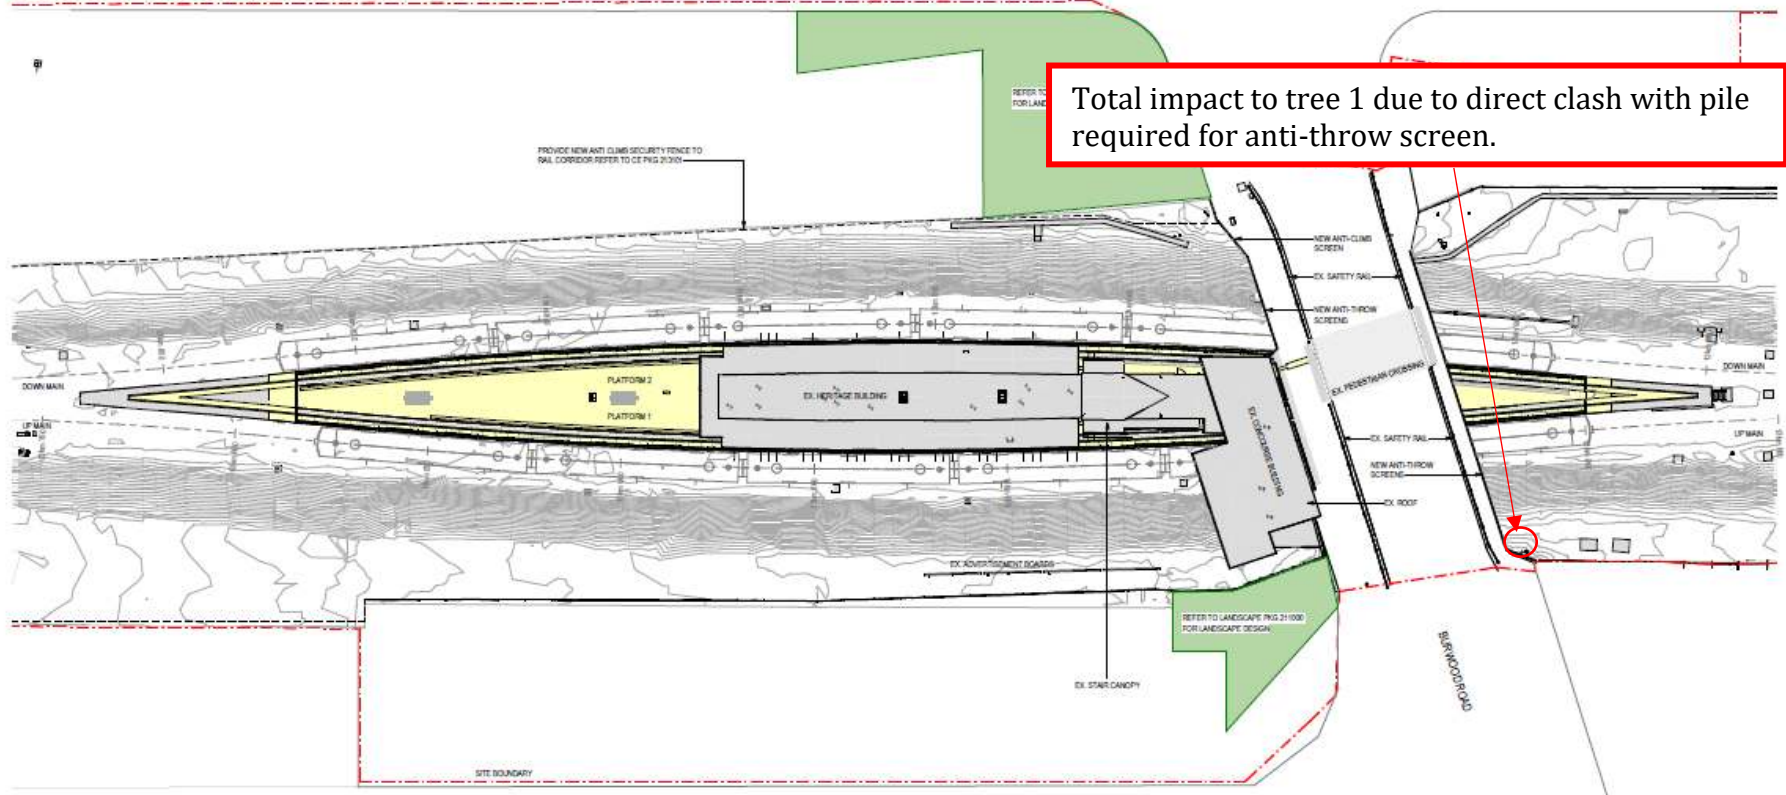
Total impact to tree 1 due to direct clash with pile required for anti-throw screen.

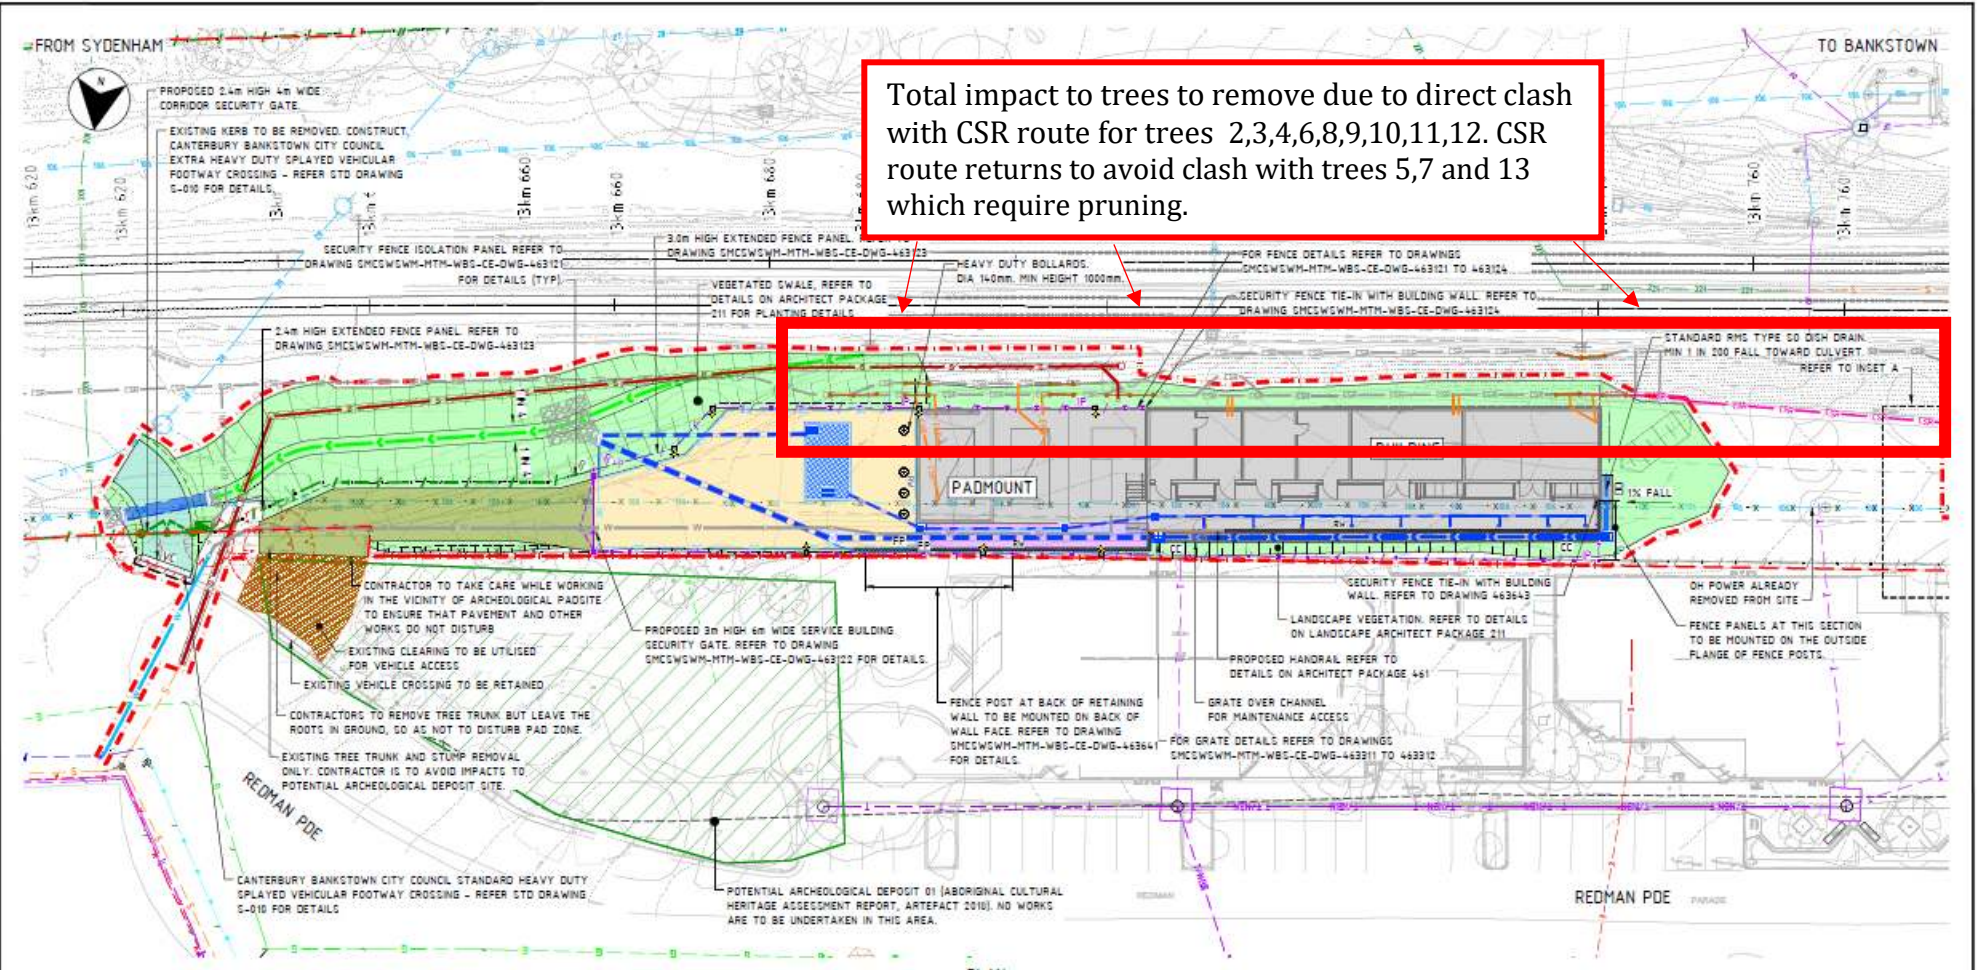
Total impact to trees to remove due to direct clash with CSR route for trees 2,3,4,6,8,9,10,11,12. CSR route returns to avoid clash with trees 5,7 and 13 which require pruning.

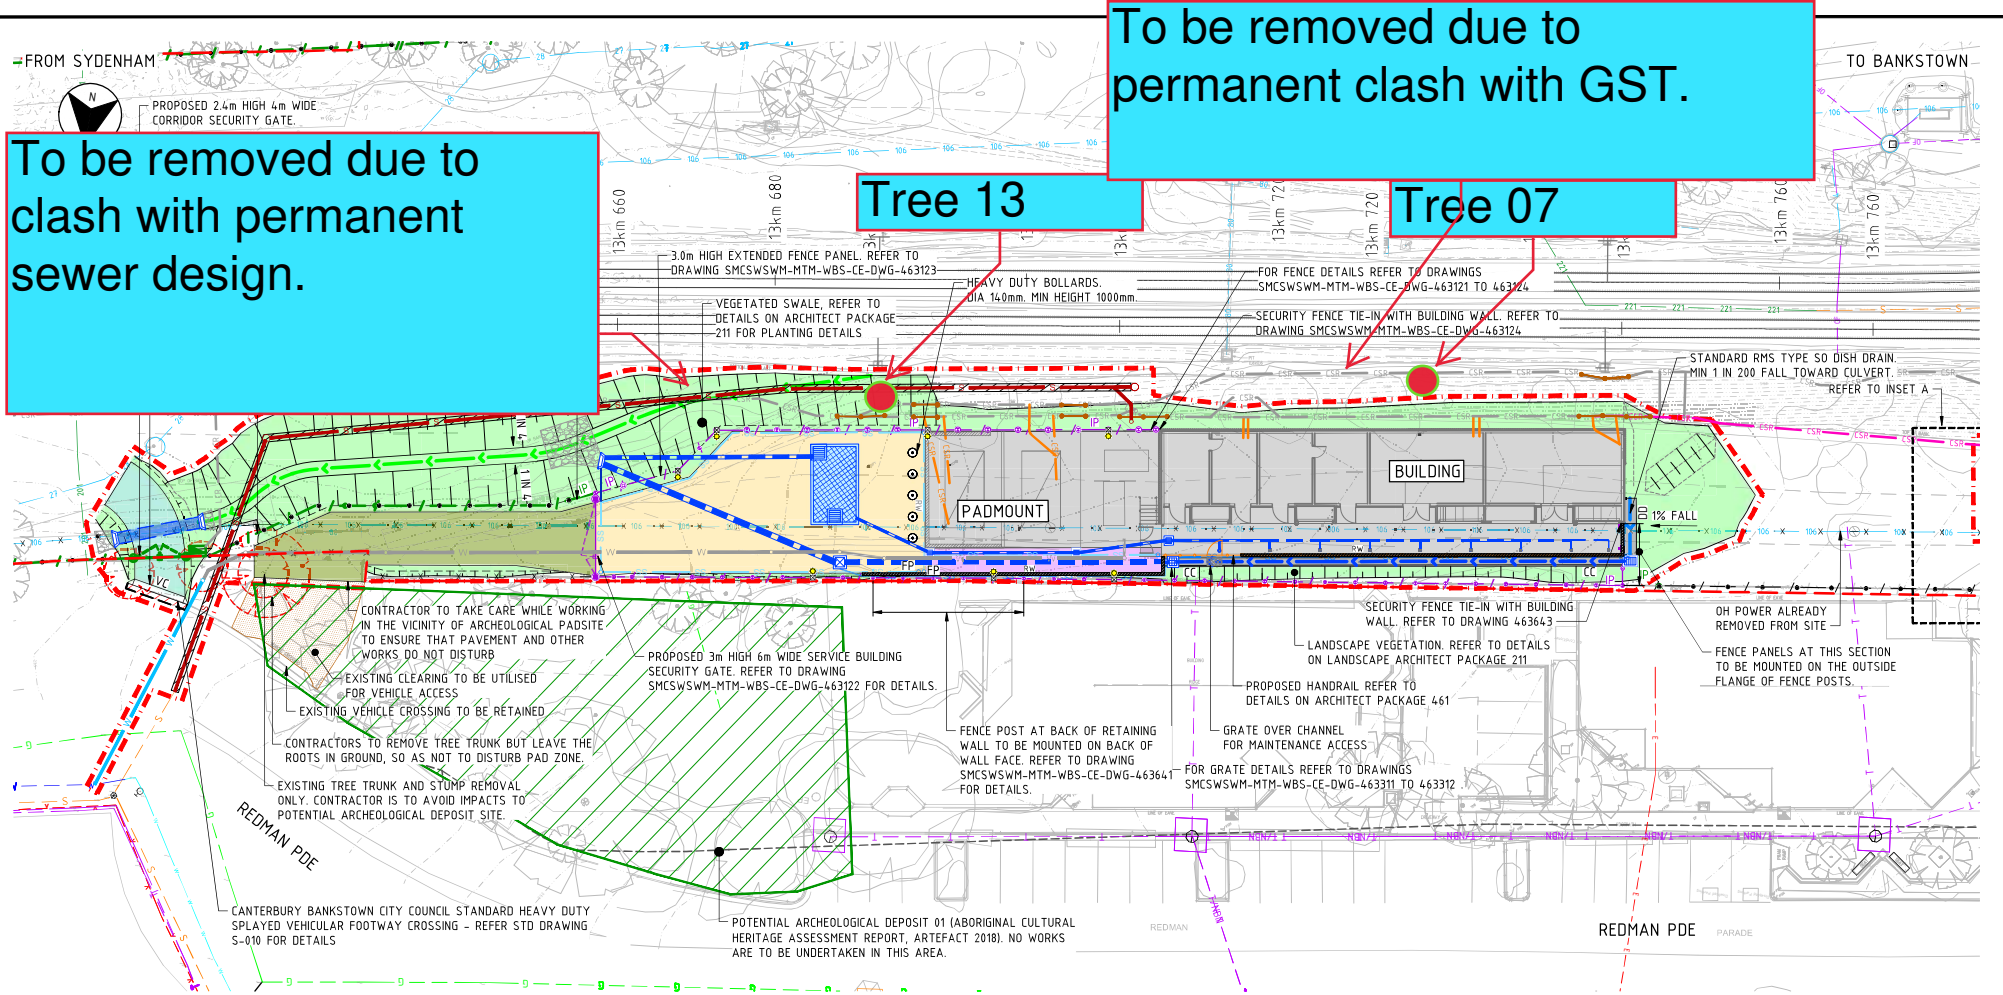
To be removed due to clash with permanent sewer design.

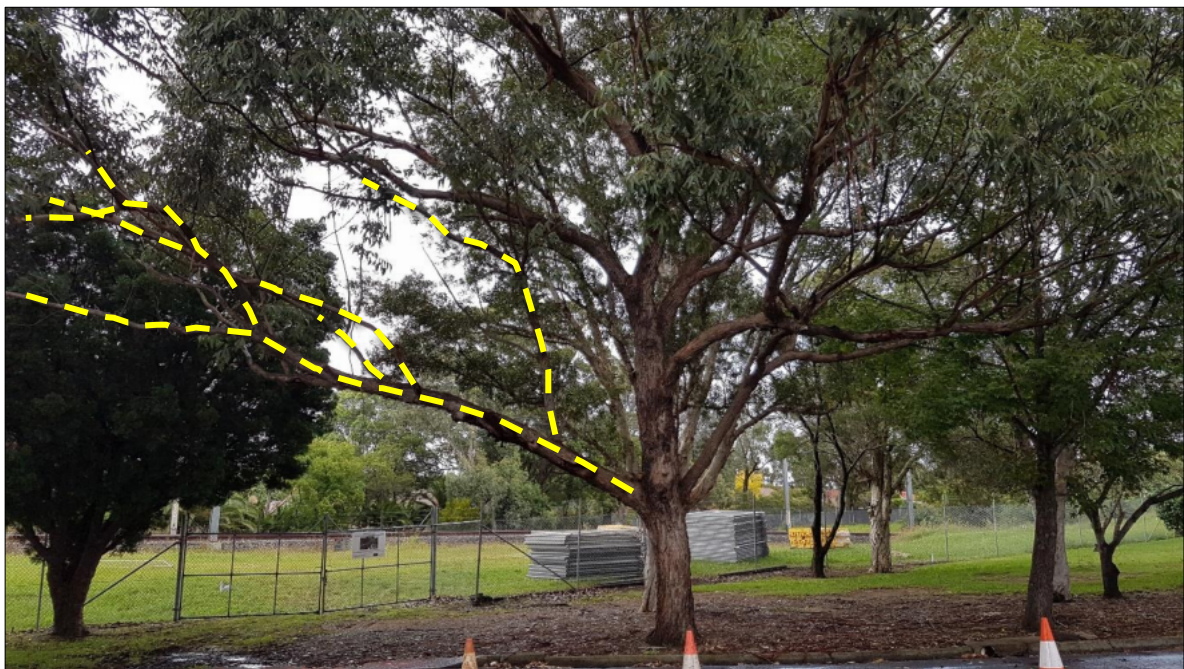
Tree 14 *Eucalyptus robusta* (Swamp Mahogany) identified pruning involves the removal of one first order branch at 2m height. The branch is approximately 300mm in diameter and constitutes 30% of the total canopy volume of the tree. A reduction in tree growth and physiological function can be expected as a result of the pruning works. Exposure of internal woody tissues at the site of the final pruning cut shall be susceptible to infection by decay causing fungi. The removal of the branch is not considered to significantly affect vocal amenity.

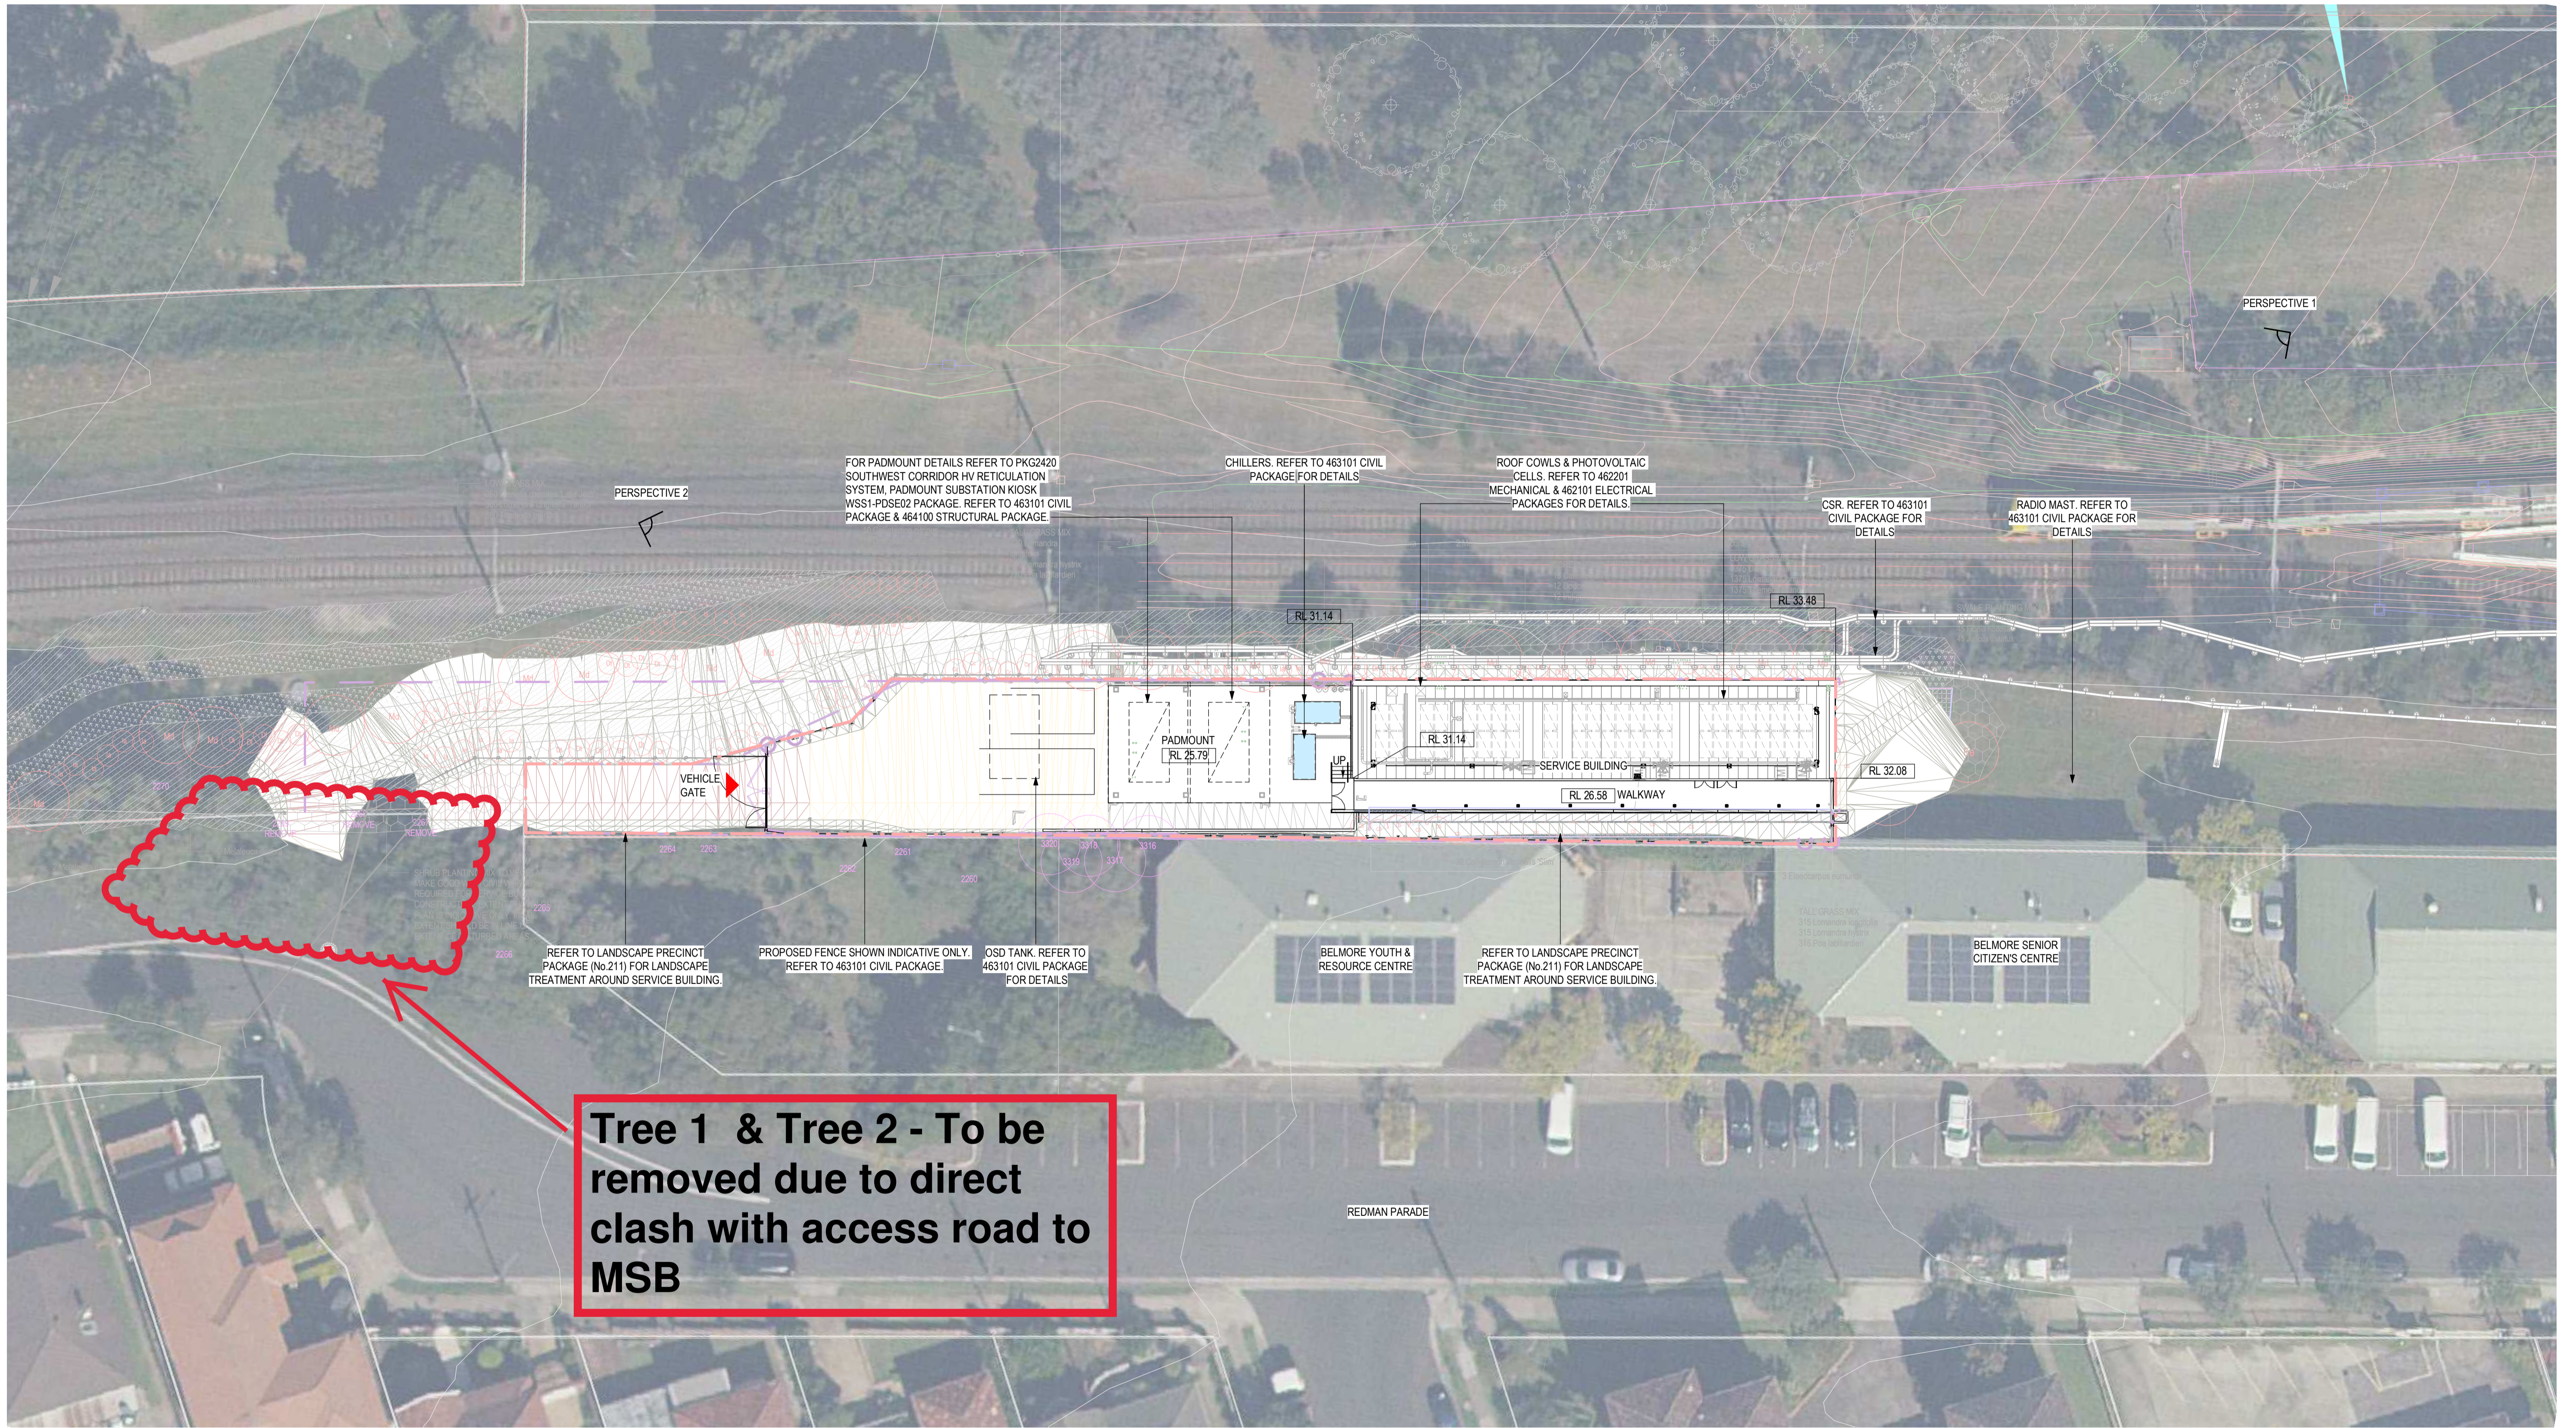
Tree 1 & Tree 2 - To be removed due to direct clash with access road to MSB

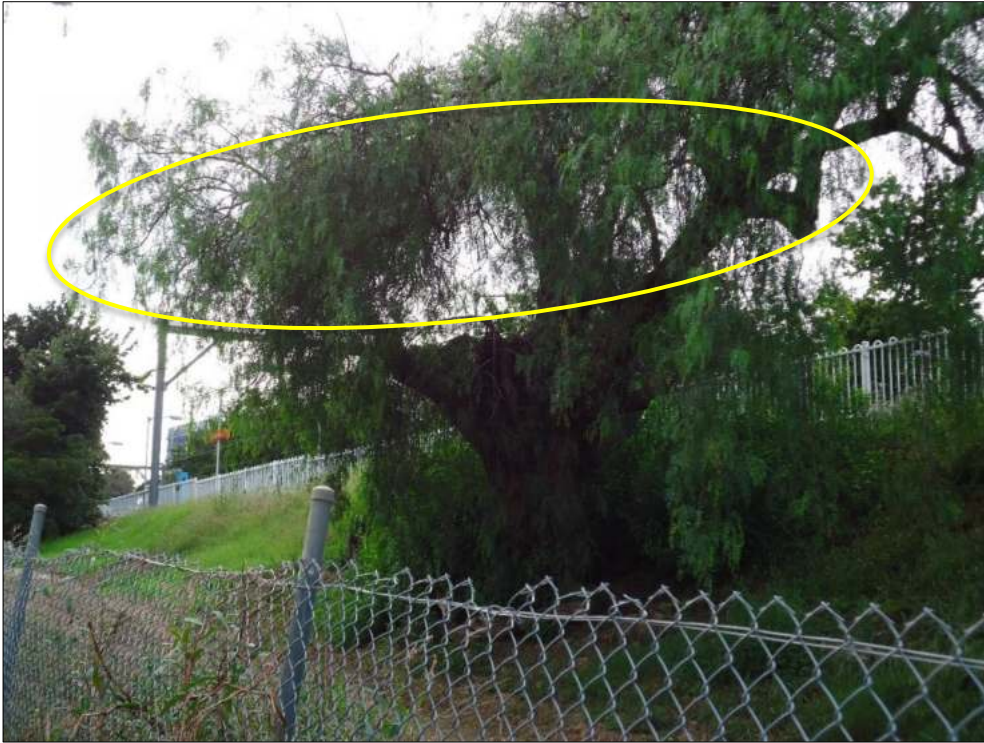
Pruning works were identified to be undertaken on tree 692 *Schinus molle* (Peppercorn Tree) to provide clearance along the rail corridor access track for plant and equipment. It is envisioned that pruning works shall involve the reduction and removal of selected branches up to 100mm in diameter and constitute approximately 25-30% of the total live canopy volume of the tree. Based upon the current health and condition of the tree these pruning works are considered to be significant and shall likely result in a reduction of tree growth and physiological function. All pruning works are to be undertaken by suitably qualified tree workers and meet the requirements of *AS4373-2007 Pruning of Amenity Trees*. Image 2 shows the tree and branches that overhang the access road.

Image 2: Yellow outline indicates branches from Tree 692, *Schinus molle* (Peppercorn Tree), that shall require selective removal to provide clearances along the rail corridor access track.

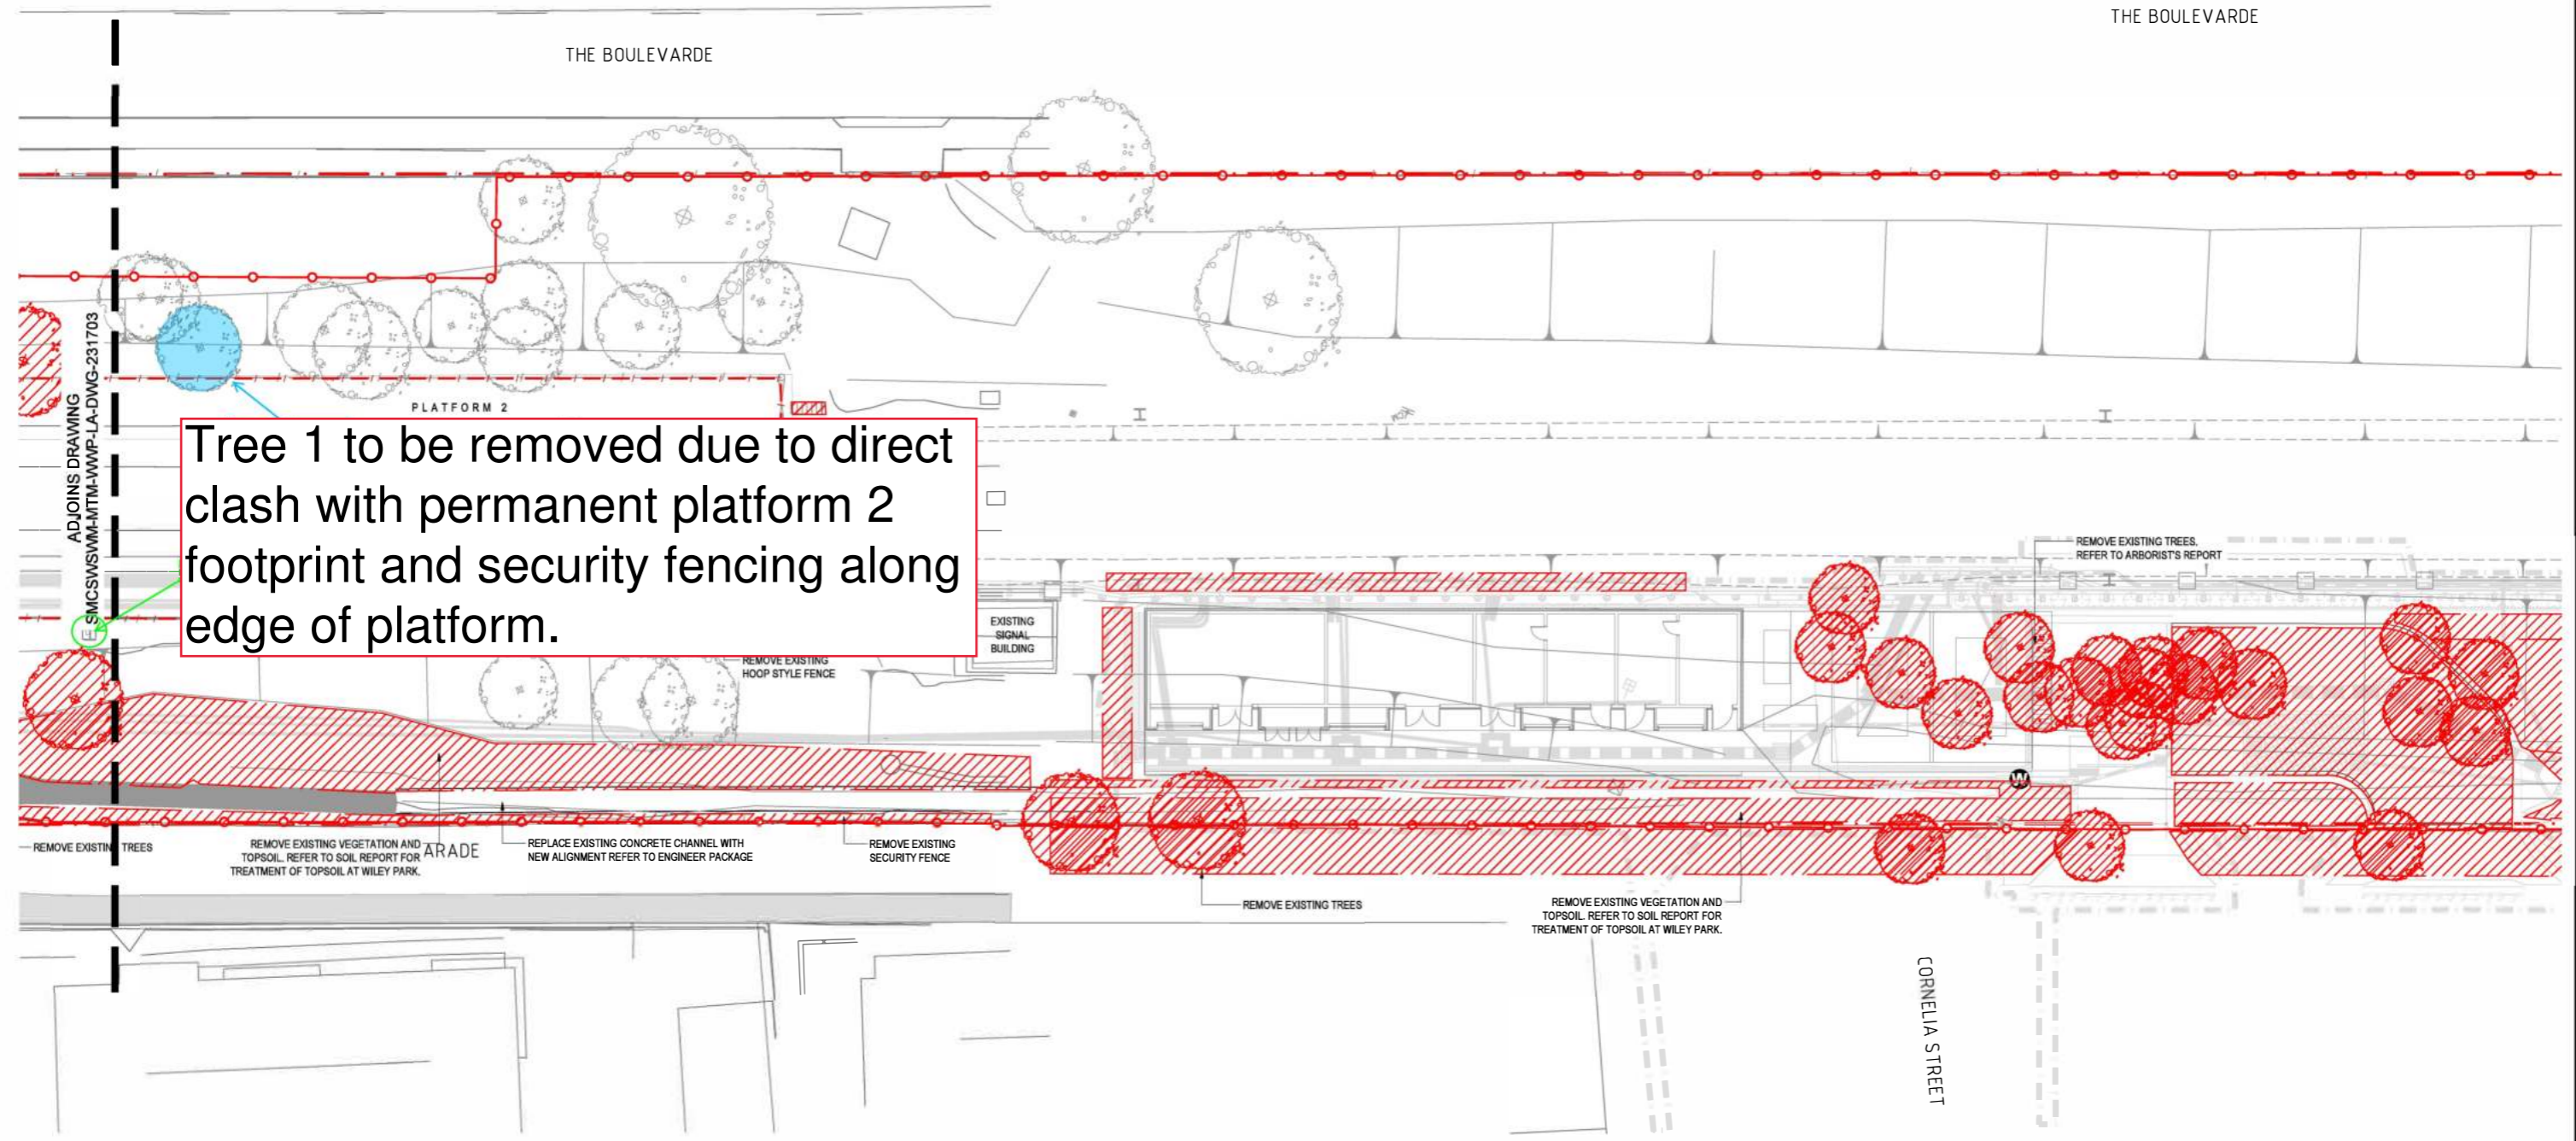
Tree 1 to be removed due to direct clash with permanent platform 2 footprint and security fencing along edge of platform.

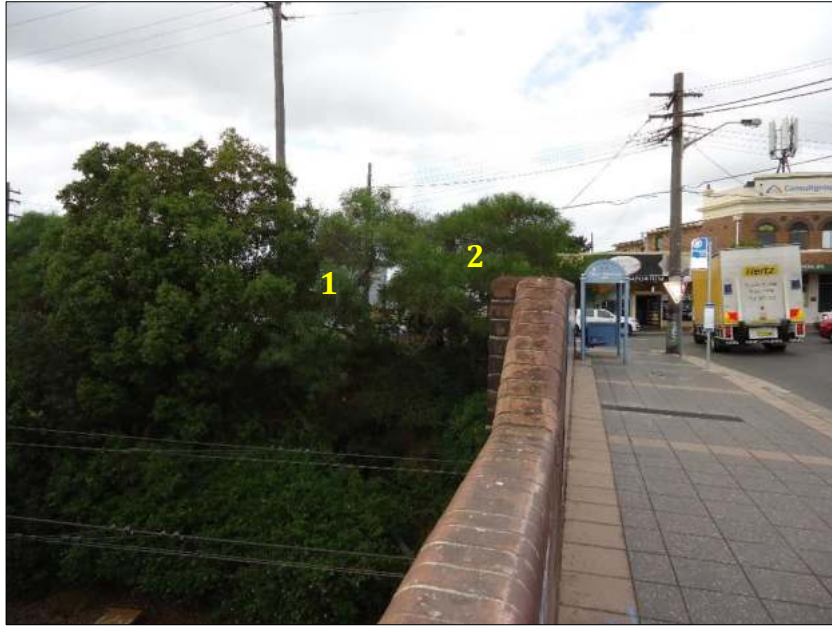
Image 2: Trees 1 and 2, Wattles require removal to accommodate soil pinning works adjacent the bridge.

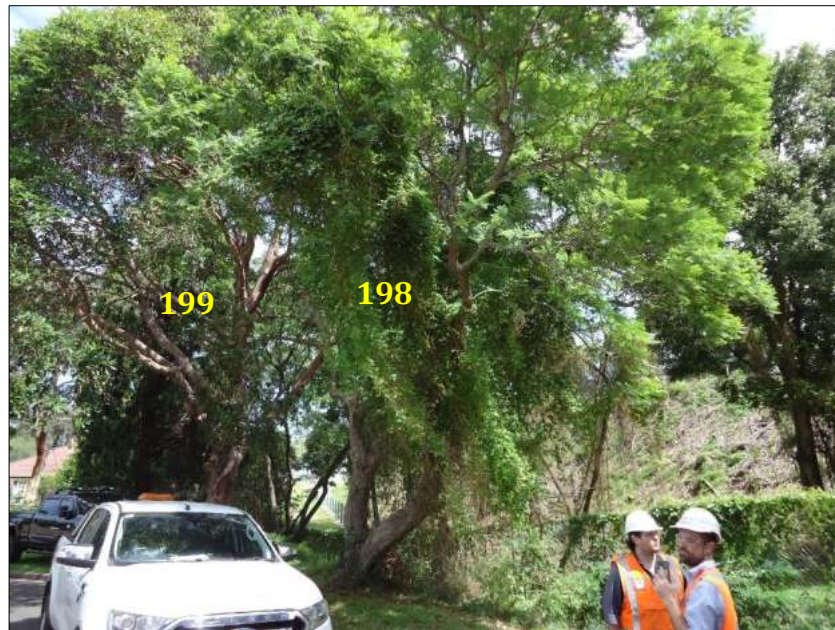
Image 5: Trees 198 and 199 as identified within the AIA report shall require removal for the Metro Services Building access road.

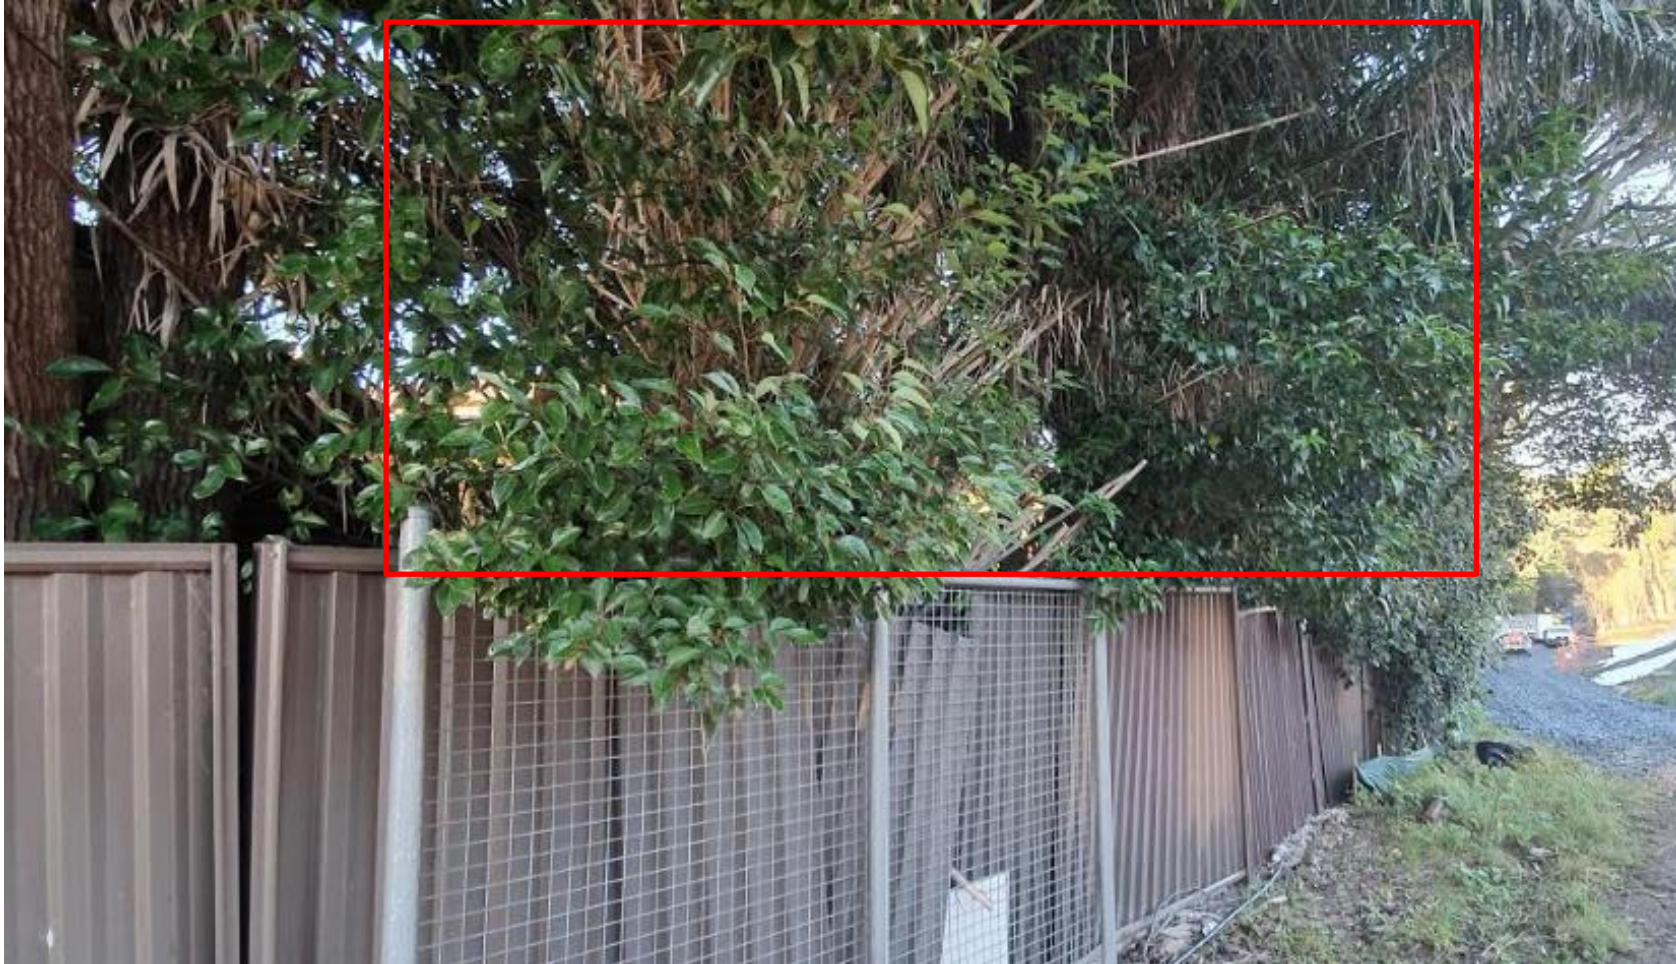
This area of foliage is minor regrowth from weed species and is requested to be pruned back to the fence line.

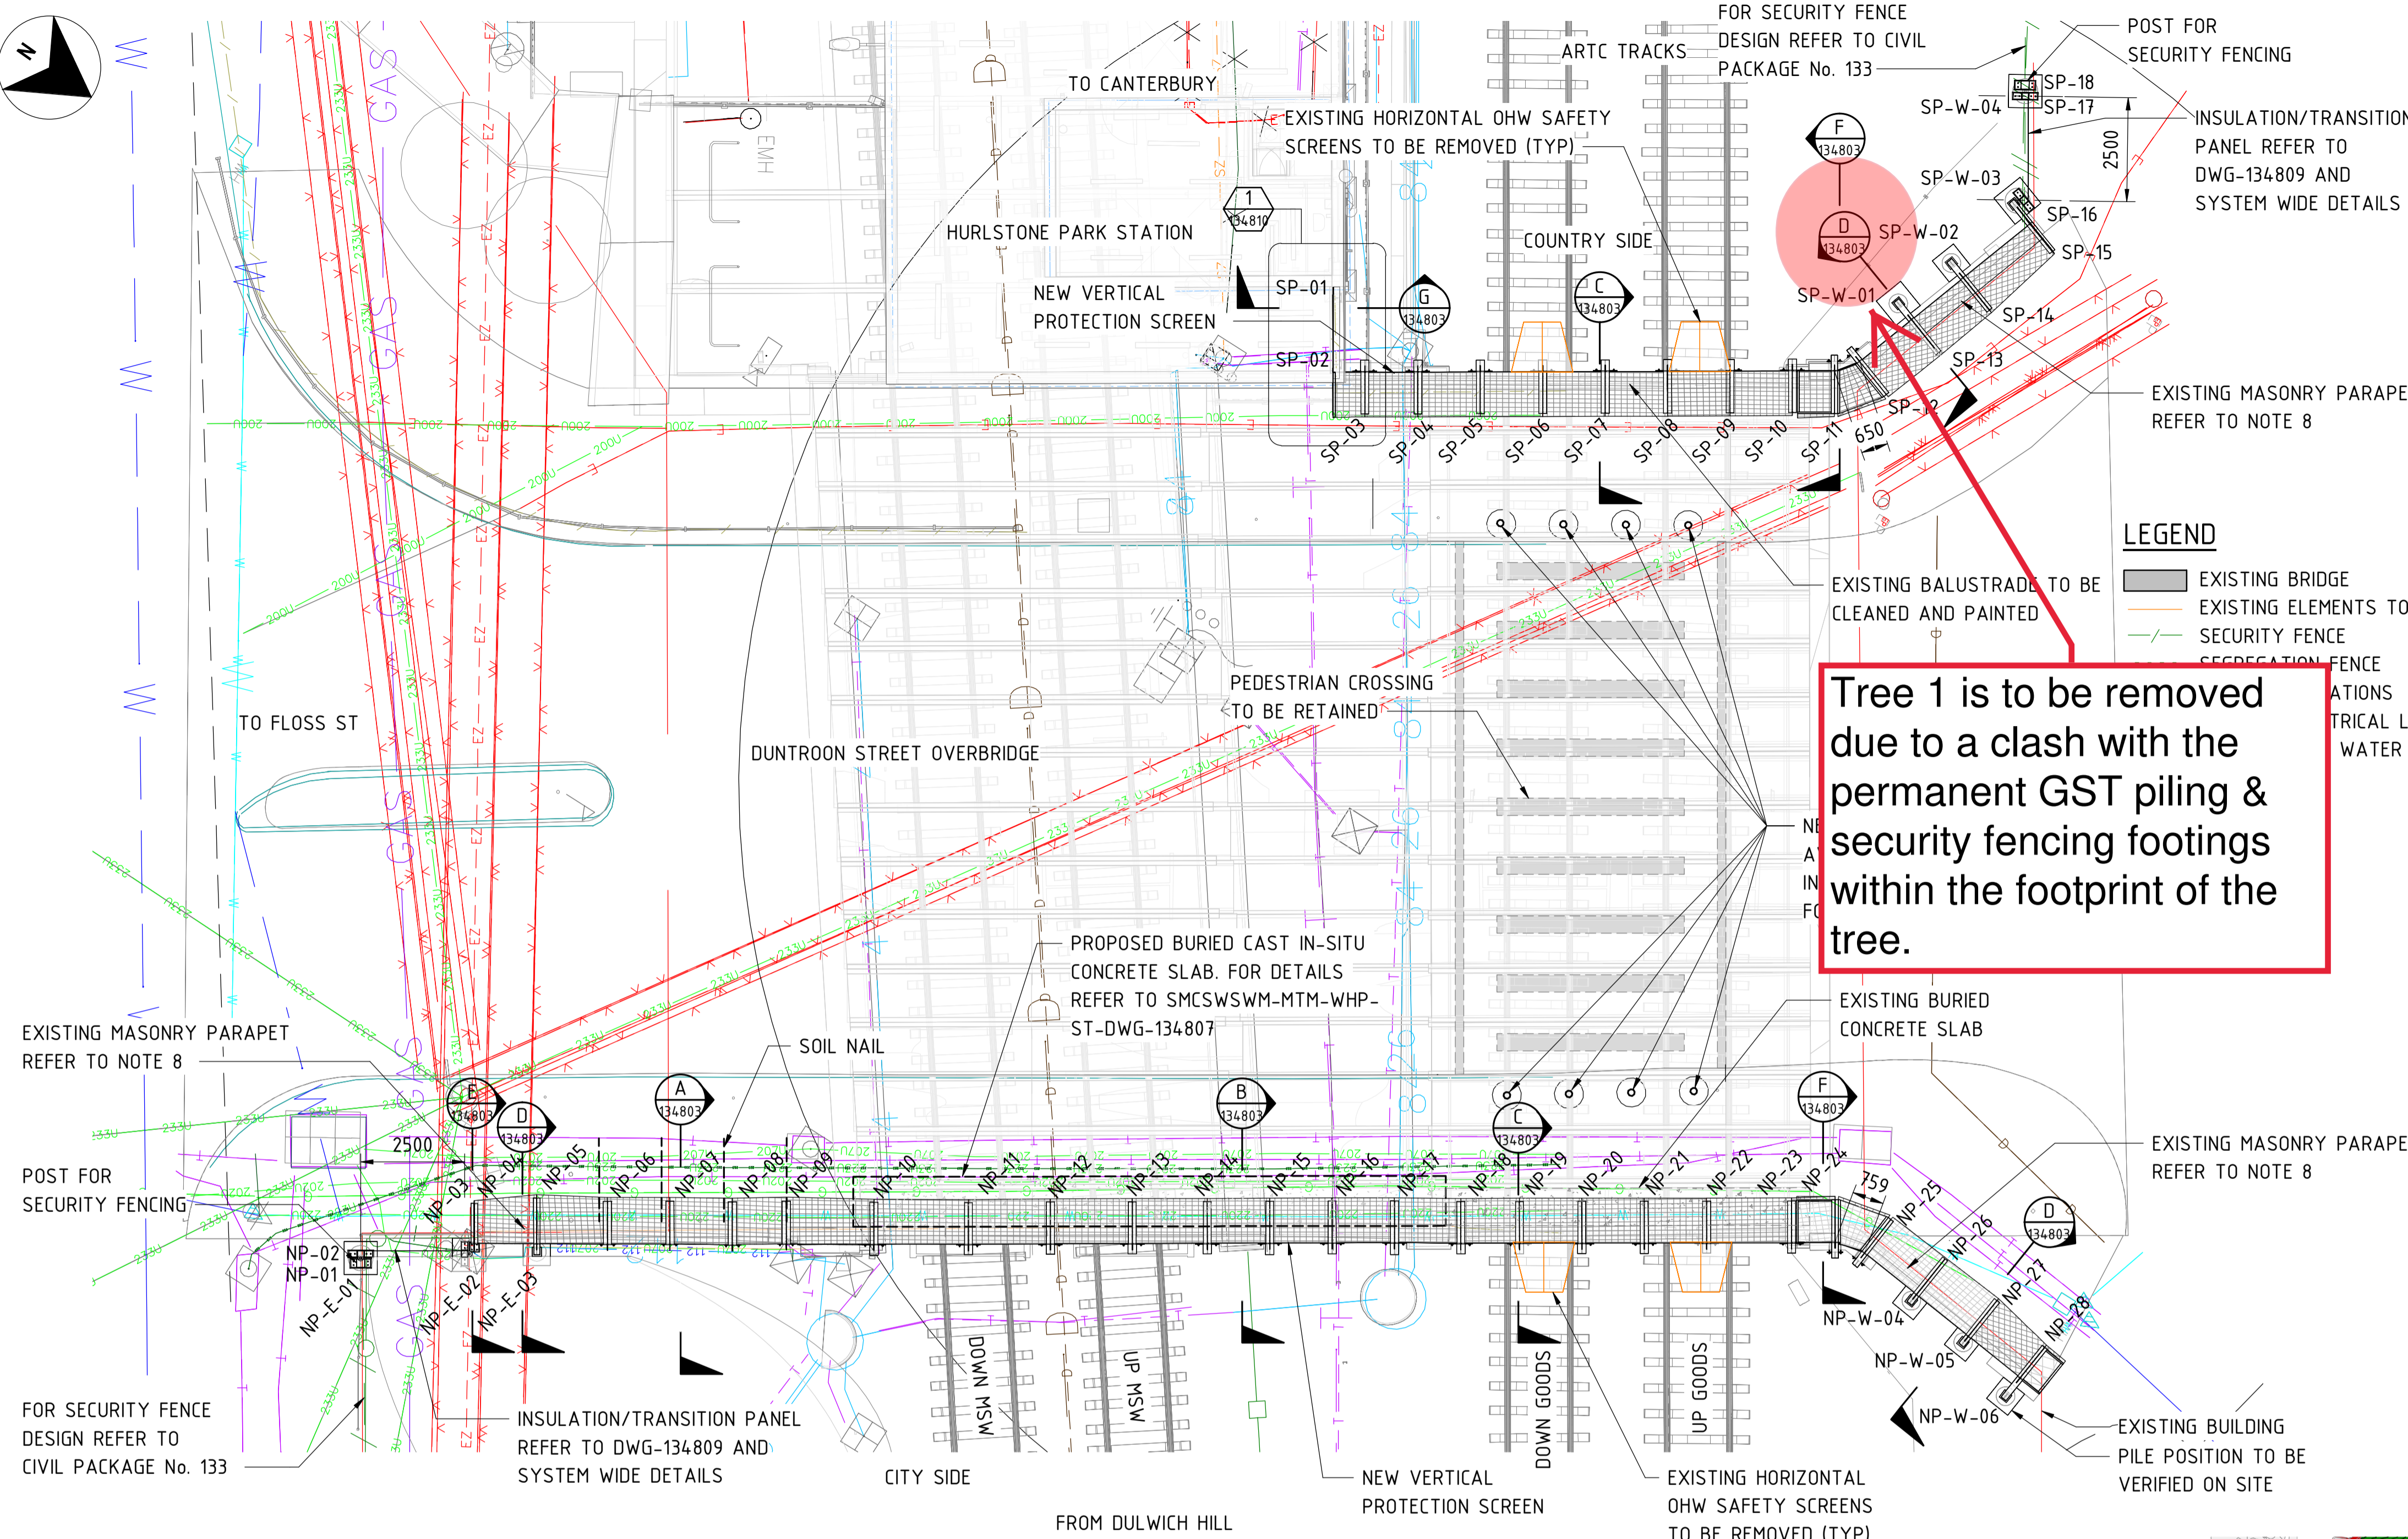
Tree 1 is to be removed due to a clash with the permanent GST piling & security fencing footings within the footprint of the tree.
