Tree Impact Assessment Report

City and Southwest Metro Station Upgrade Works Package 5 & 6

**Project wide: Hurlstone Park, Wiley Park, Belmore,
Campsie, Dulwich Hill and Punchbowl**

P5 Document No. SMCSWSW5-DEW-WEC-EM-REP-000542

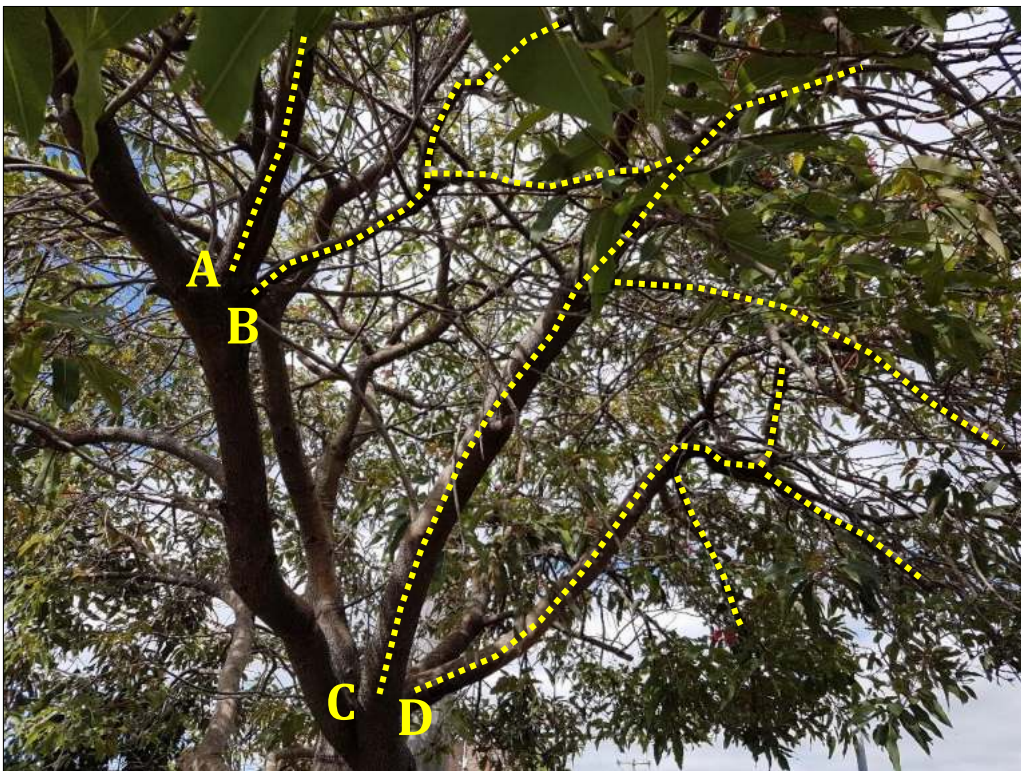
Photograph 3: Branches identified for removal from tree 591 to provide clearance for the proposed concourse roof structure. Branch A is 40mm in diameter at 2.7m height, branch B is 20mm in diameter at 2.7m height, branch C is 120mm in diameter at 2.1m height, branch D is 120mm in diameter at 2.2m height. The removal of identified branches constitutes approximately 35% of the total live canopy volume of the tree.
