Tree Impact Assessment Report

City and Southwest Metro Station Upgrade Works Package 5 & 6

Contract: Package 5/6: 00013/11766

P5 Document No. SMCSWSW5-DEW-WEC-EM-REP-000542

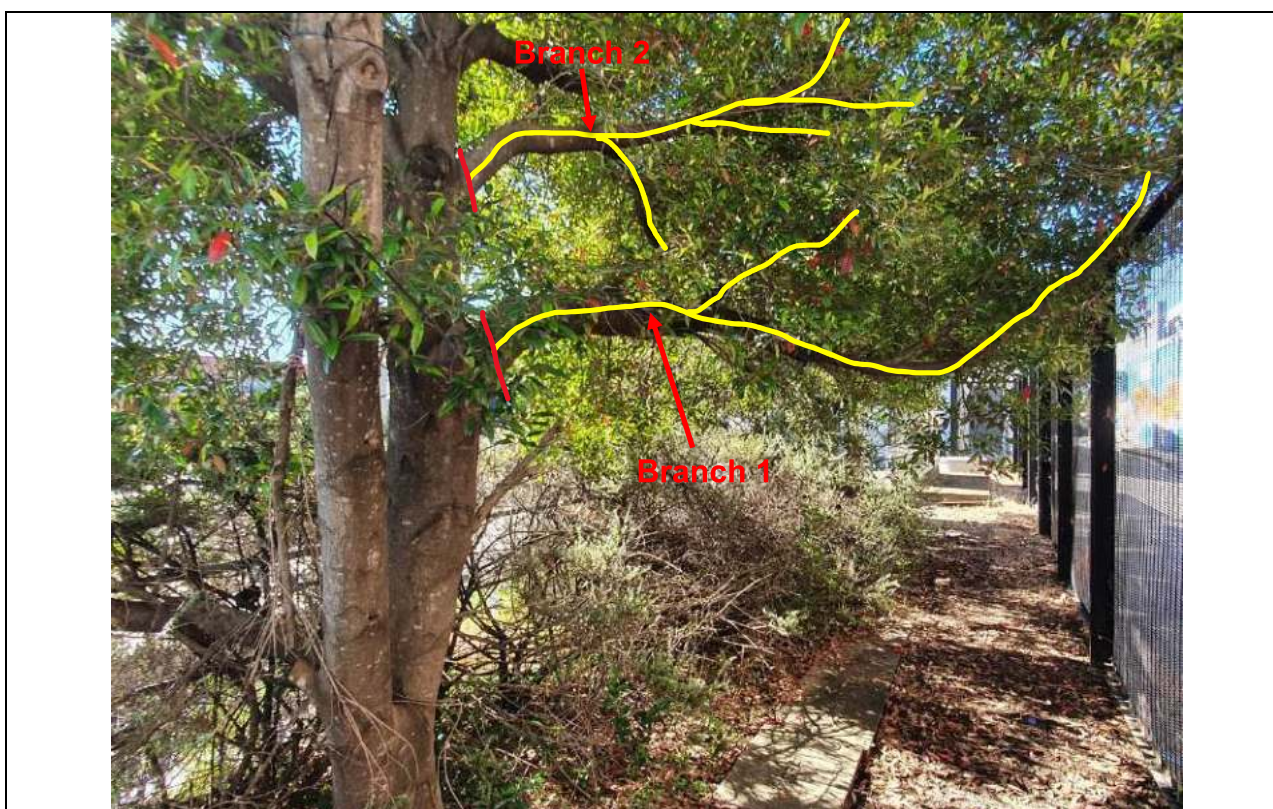
Image 1: Looking East from within the site towards tree 612, showing branch 1 and 2. The yellow lines indicate the branches to be removed, the red lines indicated the approximate location of the final pruning cuts.

The pruning specified above will result in removing 10-15% of the overall live crown. The pruning will not adversely impact the condition of the tree. The pruning is therefore considered minor and acceptable. All pruning can and must be carried out in accordance with section 7.2.4 of AS4373-2007 for selective pruning.⁸ The final pruning cut must be to the branch collar/union.

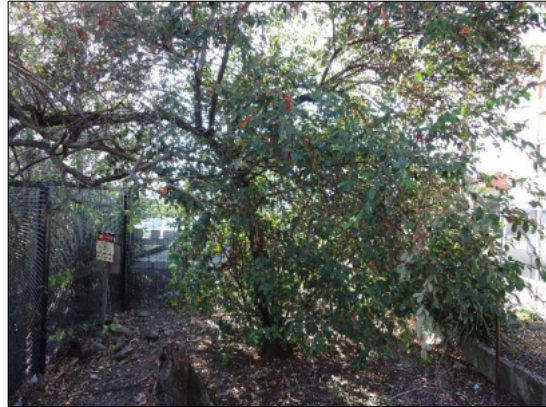
Photograph 2: Tree 516 *Leptosporum petersonii* (Lemon-scented Teatree) was found to be dead.

Trees 515, 516, 517 & 519 must be cleared to provide adequate construction access to the GST route on the Sydney Trains rail corridor embankment. The GST route can't be constructed from the track due to the topographical restrictions preventing the safe construction of the permanent asset

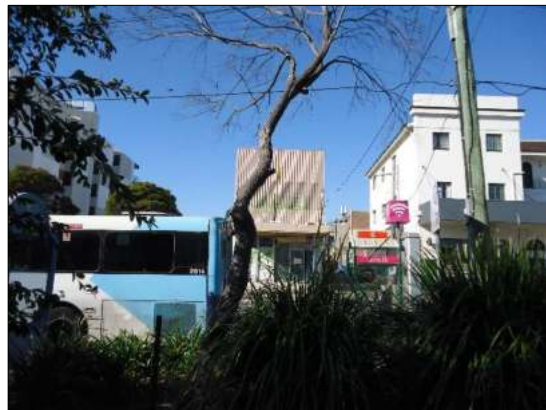
Photograph 3: Tree 517 *Pittosporum undulatum* (Sweet Pittosporum) was found to be dead.

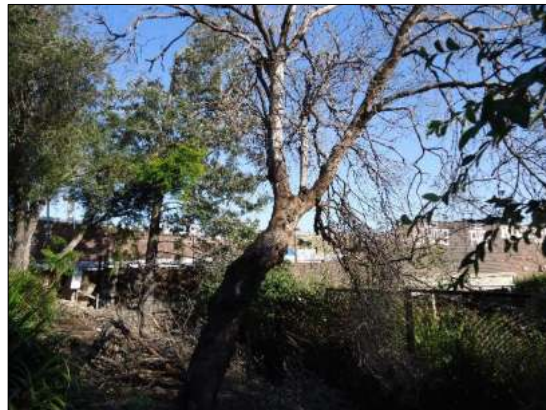
Photograph 4: Tree 519 *Callistemon viminalis* (Weeping Bottlebrush) located adjacent the northern side of South Parade.

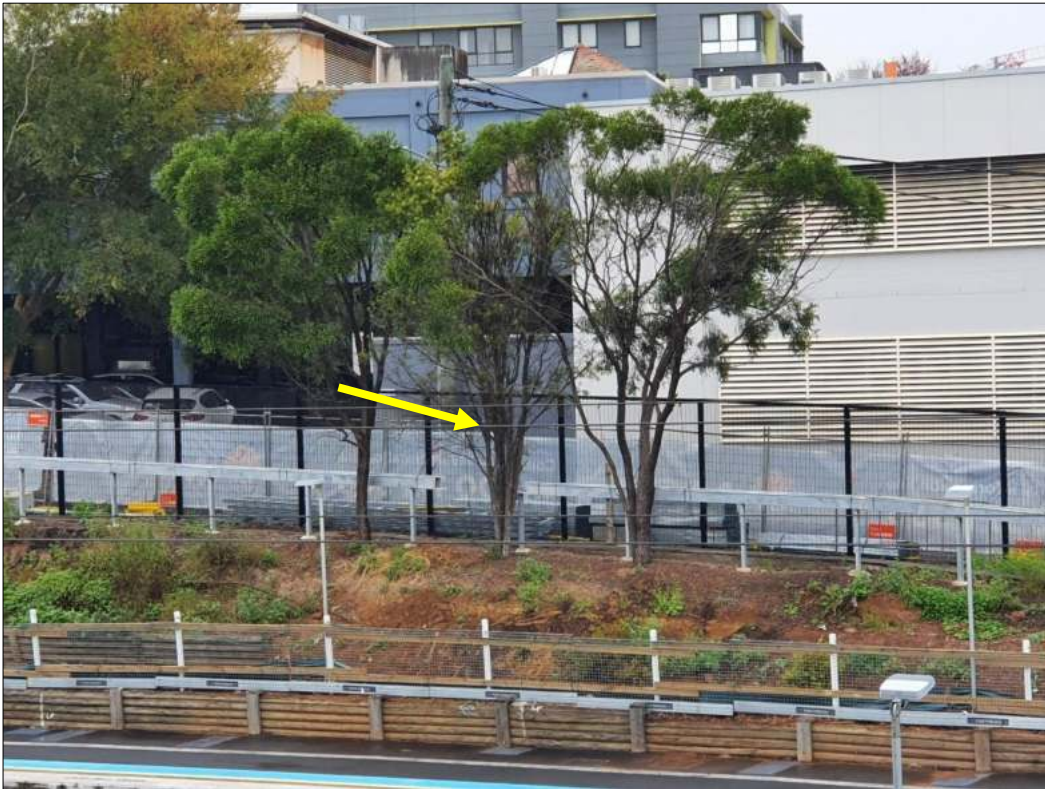
Photograph 1: Tree 618 *Callistemon viminalis* (Weeping Bottlebrush) as seen from the northern side of the rail corridor.

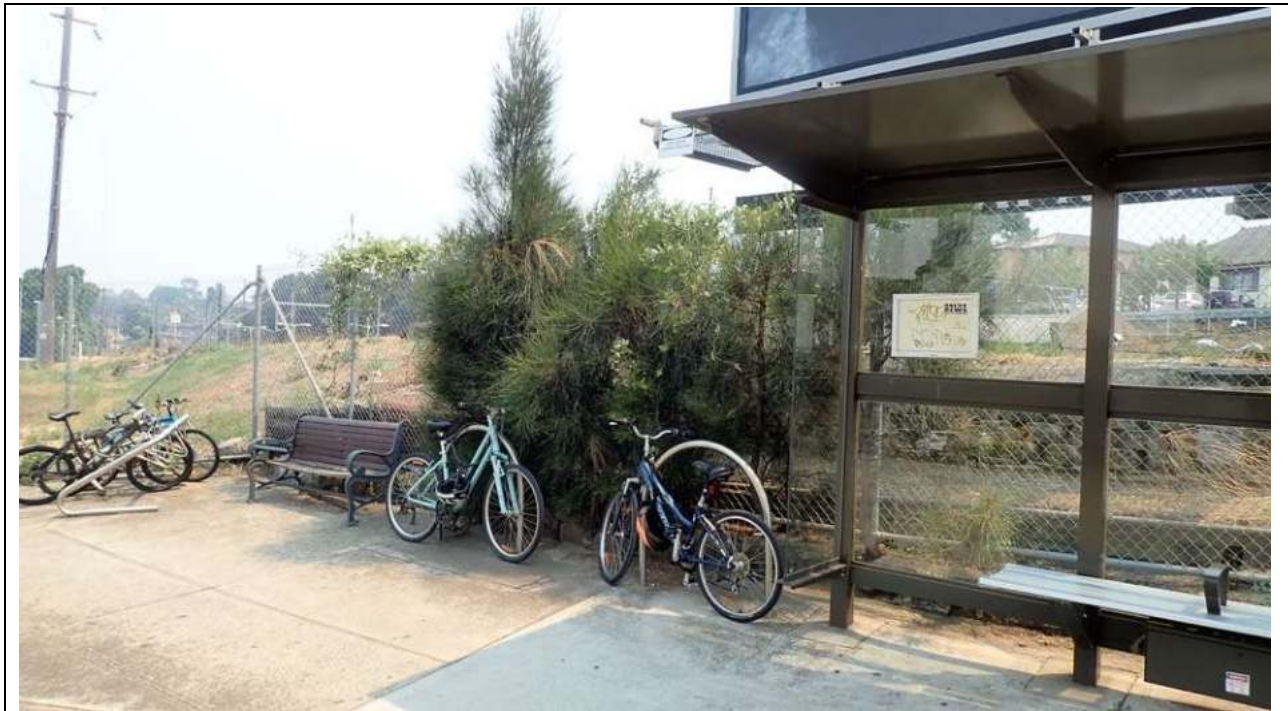
Image 1: Looking North towards trees 586, 587, 588, 589 and 590. The trees have been recommended for removal due to impacts from the proposed hard surfacing excavations.

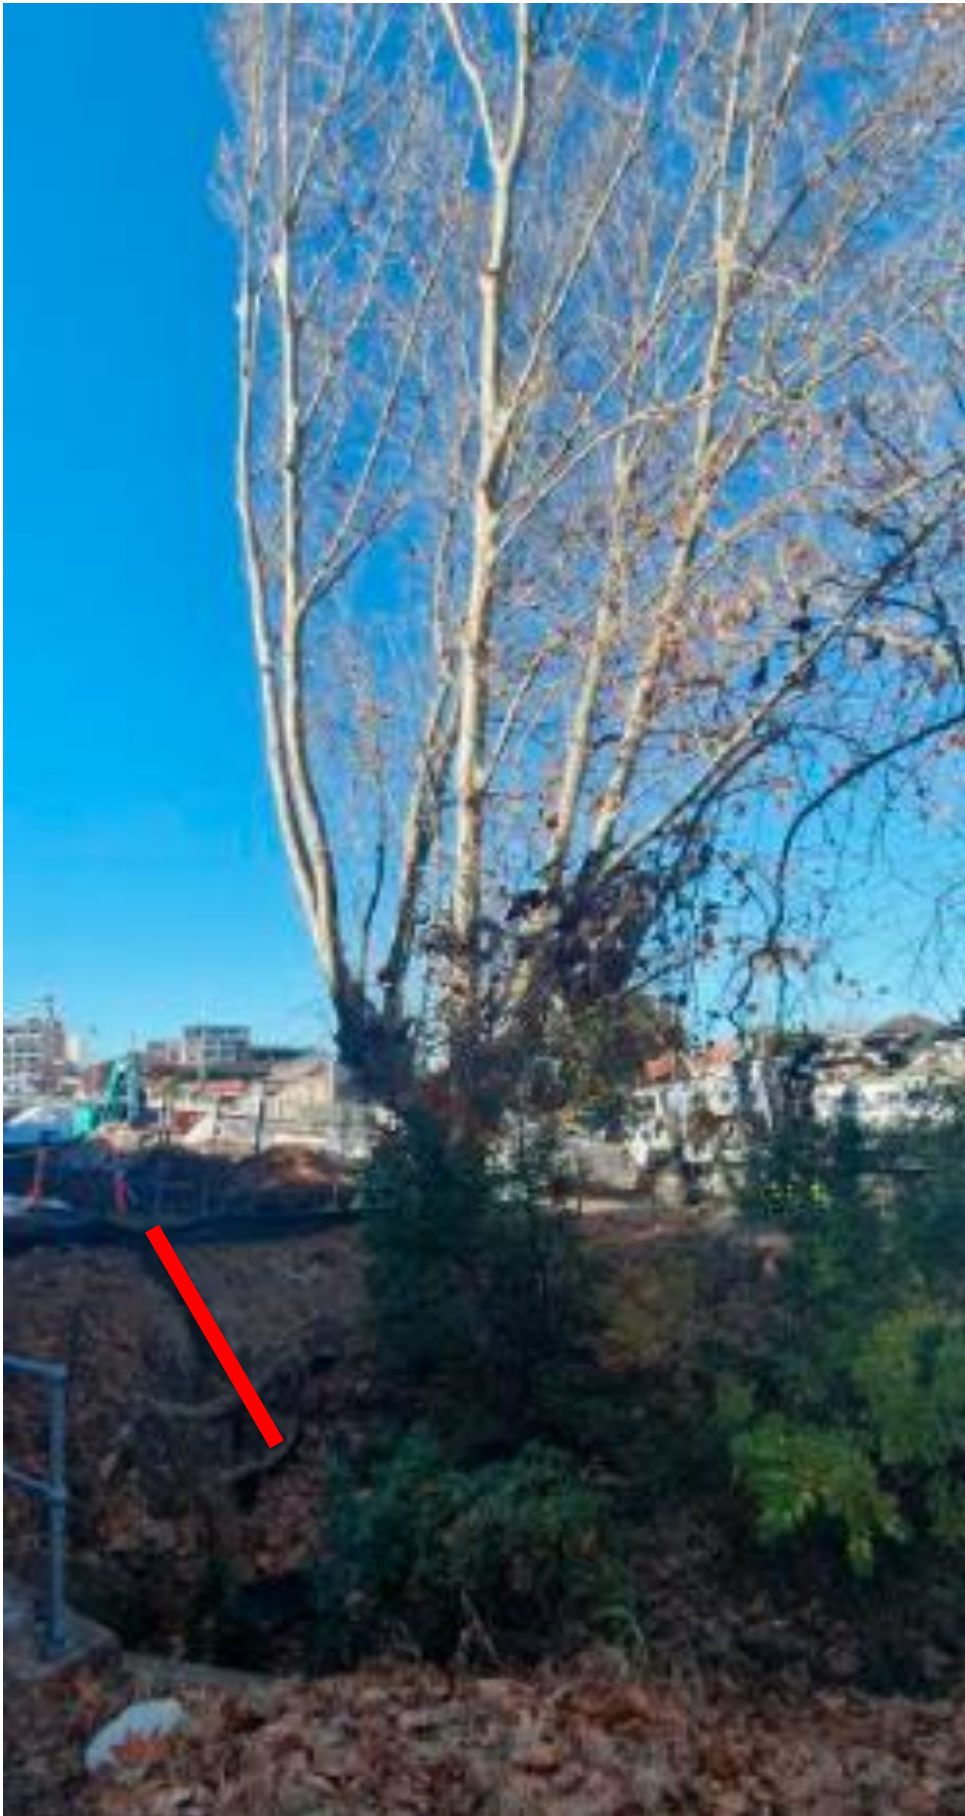
Image of the subject tree (Tree 94) taken on the 15th June 2021 (red line shows approximate location of required excavations).

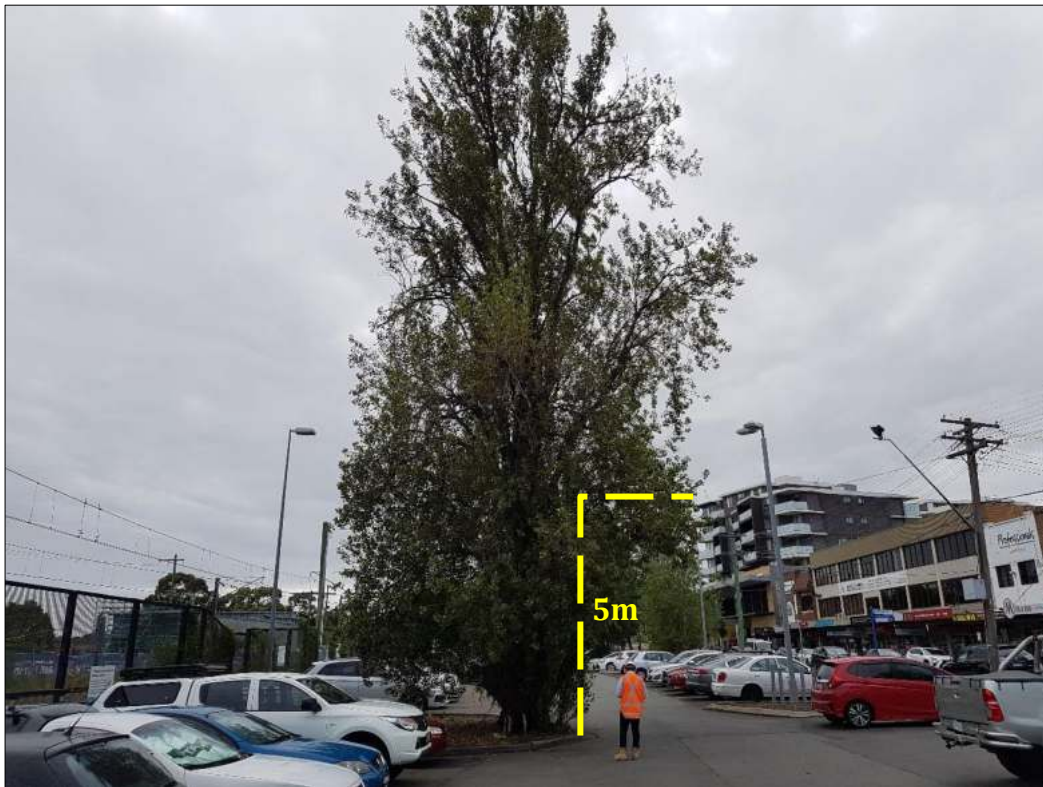
Photograph 1: Tree 1 *Populus nigra* 'Italica' (Lombardy Poplar as seen from the carpark area adjacent The Boulevard. 5m of vertical clearance is required from the outside edge of kerb adjacent the base of the tree.
