Tree Impact Assessment Report

City and Southwest Metro Station Upgrade Works Package 5 & 6

**Project wide: Hurlstone Park, Wiley Park, Belmore,
Campsie, Dulwich Hill and Punchbowl**

P5 Document No. SMCSWSW5-DEW-WEC-EM-REP-000542

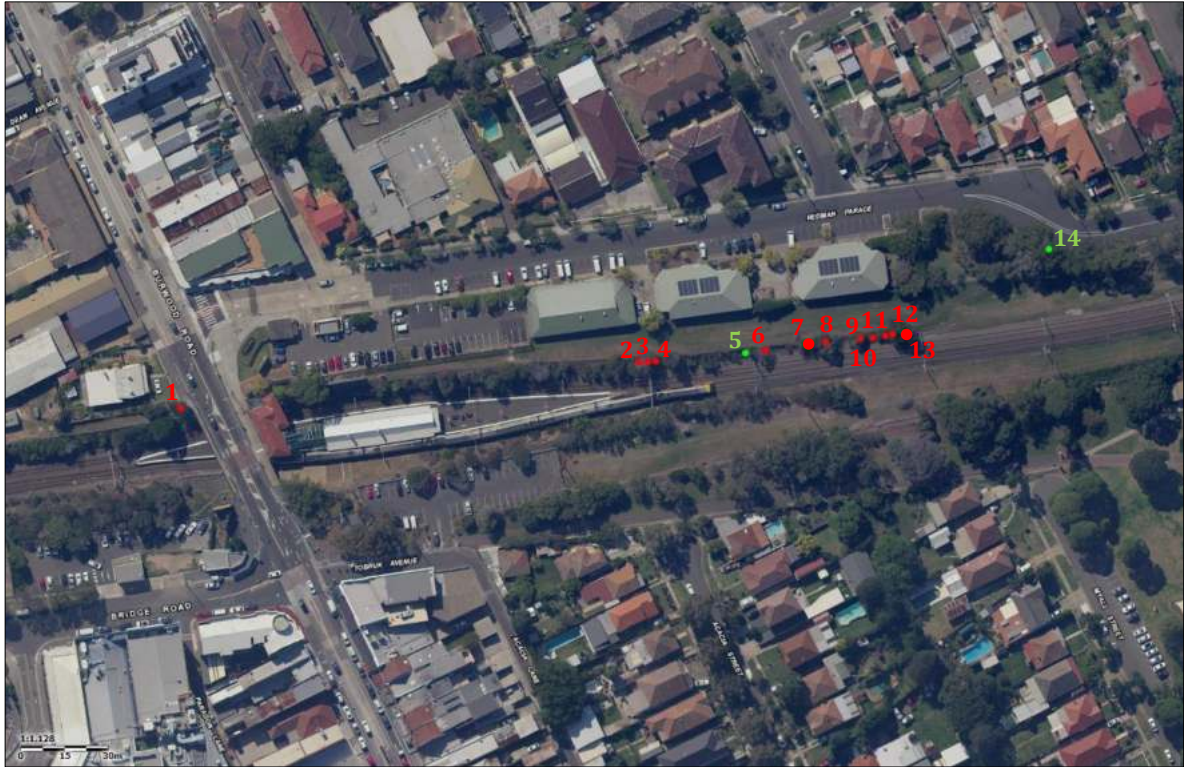
All appropriate approvals and consents are to be obtained prior to tree and vegetation removal works commencing. Given their size and location, it is felt that trees 2, 3, 4, 6, 7, 8, 9, 10, 11, 12 and 13 may be removed using an excavator without significant impact on tree 5.

Image 1: Aerial image of Belmore station showing approximate tree locations. Red dots indicate trees to be removed, green dots indicate trees to be pruned.

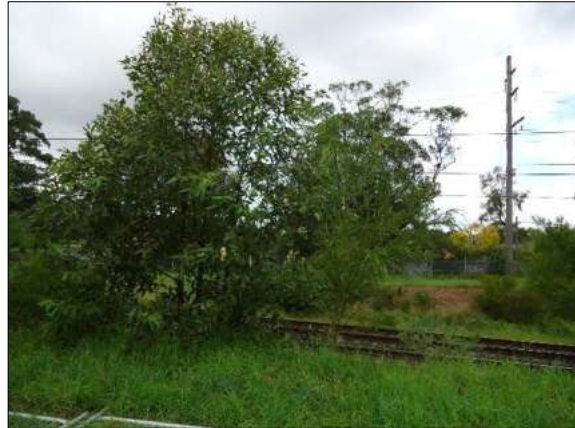
Photograph 5: Tree 7 *Eucalyptus robusta* (Swamp Mahogany) to be removed to accommodate the new GST alignment.

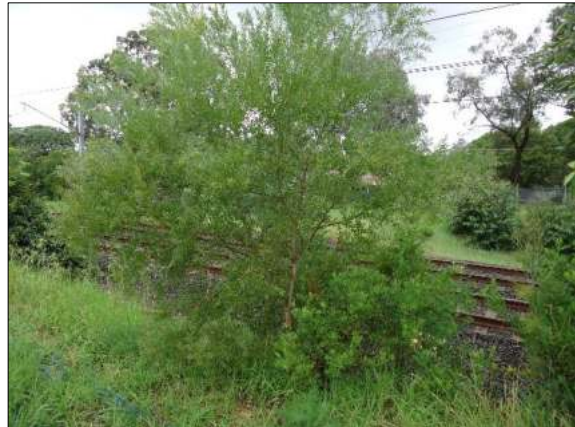
Photograph 6: Tree 8 *Acacia* sp (Wattle) to be removed for MSB works.

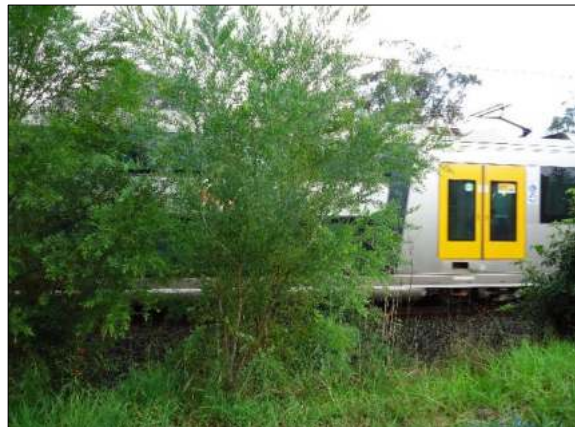
Photograph 8: Tree 10 *Acacia* sp (Wattle) to be removed for MSB works.

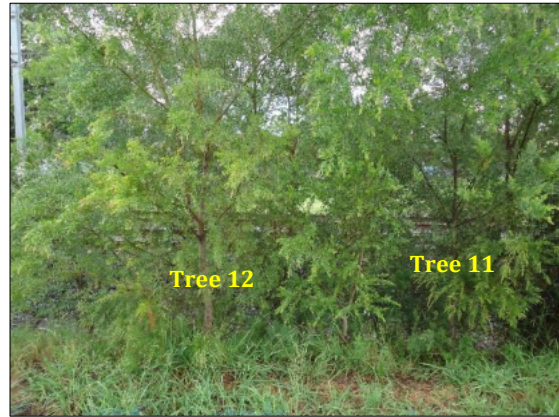
Photograph 9: Trees 11 and 12 *Acacia* sp (Wattle) to be removed for MSB works.

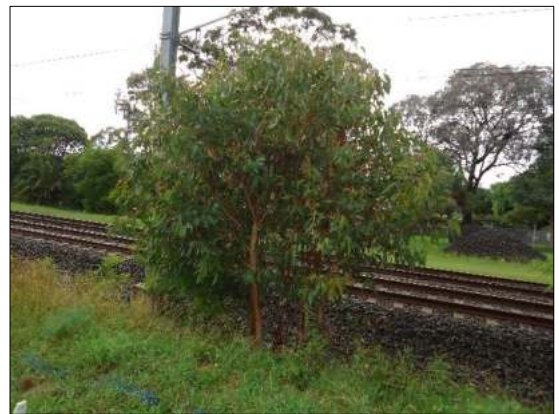
Photograph 10: Tree 13 *Eucalyptus robusta* (Swamp Mahogany) to be removed to accommodate the new sewer alignment.

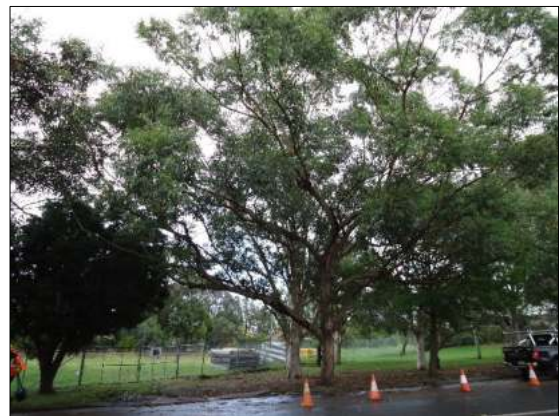
Photograph 11: Tree 14 *Eucalyptus robusta* (Swamp Mahogany) located within road reserve to be selectively pruned for site access clearances.

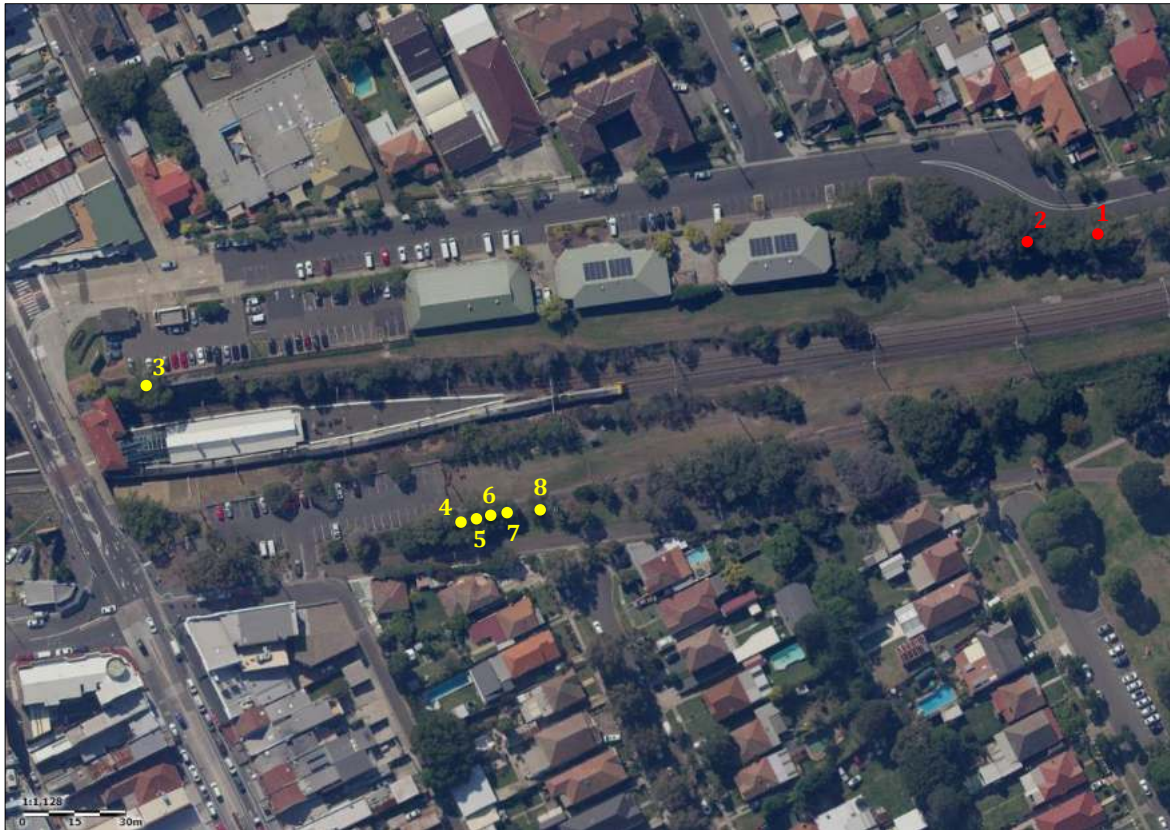
Eight additional trees were assessed with respects to the proposed works. Their locations are shown within Figure 1. Trees 1 and 2 have been identified for removal. Trees 3, 4, 5, 6, 7 and 8 have been identified for selective pruning works. Additional controls with respects to undertaking excavation works within the TPZ of tree 3 have been provided. Tree data can be found as Appendix 1 of this report.

Image 1: Aerial image of Belmore station showing the approximate locations of assessed trees. (Source: Six Maps accessed 20/05/2021).

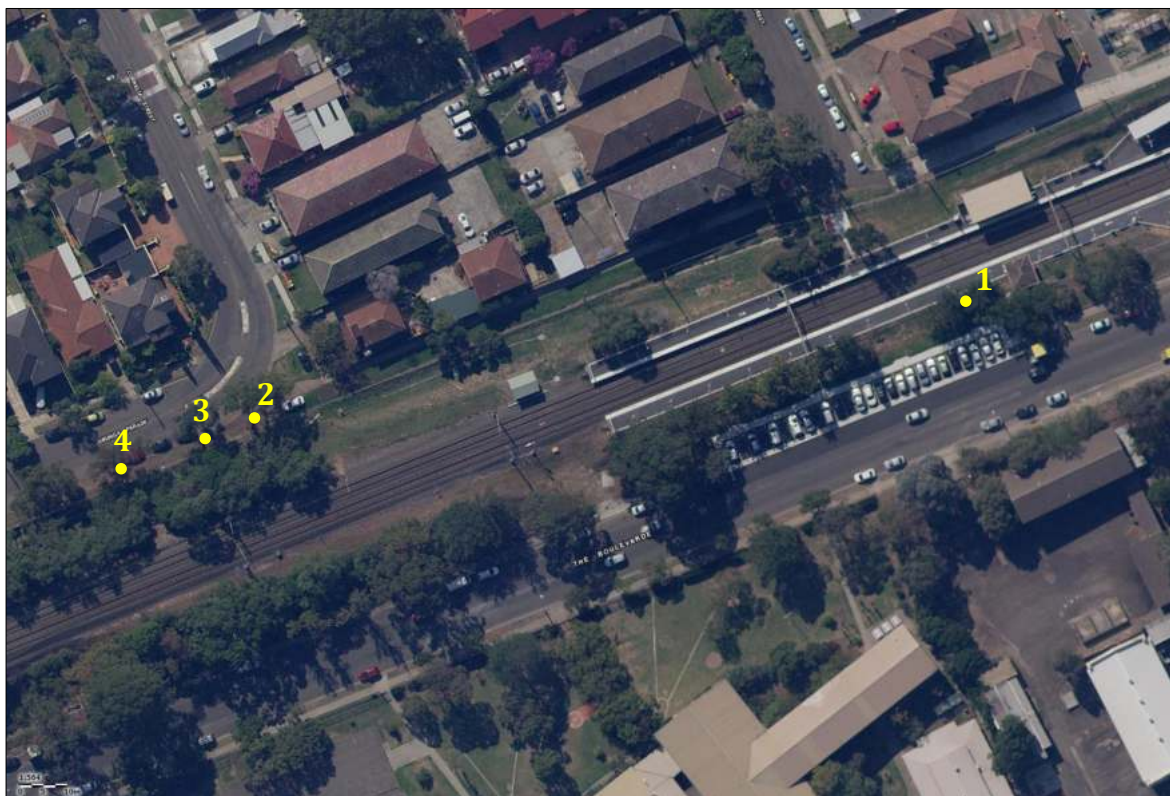
located within the footprint of the proposed works and cannot be retained under the current design. The Sweet Pittosporum is considered to have low landscape significance. Its removal is not expected to have a significant impact upon the local amenity. The Blackbutt, Swamp Mahogany and Wallangarra White Gum are considered to have medium landscape significance. Their removal shall expose the northern end of Urunga parade to the new Metro Services Building, rail corridor and associated infrastructure. The locations of the additional trees to be removed can be found as Image 1. Tree data collected during the site inspection can be found as Appendix 1. Each additional tree for removal has been photographed and can be found as Appendix 2.

Image 1: Aerial image of Wiley Park Station Station showing the location of additional trees to be removed.

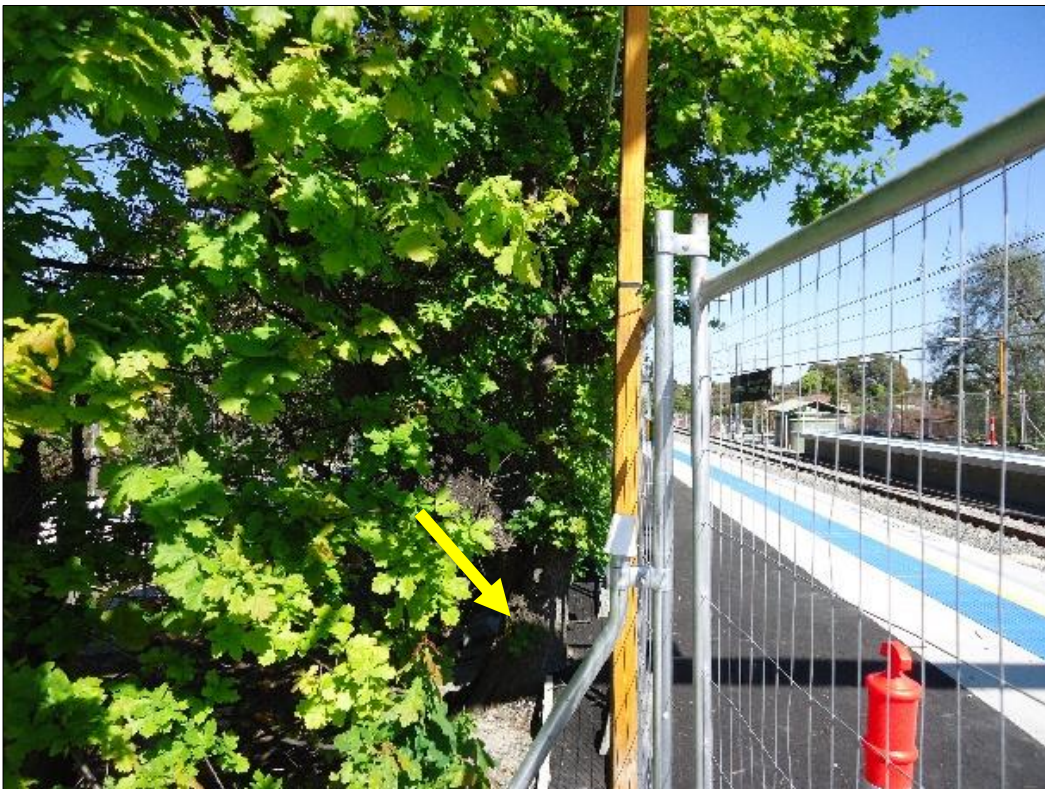
Photograph 2: The position of tree 711 with regards to the alignment of Platform 2 and proposed fence.

Tree 1 to be removed due to direct clash with permanent platform 2 footprint and security fencing along edge of platform.

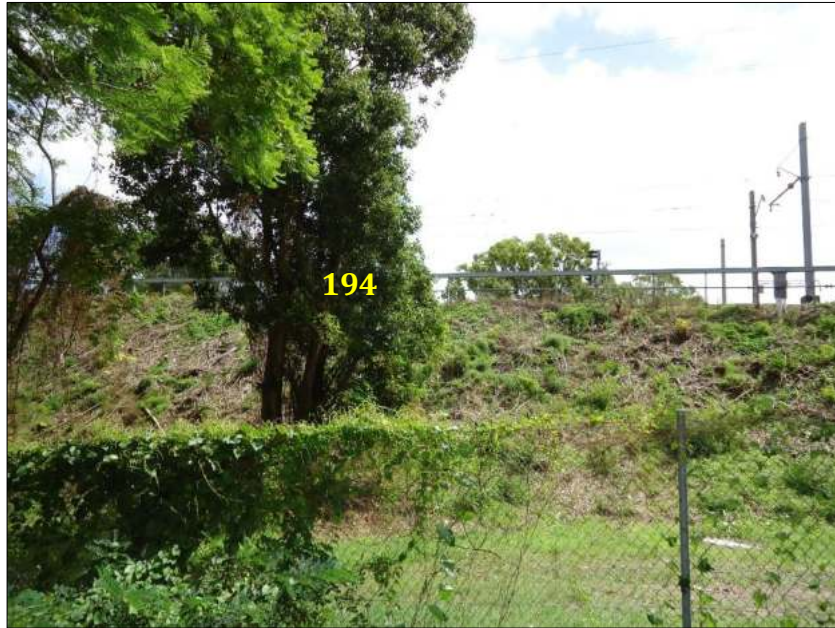
Additional tree removals were identified within the rail corridor associated with the construction of the Metro Services Building. A concrete pad is to be relocated from adjacent trees 166 and 167 to overlay the position of tree 194 *Cinnamomum camphora* (Camphor Laurel) requiring its removal. The tree has been identified for removal on demolition documentation viewed during the on-site inspection. Image 4 shows the tree.

Image 4: Tree 194 as identified within the AIA report shall require removal to accommodate the relocation of the concrete pad. Note the rail embankment to the rear of the tree has been cleared of woody vegetation.
