Tree Impact Assessment Report

City and Southwest Metro Station Upgrade Works Package 5 & 6

Contract: Package 5/6: 00013/11766

P5 Document No. SMCSWSW5-DEW-WEC-EM-REP-000542

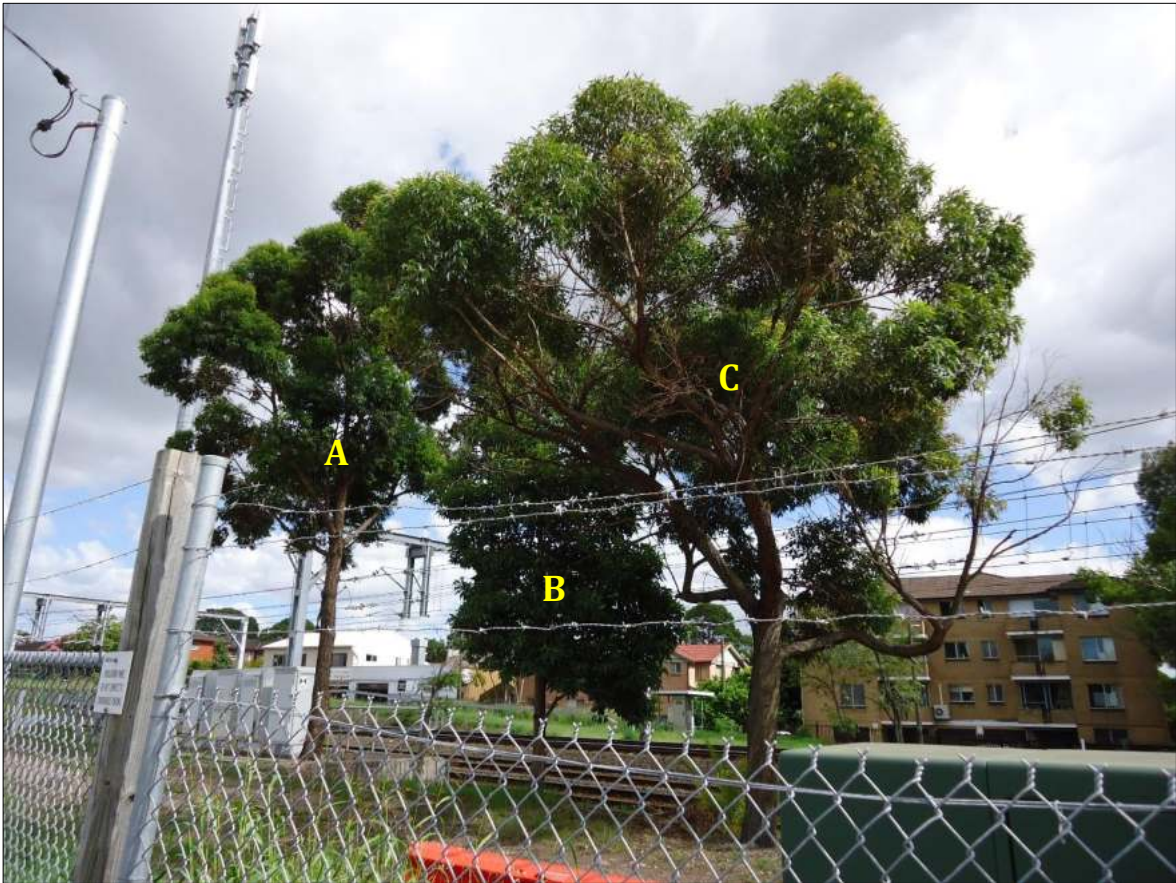
Trees A, Tallowwood and B Brush Box were found to be in good health and condition. They are considered to have a medium useful life expectancy and landscape significance. Tree C Tallowwood was found to have normal vigour and fair condition. Deadwood and canopy dieback was observed within the tree indicating a possible decline in health and condition. As such the tree is considered to have a short useful life expectancy. Image 2 shows the subject trees. The trees provide some screening and relief from the rail corridor and associated infrastructure along Lillian Street.

Image 2: The three additional trees identified for removal as part of the Southwest Metro Package works.

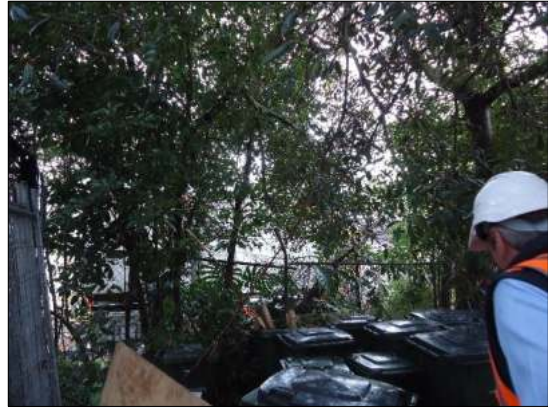
Photograph 1: Clump of vegetation consisting of approximately 14 individual stems of *Cinnamomum camphora* (Camphor Laurel) and a dead tree identified for removal.

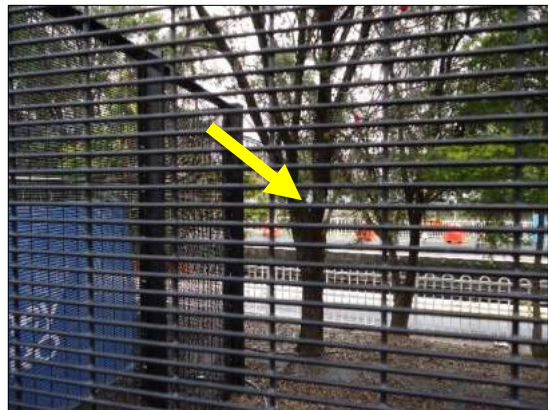
Photograph 2: Tree 632 *Callistemon viminalis* (Bottlebrush) identified for removal to accommodate the new GST alignment.

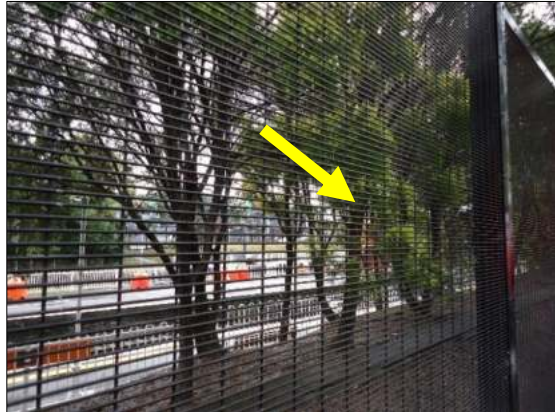
Photograph 3: Tree 627 *Leptospermum petersonii* (Lemon-scented Teatree) identified for selective pruning works create clearances to allow for the new GST alignment.

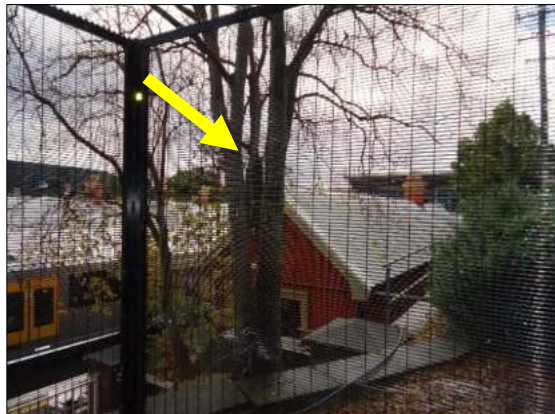
Photograph 4: Tree 614 *Sapium sebiferum* (Chinese Tallowwood) identified for removal to accommodate the new GST alignment.

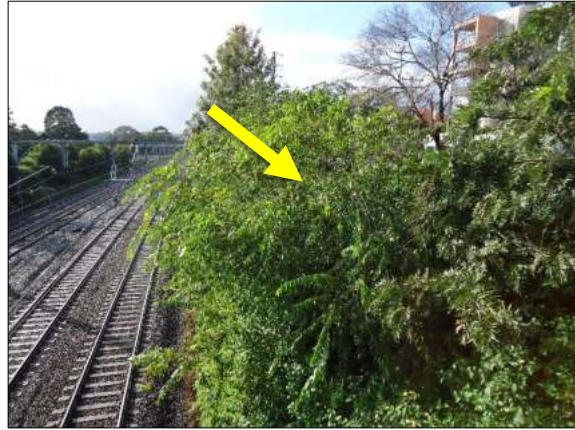
Photograph 5: Tree 6 *Celtis sinensis* (Hackberry) located within rail corridor. Tree to be removed to accommodate the new GST alignment. The surrounding Lantana along the rail embankment is also to be removed.

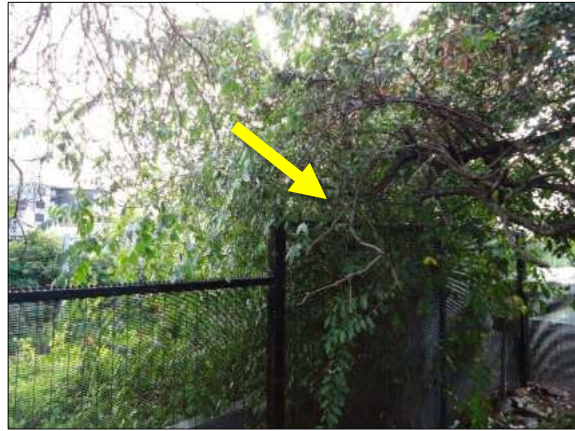
Photograph 6: Tree 7 *Celtis sinensis* (Hackberry) located within rail corridor. Tree to be removed to accommodate the new GST alignment.

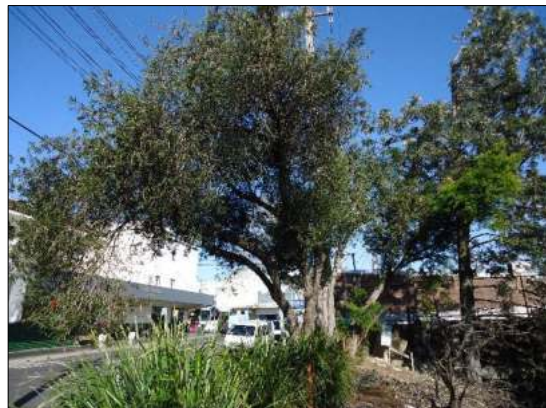
Photograph 4: Tree 519 *Callistemon viminalis* (Weeping Bottlebrush) located adjacent the northern side of South Parade.

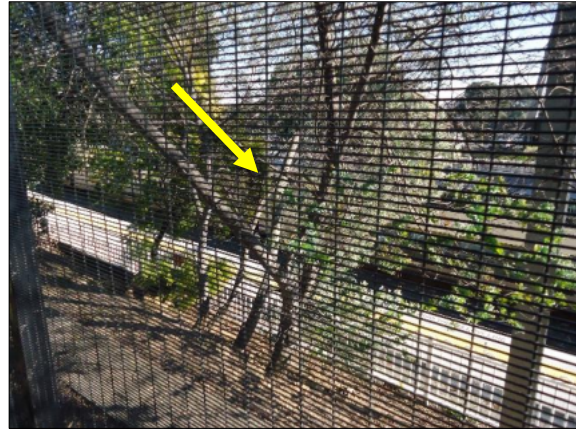
dead. Tree 615 was also found to be in a state of declining health and beyond reasonable attempts to remediate. The AIA report also identifies trees 615 and 620 as being exempt from local tree preservation controls. The additional trees to be removed are not representative of an endangered or threatened species or ecological community. Photographs of the assessed trees have been attached to the rear of this report as Appendix 2 Site Photographs.

Photograph 5: Tree 615 *Acacia podalyrifolia* (Queensland Silver Wattle) located adjacent Platform 2. The adjacent Queensland Silver Wattle's are near dead.

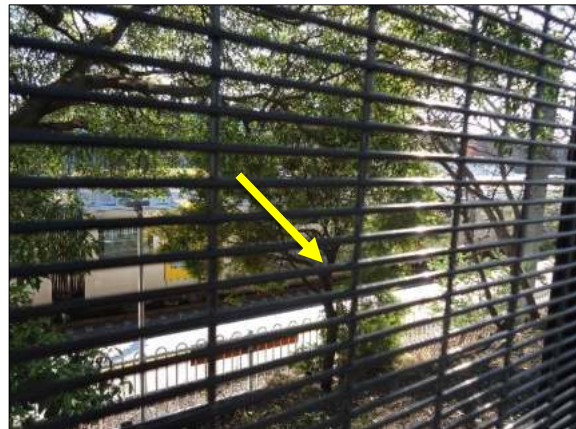
Photograph 6: Tree 5 *Melaleuca bracteata* (Black Teatree) located adjacent Platform 2.

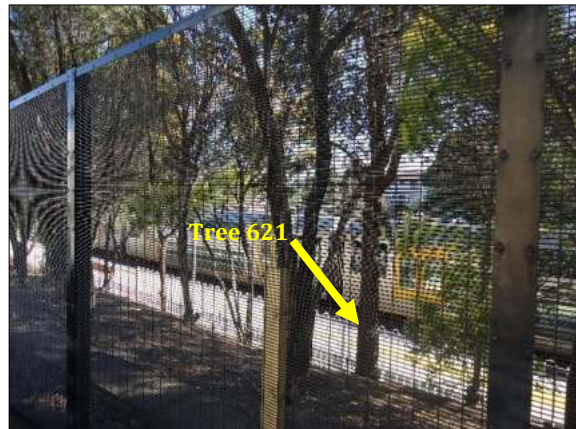
Photograph 7: Showing trees adjacent Platform 2. Tree 621 *Syncarpia glomulifera* (Turpentine) is shown for reference.

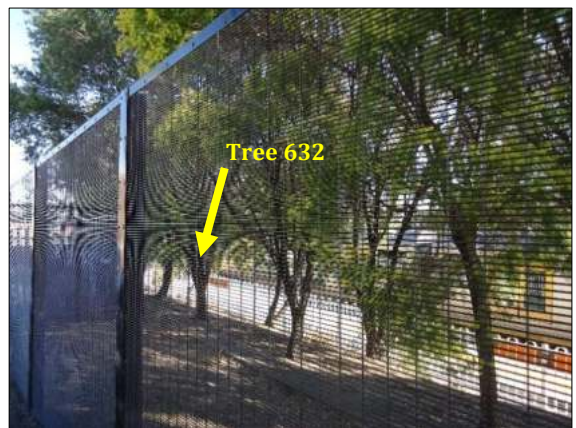
Photograph 8: Showing trees adjacent Platform 2. Tree 632 *Callistemon viminalis* (Weeping Bottlebrush) is shown for reference.

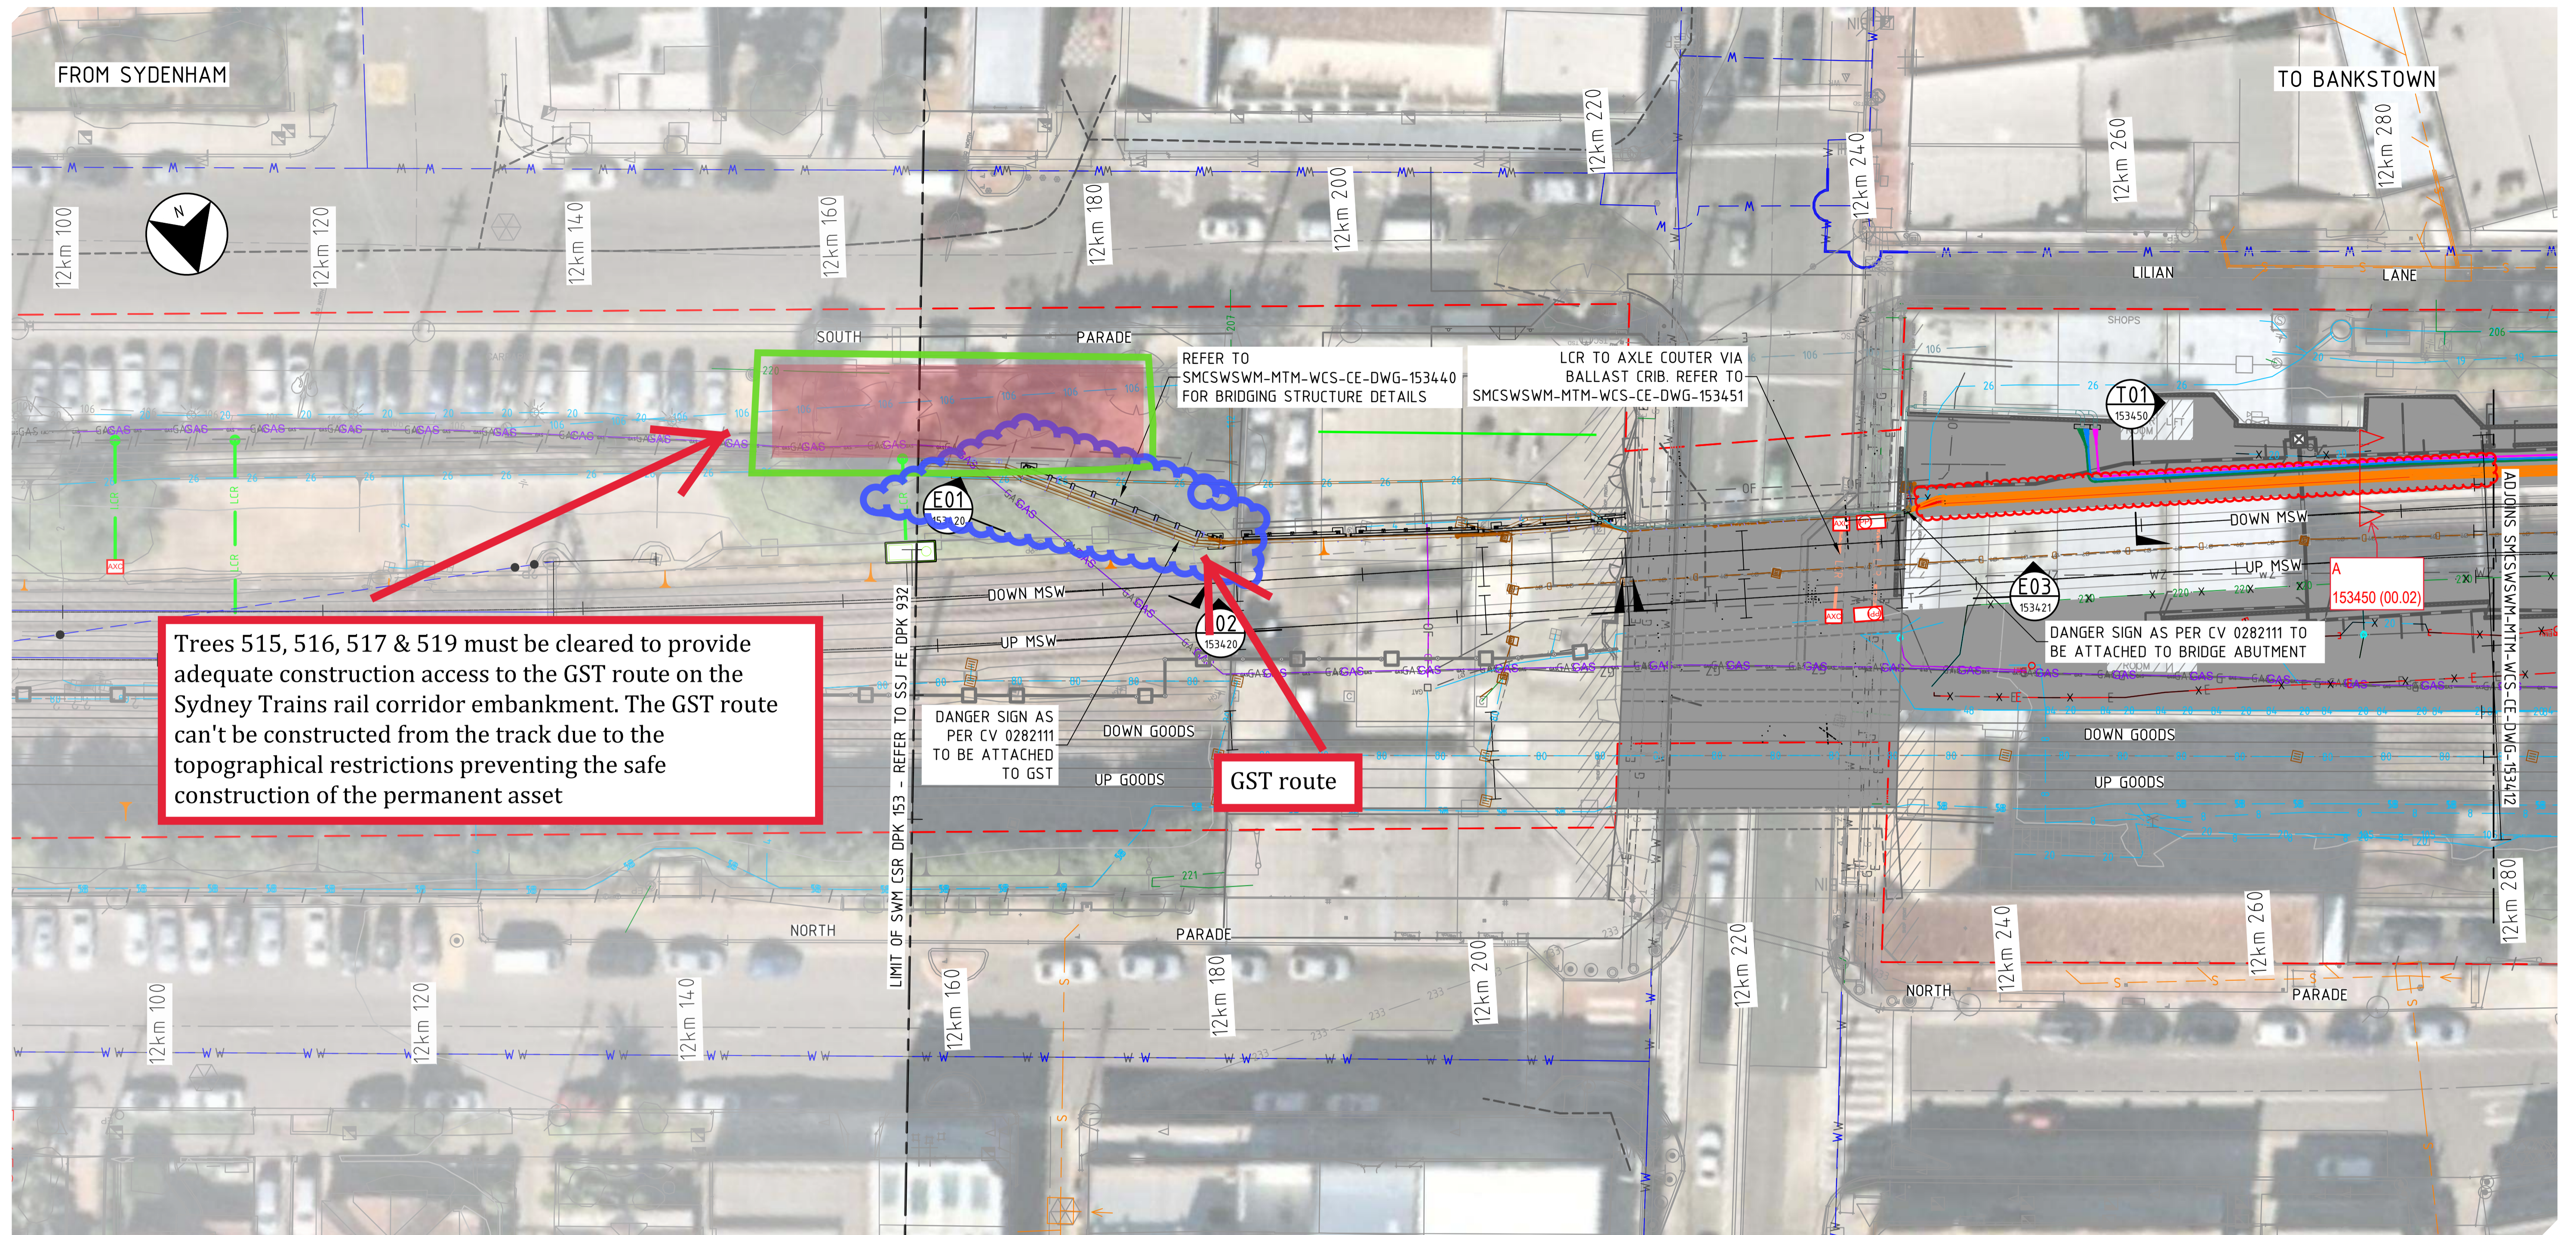
Trees 515, 516, 517 & 519 must be cleared to provide adequate construction access to the GST route on the Sydney Trains rail corridor embankment. The GST route can't be constructed from the track due to the topographical restrictions preventing the safe construction of the permanent asset

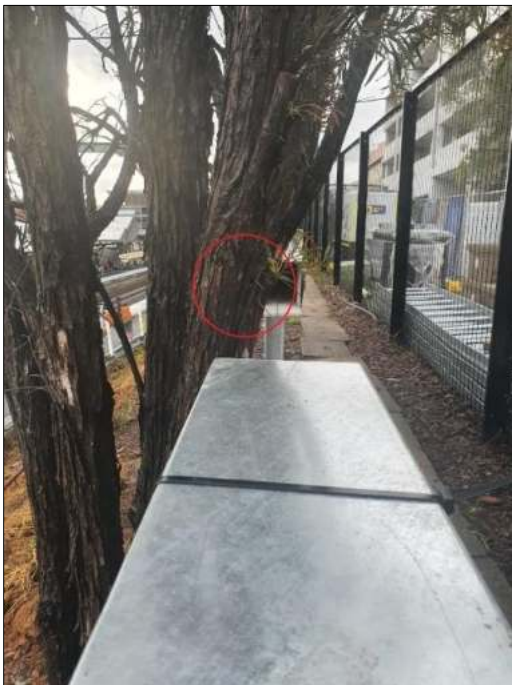
Photograph 2: Looking east along the alignment of the GST. Selective stem removal is required to allow for the GST alignment.

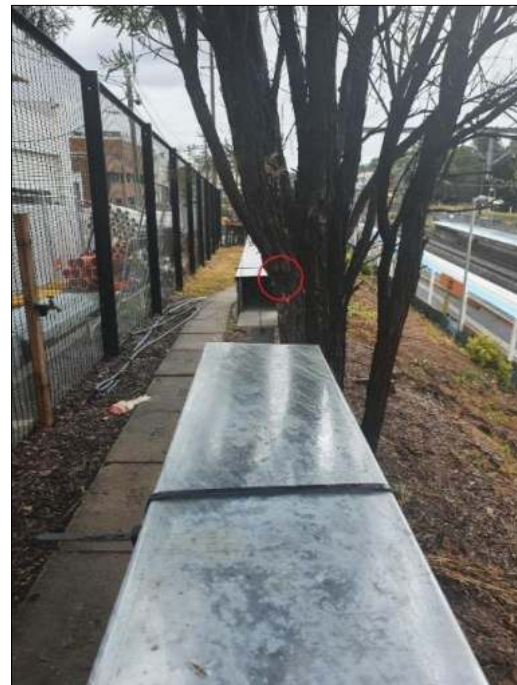
Photograph 3: Looking west along the alignment of the GST. Selective stem removal is required to allow for the GST alignment.

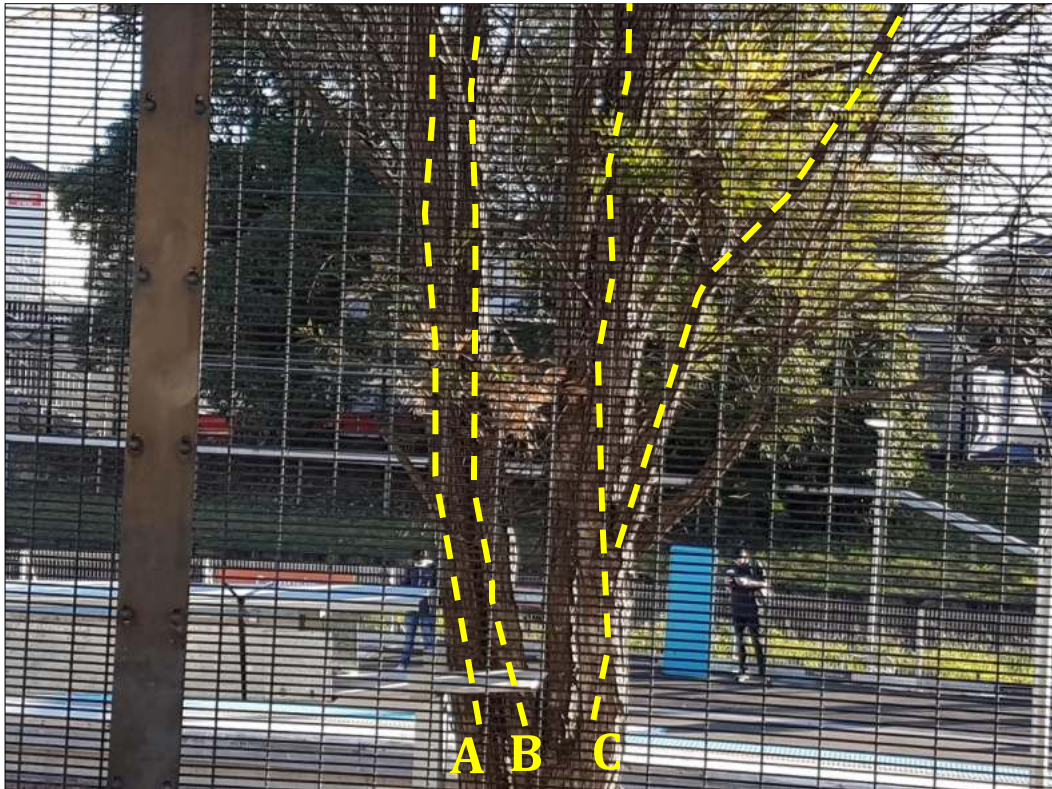
stem is to be removed at the nearest appropriate growth point. Stems B and C both originate from the same parent stem. The total pruning works constitute approximately 50% of the total canopy volume of the tree and are considered to be major pruning works. A reduction in growth, physiological function and a shortening of the trees useful life expectancy can be expected as a result of the works. Pruning wounds for branches A, B and C shall expose internal woody tissues which may become points of infection for decay causing fungi. **Appendix 2** photograph 4 shows branches identified for pruning.

Photograph 4: Stems A, B and C to be removed. Stem A is 160mm in diameter and is to be reduced to below the GST (approx. 0.7m height). Stem s B and C are 90mm and 130mm in diameter and are to be removed to the nearest appreciate growth point. The two branches originate off the same stem.

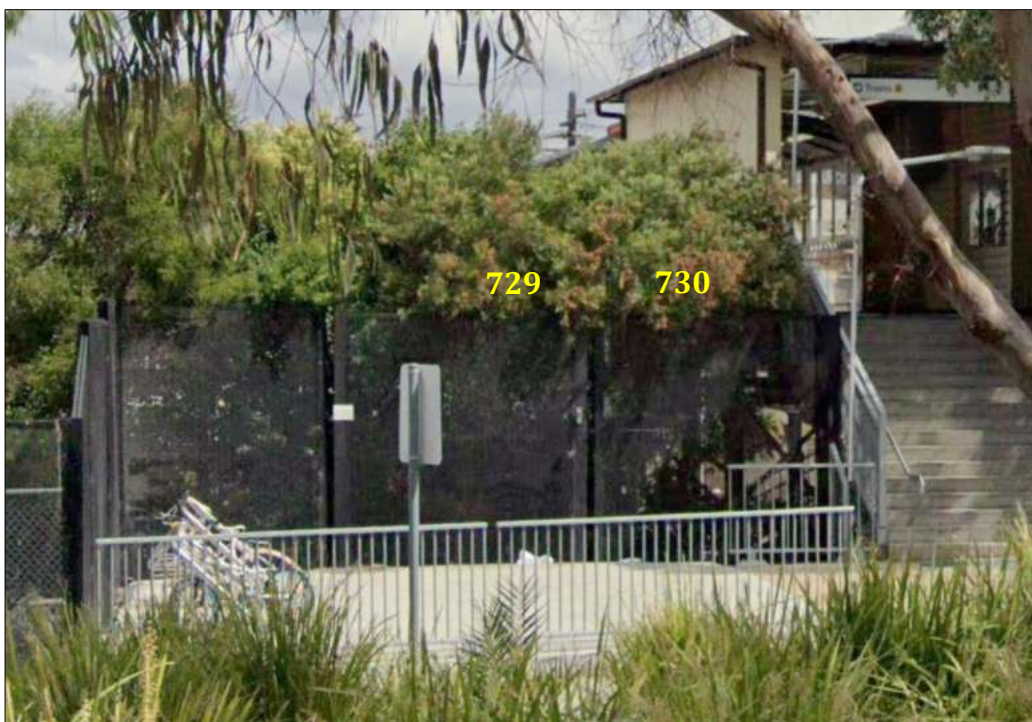
Image 2: Trees 729 and 730 are to be removed to accommodate the lift shaft works.

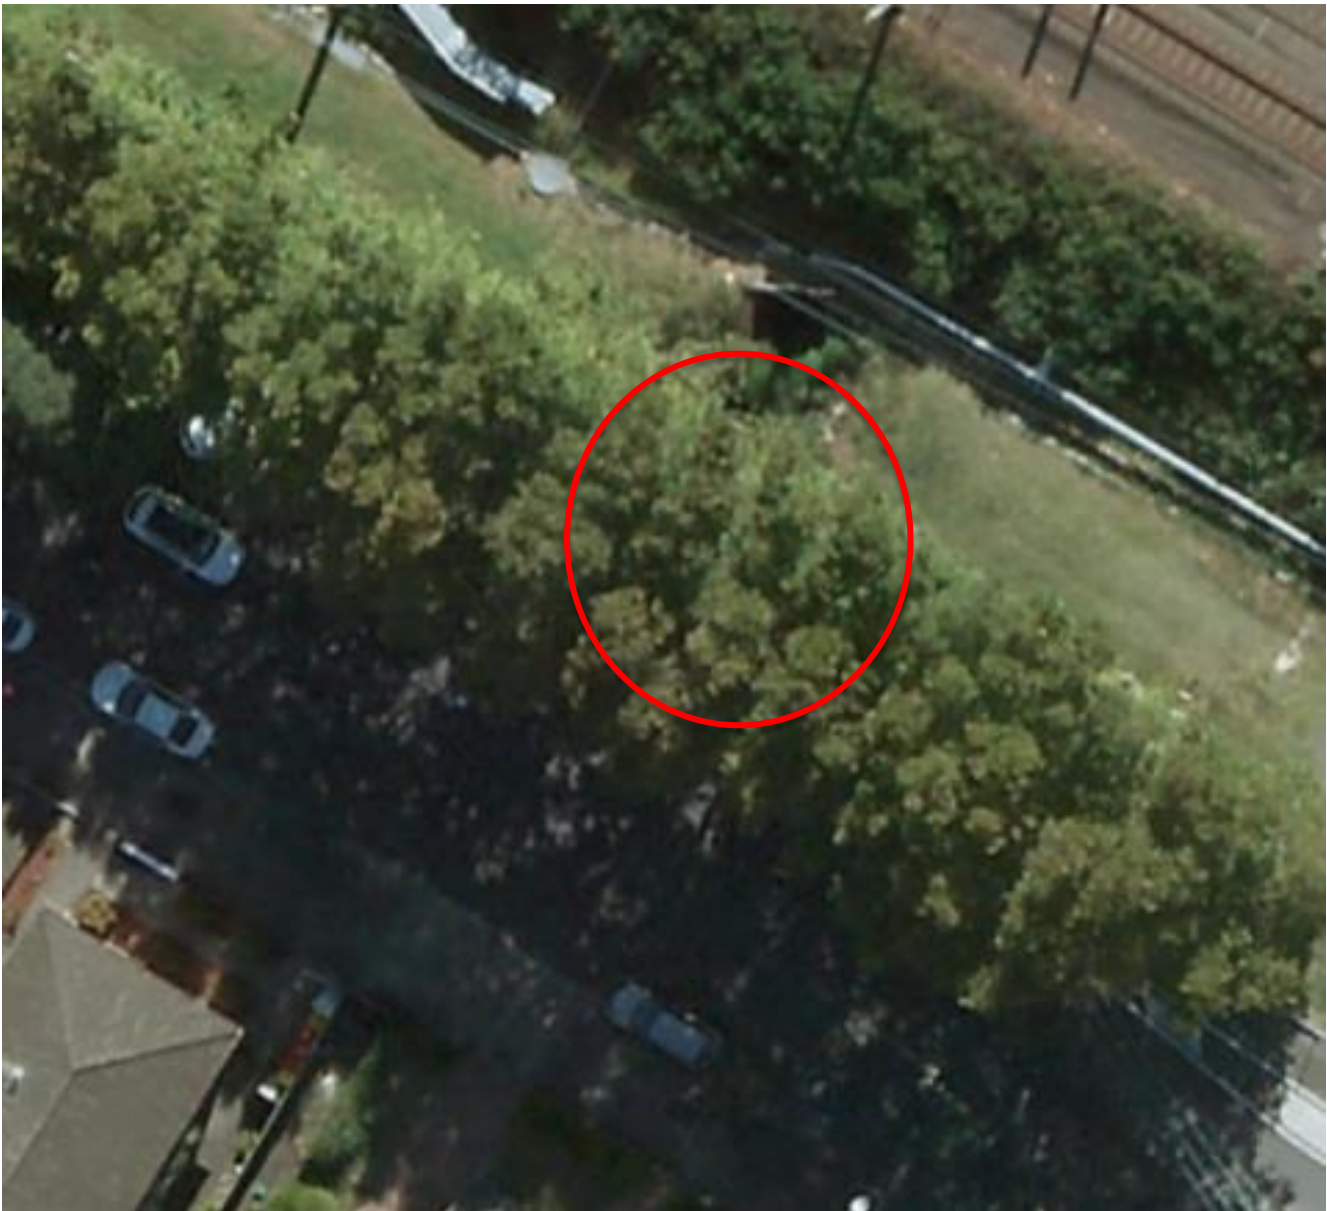
Location of the subject tree (tree 94) circled in red (*Metromap 2021*).

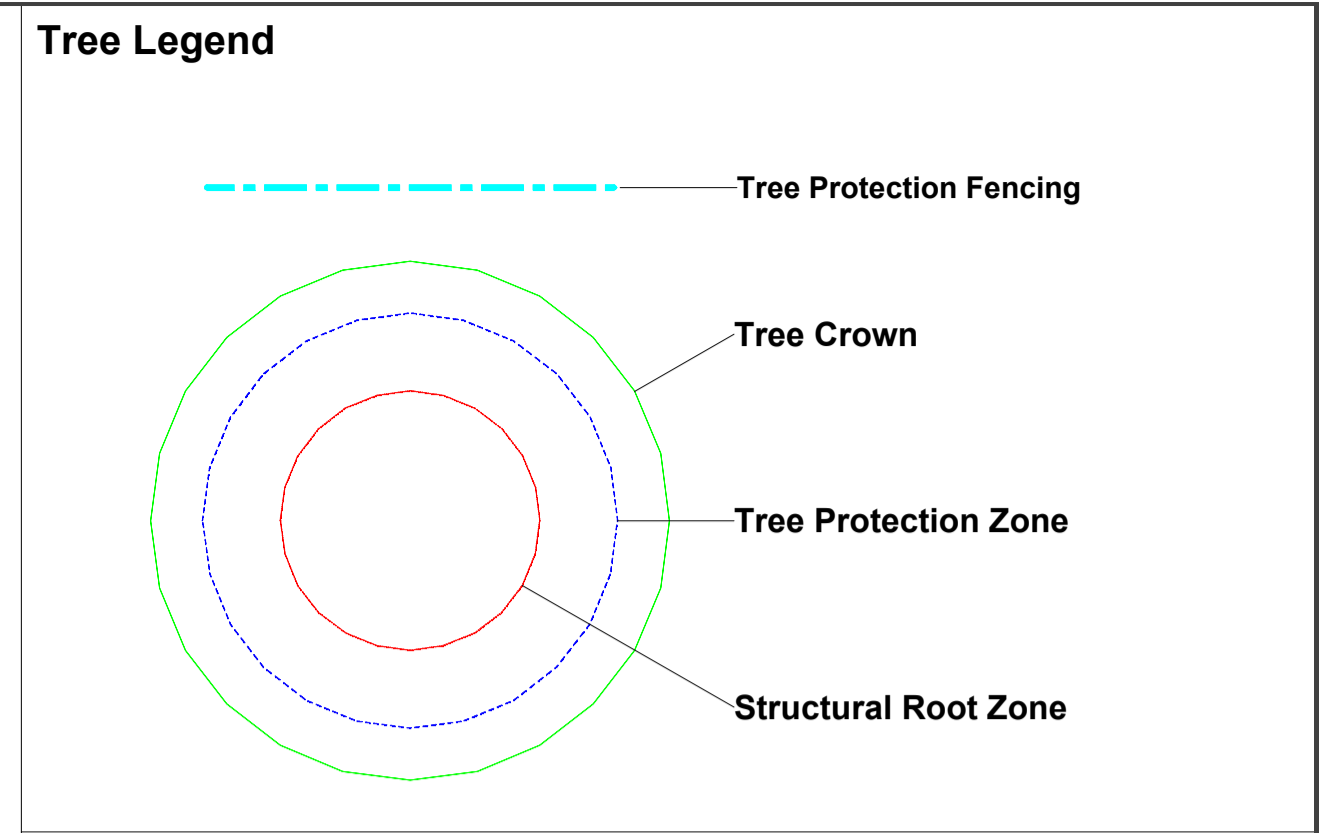
To be cleared due to clash with permanent drainage design. Drainage design indicted by blue and white dotted line.

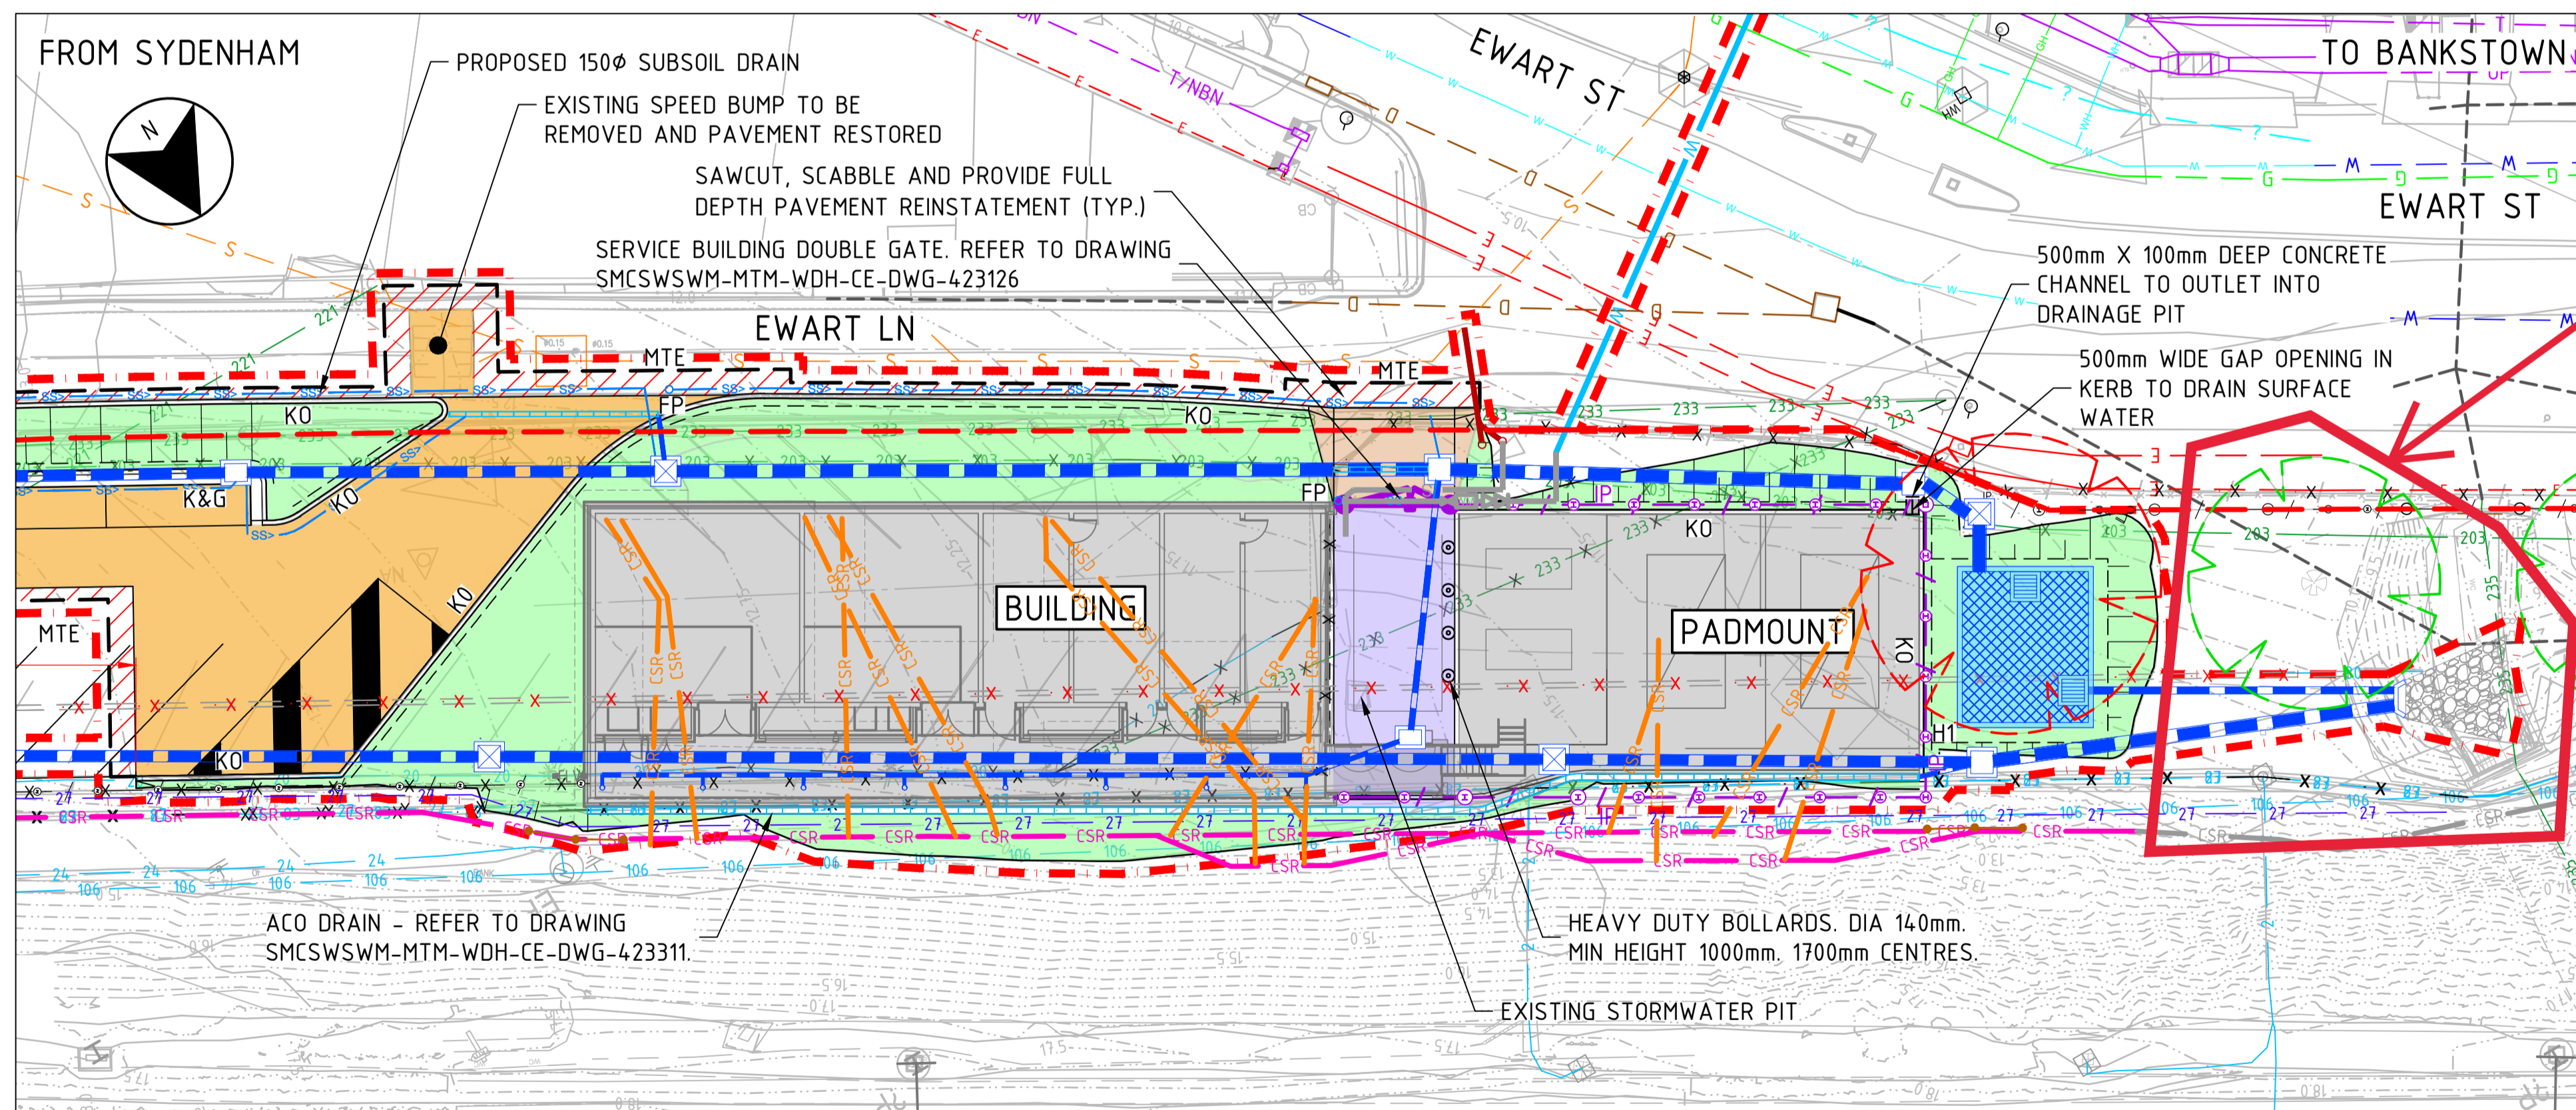
To be cleared due to clash with permanent drainage design. Drainage design indicated by blue and white dotted line.

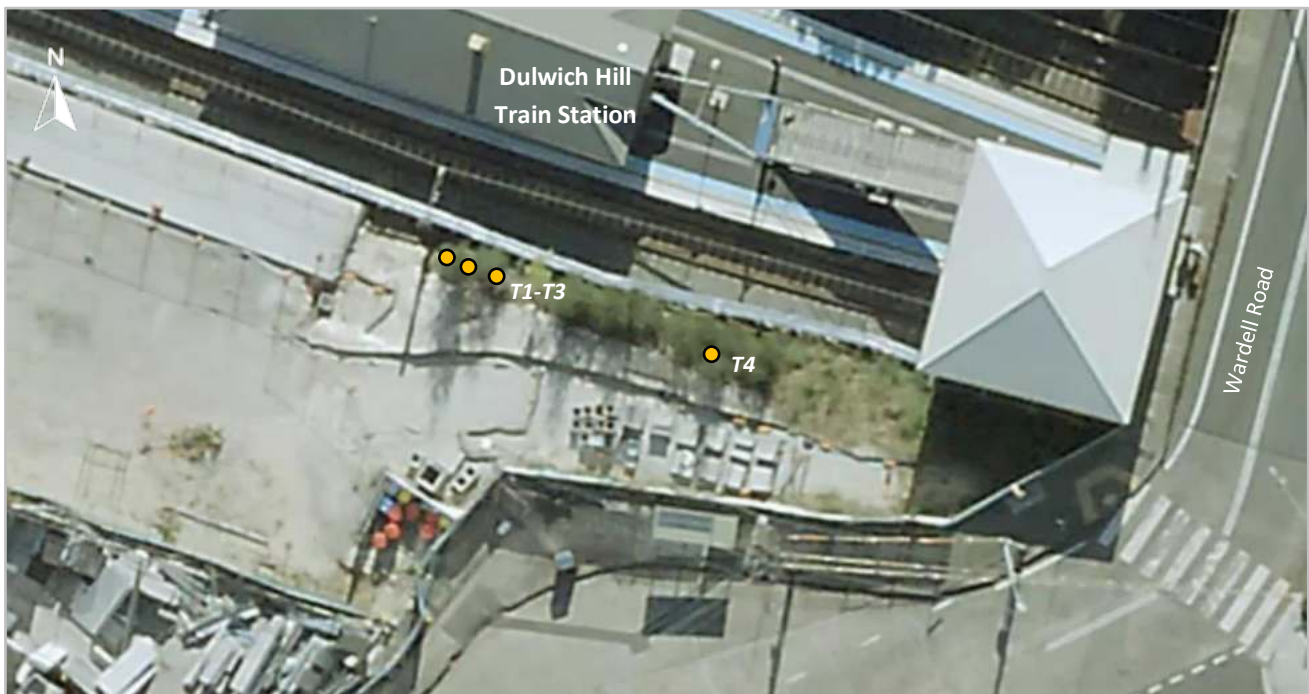
Indicative location of vegetation not viable to design

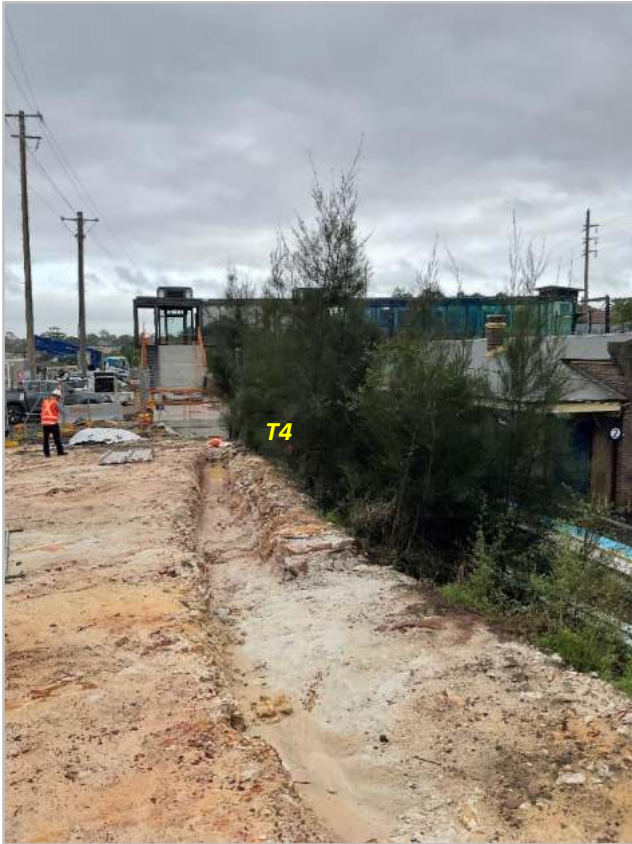
- i. The group of assessed trees were deemed to have a Low retention value with no significant impact on the landscape, furthermore the trees appear to be regenerated suckers, only a couple of years old grown from stumps arising from clearing activities with a likelihood they will be cleared again in future maintenance cycles.
- ii. Under current legislation the group of vegetation does not meet the criteria to be classified as trees, therefore removal does not warrant approval.

The subject vegetation

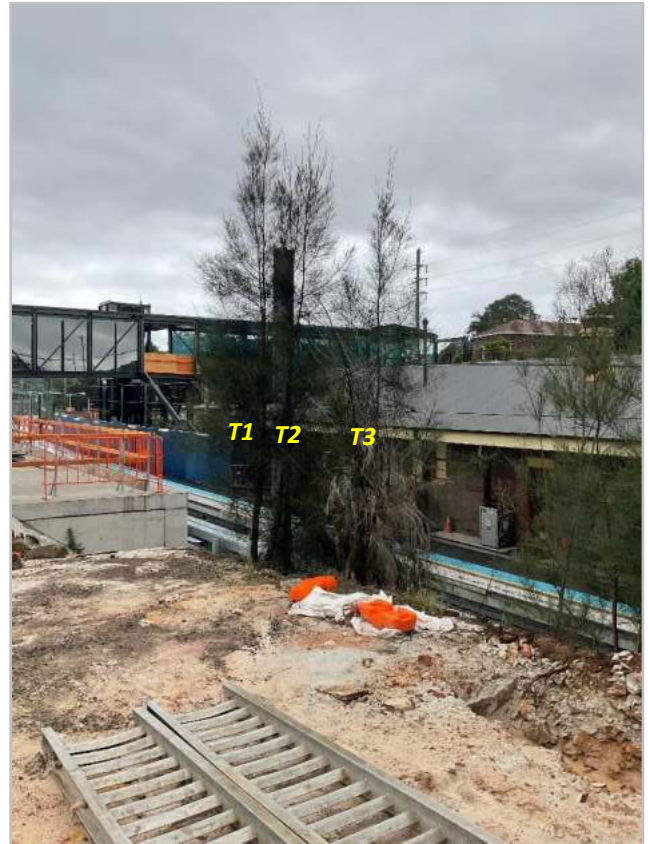
Group of trees needed to clear for trench

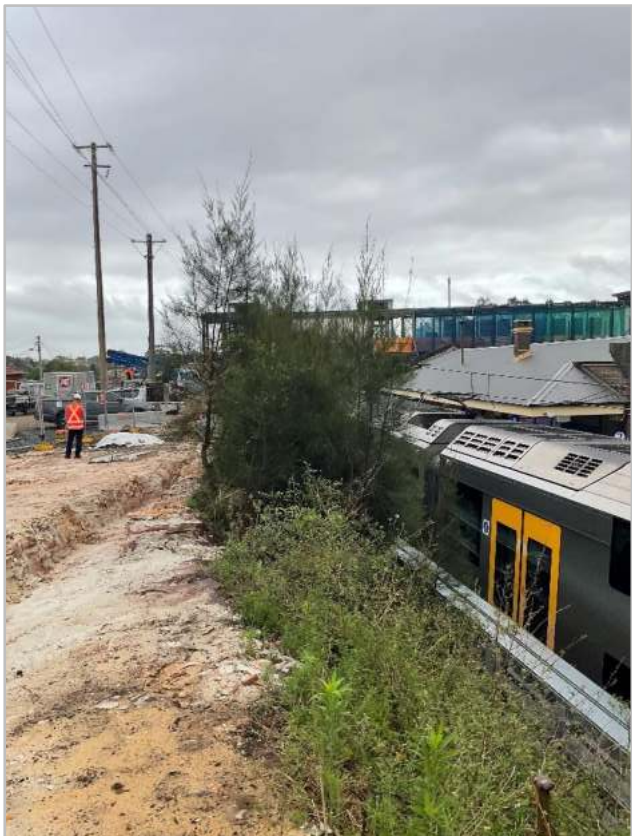
Vegetation within close proximity to infrastructure

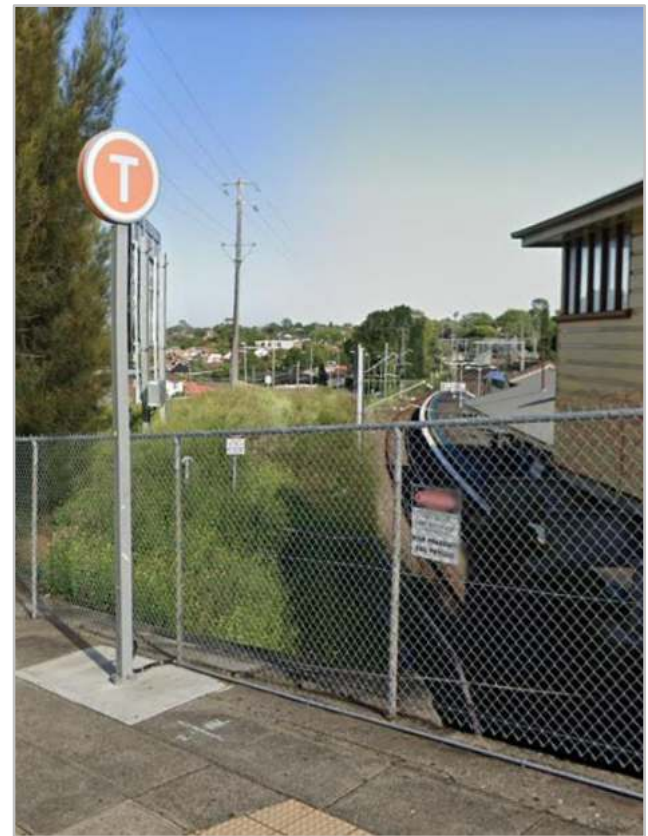
Google street view image (2021) showing no trees

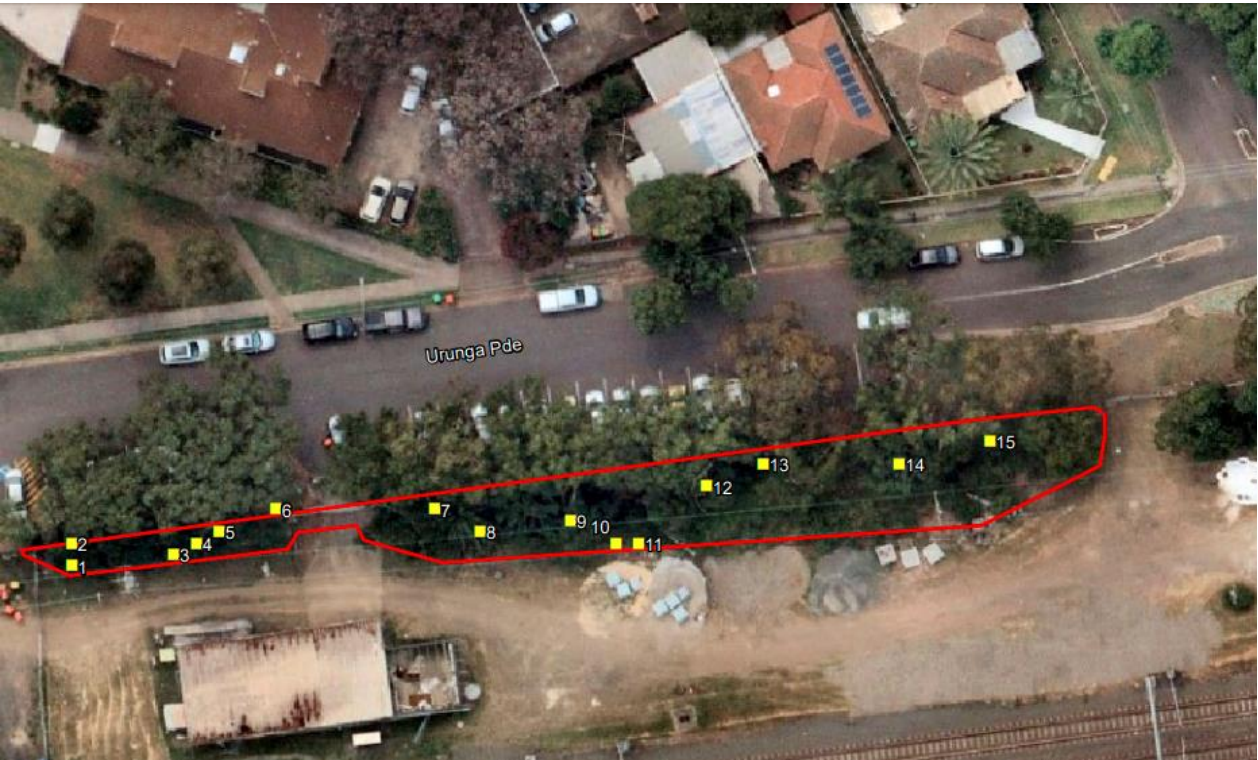
Image 1: Subject trees displayed and numbered.

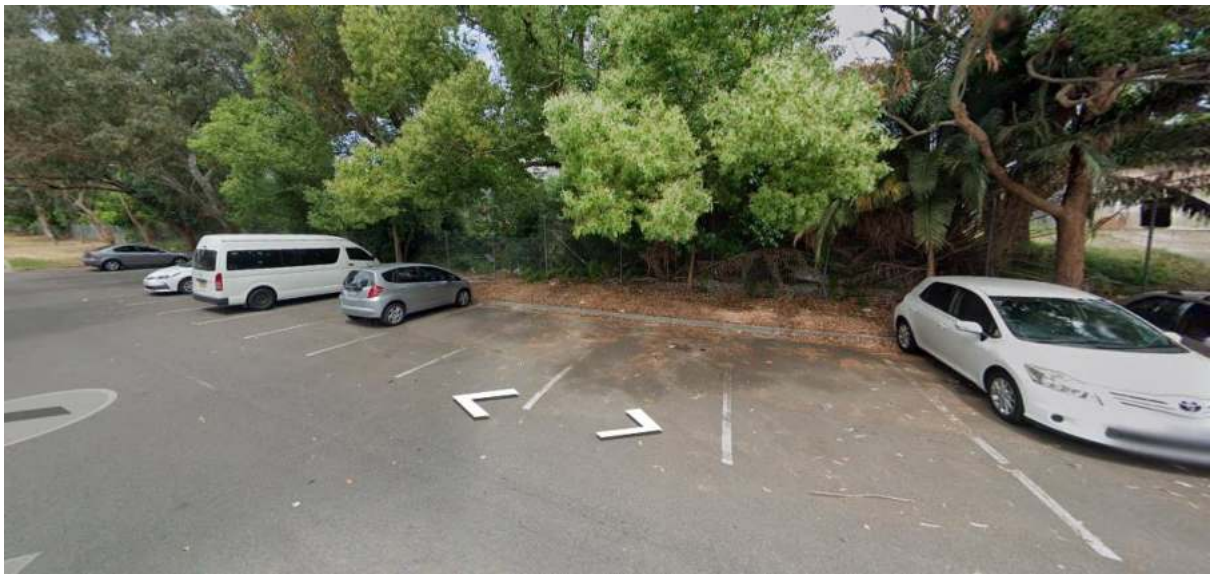
Figure 1: Street view of the subject trees taken from Urunga Parade, Punchbowl (*nearmap 2021*).

- 7.1 Due to the major TPZ/SRZ encroachments required to undertake the proposed works, all the subject trees have been recommended to be removed (subject to council approval).

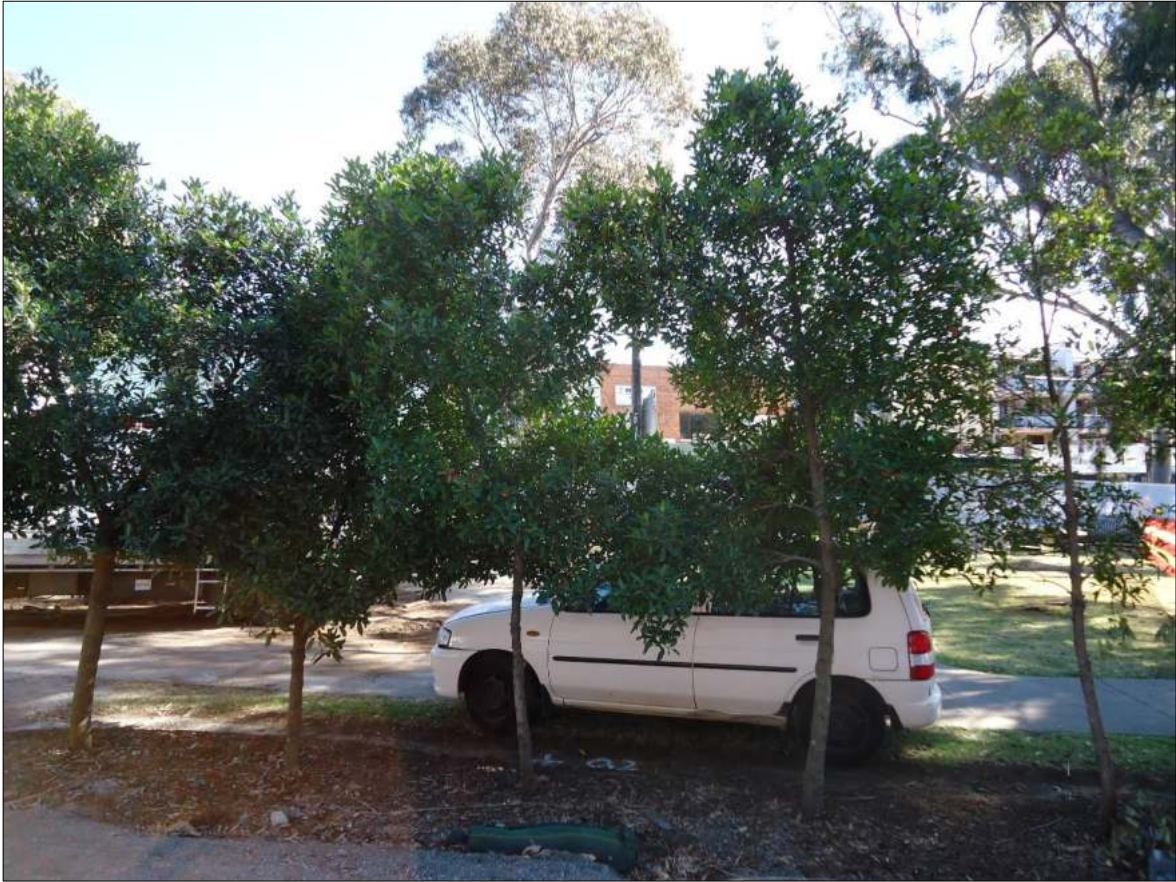
Photograph 1: Showing the five *Elaeocarpus reticulatus* (Blueberry Ash) to be removed.

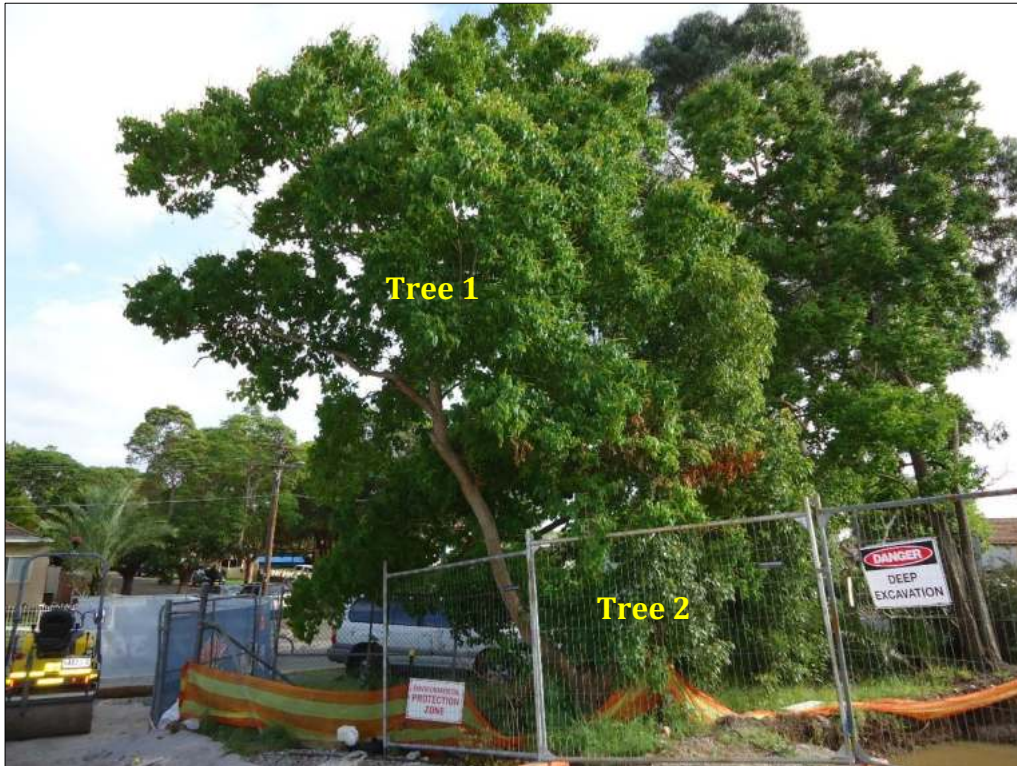
Photograph 1: The subject trees as seen from within the rail corridor. Tree 1 *Sapium sebiferum* (Chinese Tallowwood), tree 2 *Cinnamomum camphora* (Camphor Laurel).
