Tree Impact Assessment Report

City and Southwest Metro Station Upgrade Works Package 5 & 6

Contract: Package 5/6: 00013/11766

P5 Document No. SMCSWSW5-DEW-WEC-EM-REP-000542

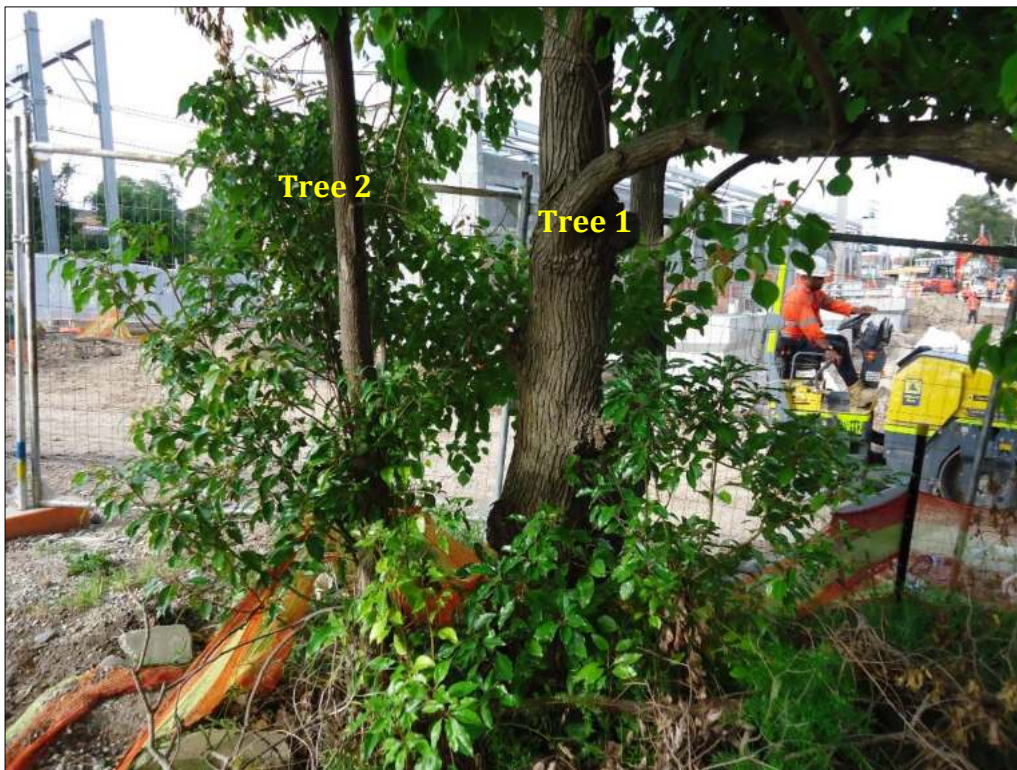
Photograph 1: Showing the individual trunks of the subject trees.

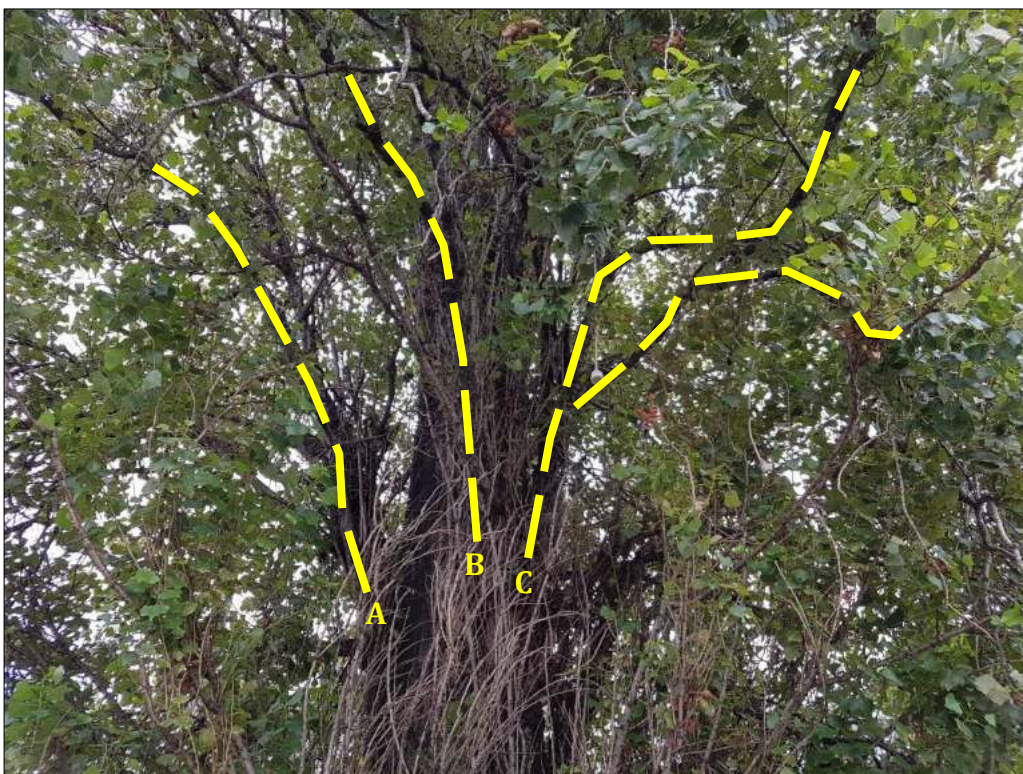
Photograph 2: Branches A, B and C identified for removal.

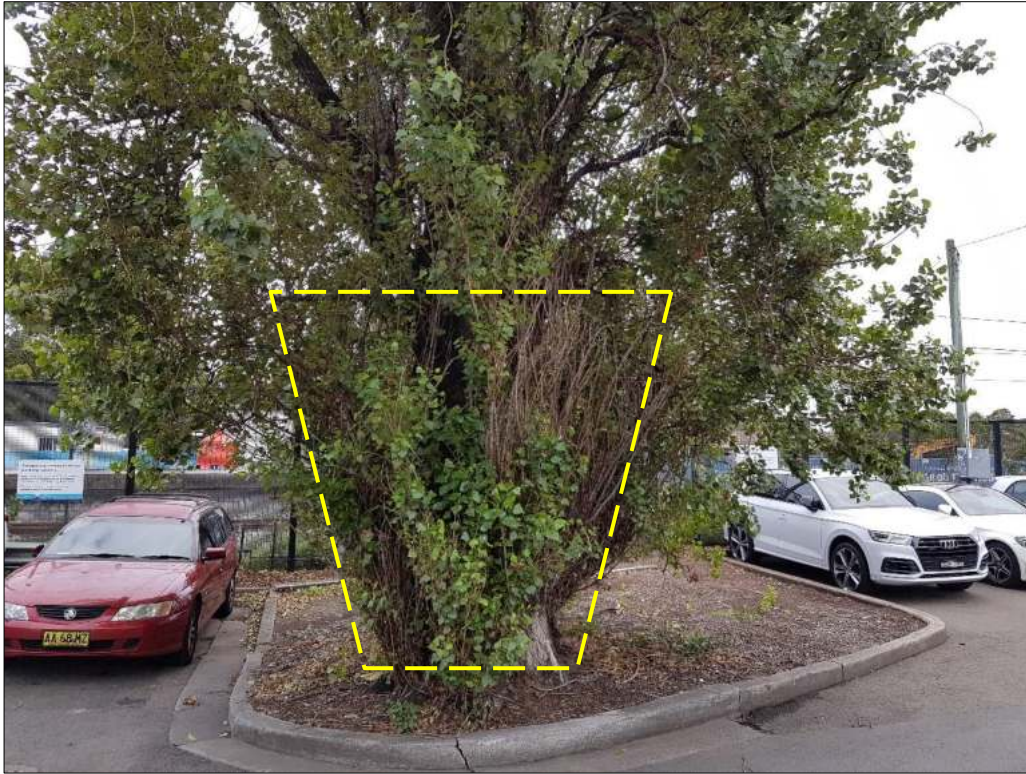
Photograph 3: Multiple epicormic shoots originating from the base of the trunk are to be removed.

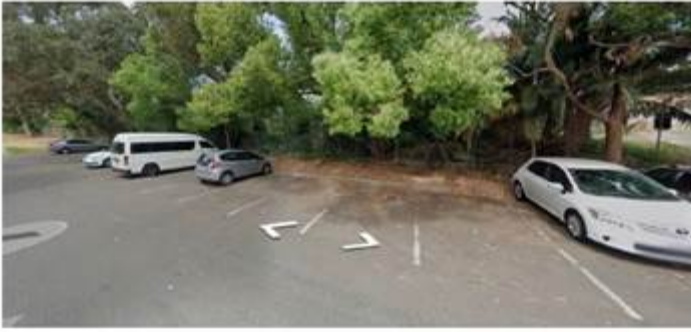
Figure 1: Street view of the subject trees taken from Urunga Parade, Punchbowl (neormap 2021).
