Tree Impact Assessment Report

City and Southwest Metro Station Upgrade Works Package 5 & 6

P5 Document No. SMCSWSW5-DEW-WEC-EM-REP-000542

P6 Document No. SMCSWSW6-DEW-WEC-EM-REP-000632

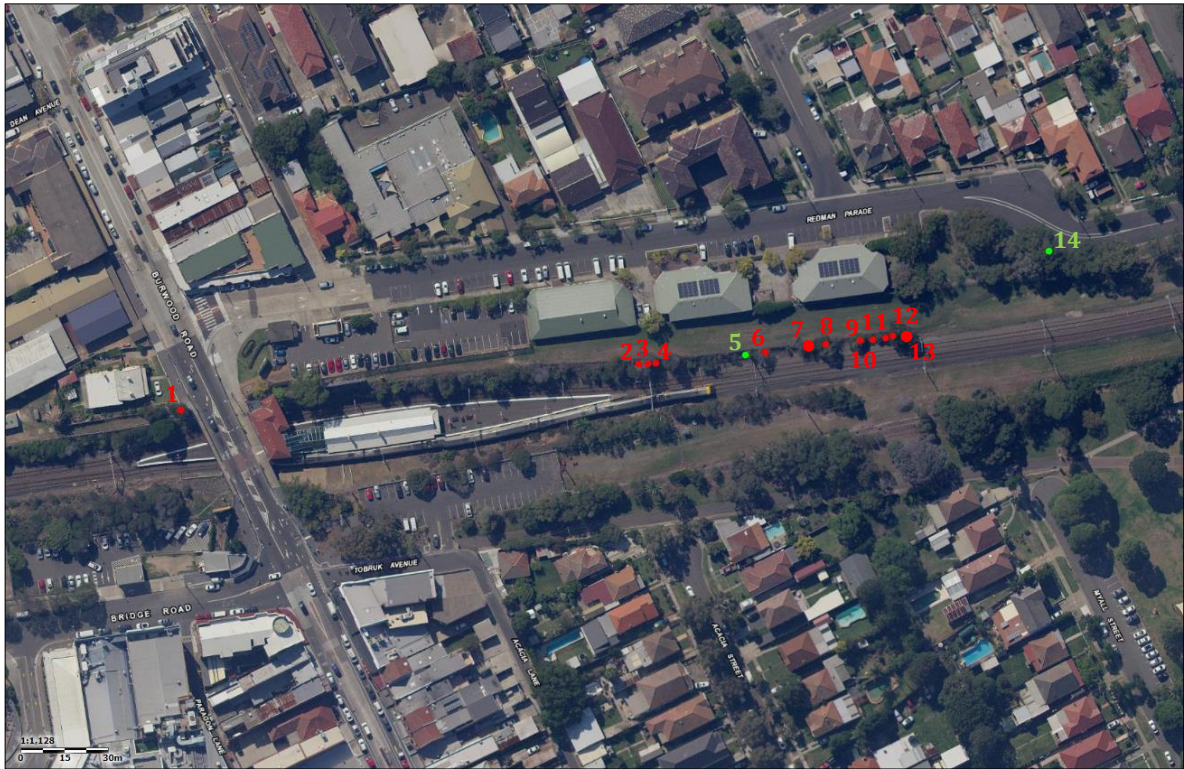
All appropriate approvals and consents are to be obtained prior to tree and vegetation removal works commencing. Given their size and location, it is felt that trees 2, 3, 4, 6, 7, 8, 9, 10, 11, 12 and 13 may be removed using an excavator without significant impact on tree 5.

Image 1: Aerial image of Belmore station showing approximate tree locations. Red dots indicate trees to be removed, green dots indicate trees to be pruned.

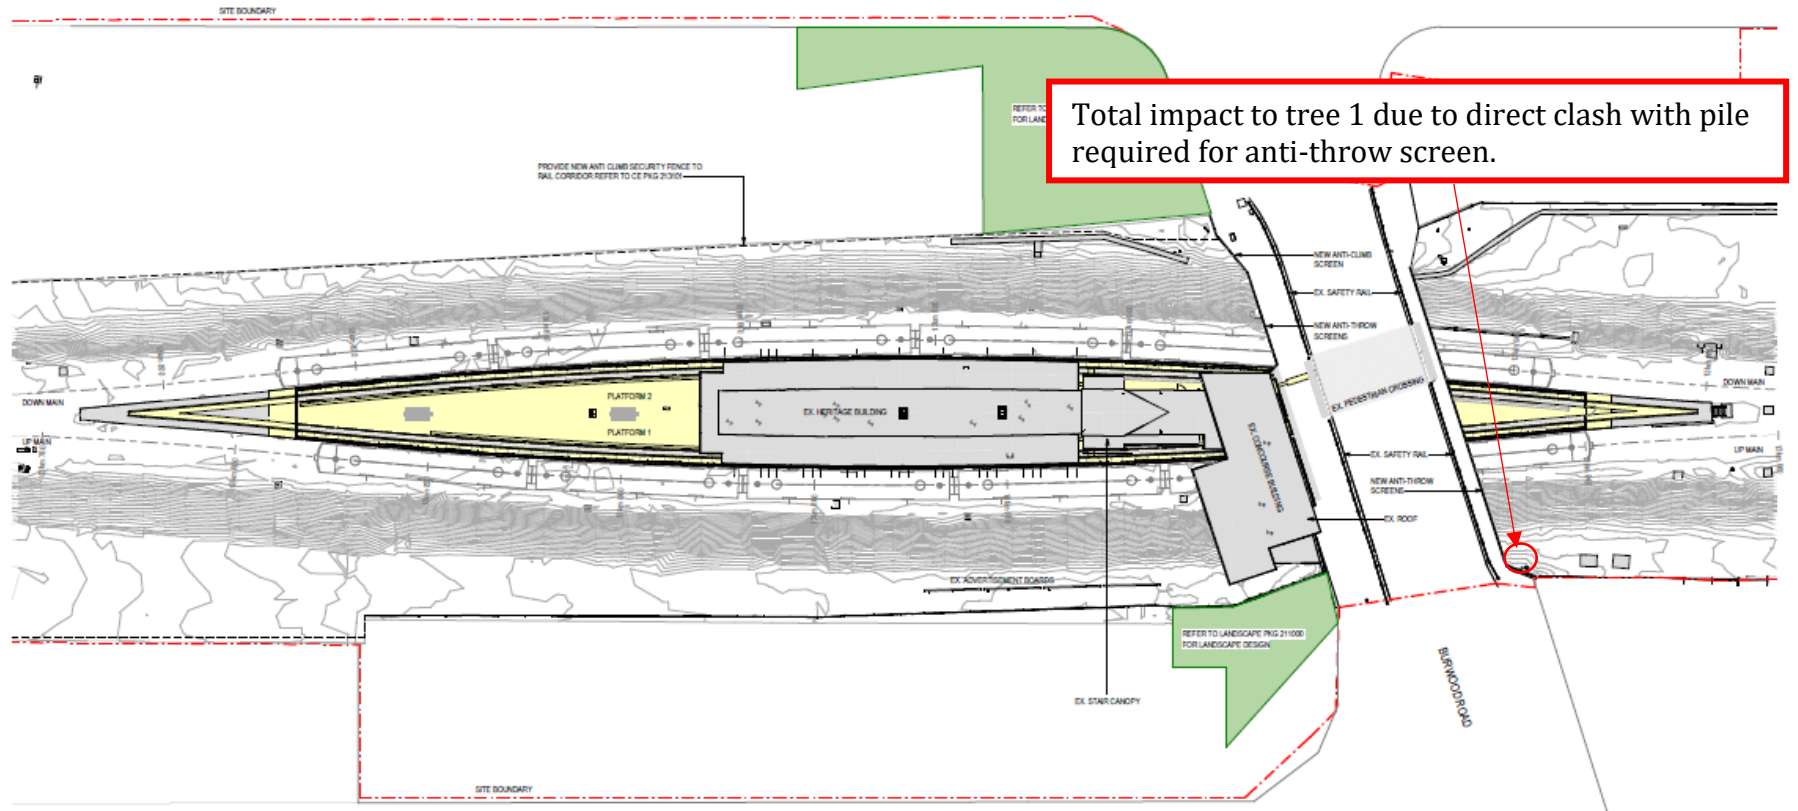
Total impact to tree 1 due to direct clash with pile required for anti-throw screen.

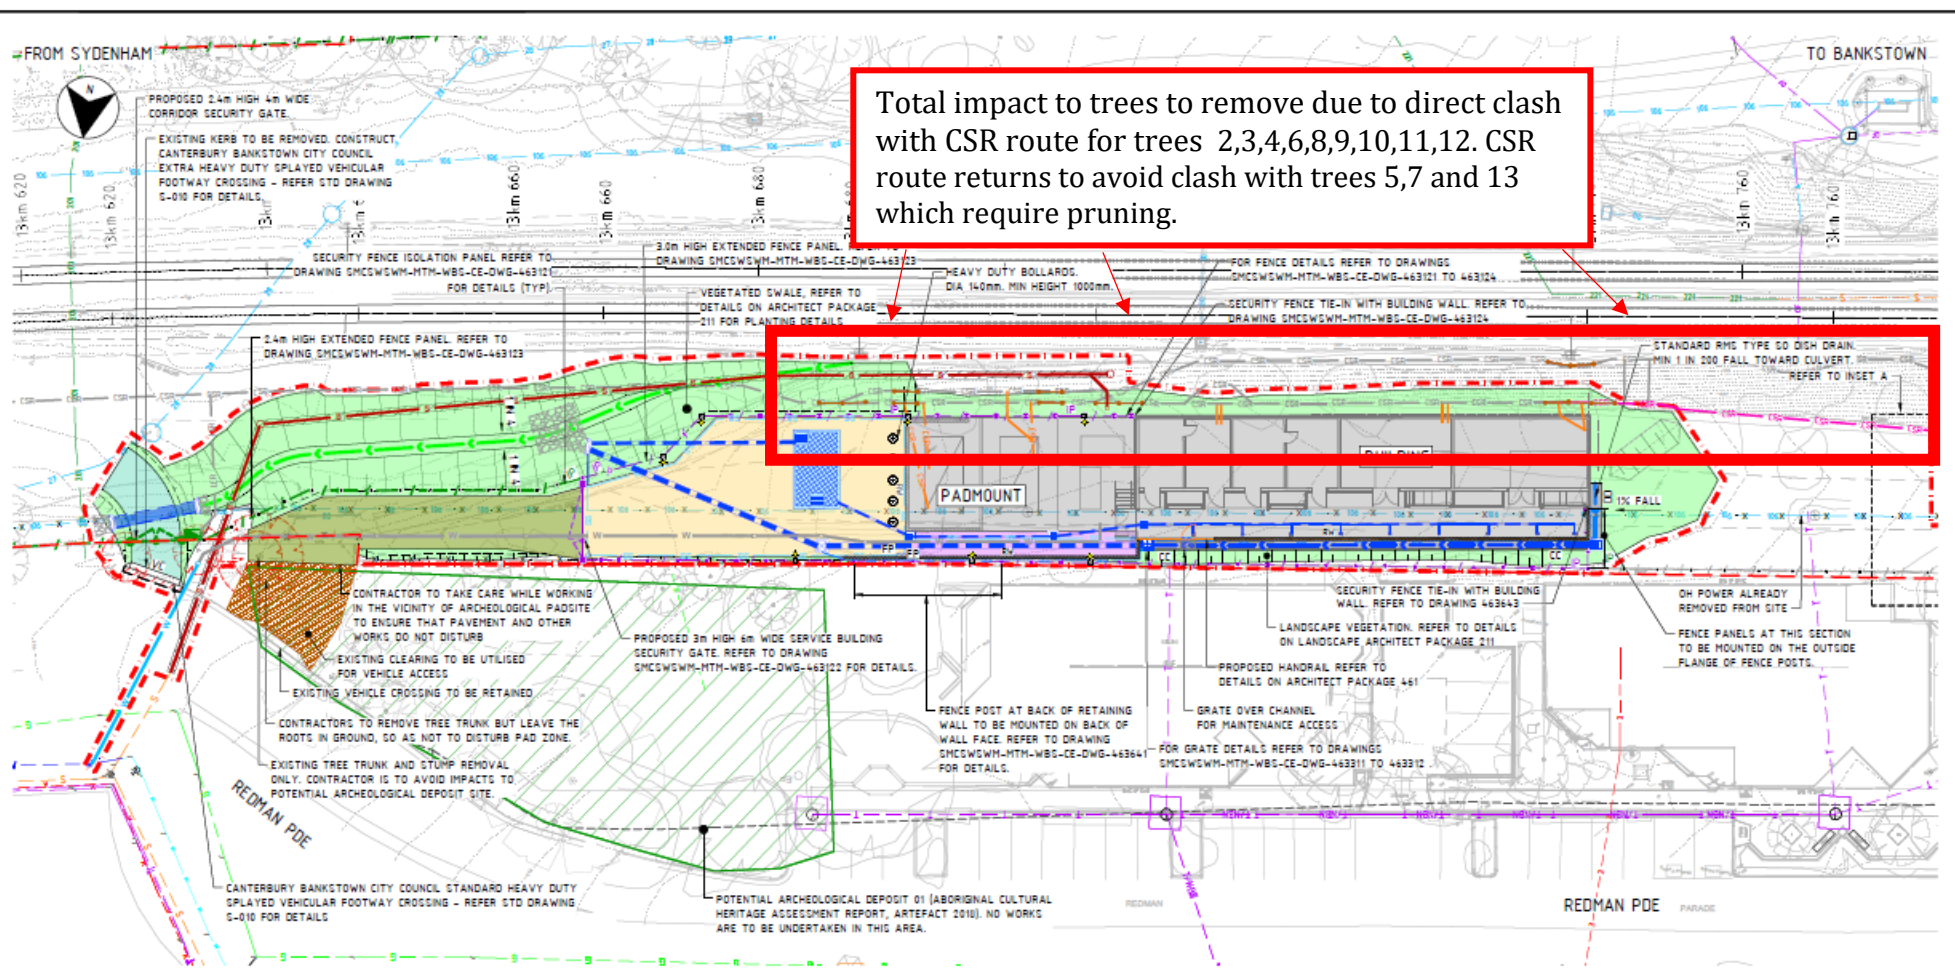
DRG No: SMCSWSM4TM-WBS-AT-DWG-211120 REV: 00

Total impact to trees to remove due to direct clash with CSR route for trees 2,3,4,6,8,9,10,11,12. CSR route returns to avoid clash with trees 5,7 and 13 which require pruning.

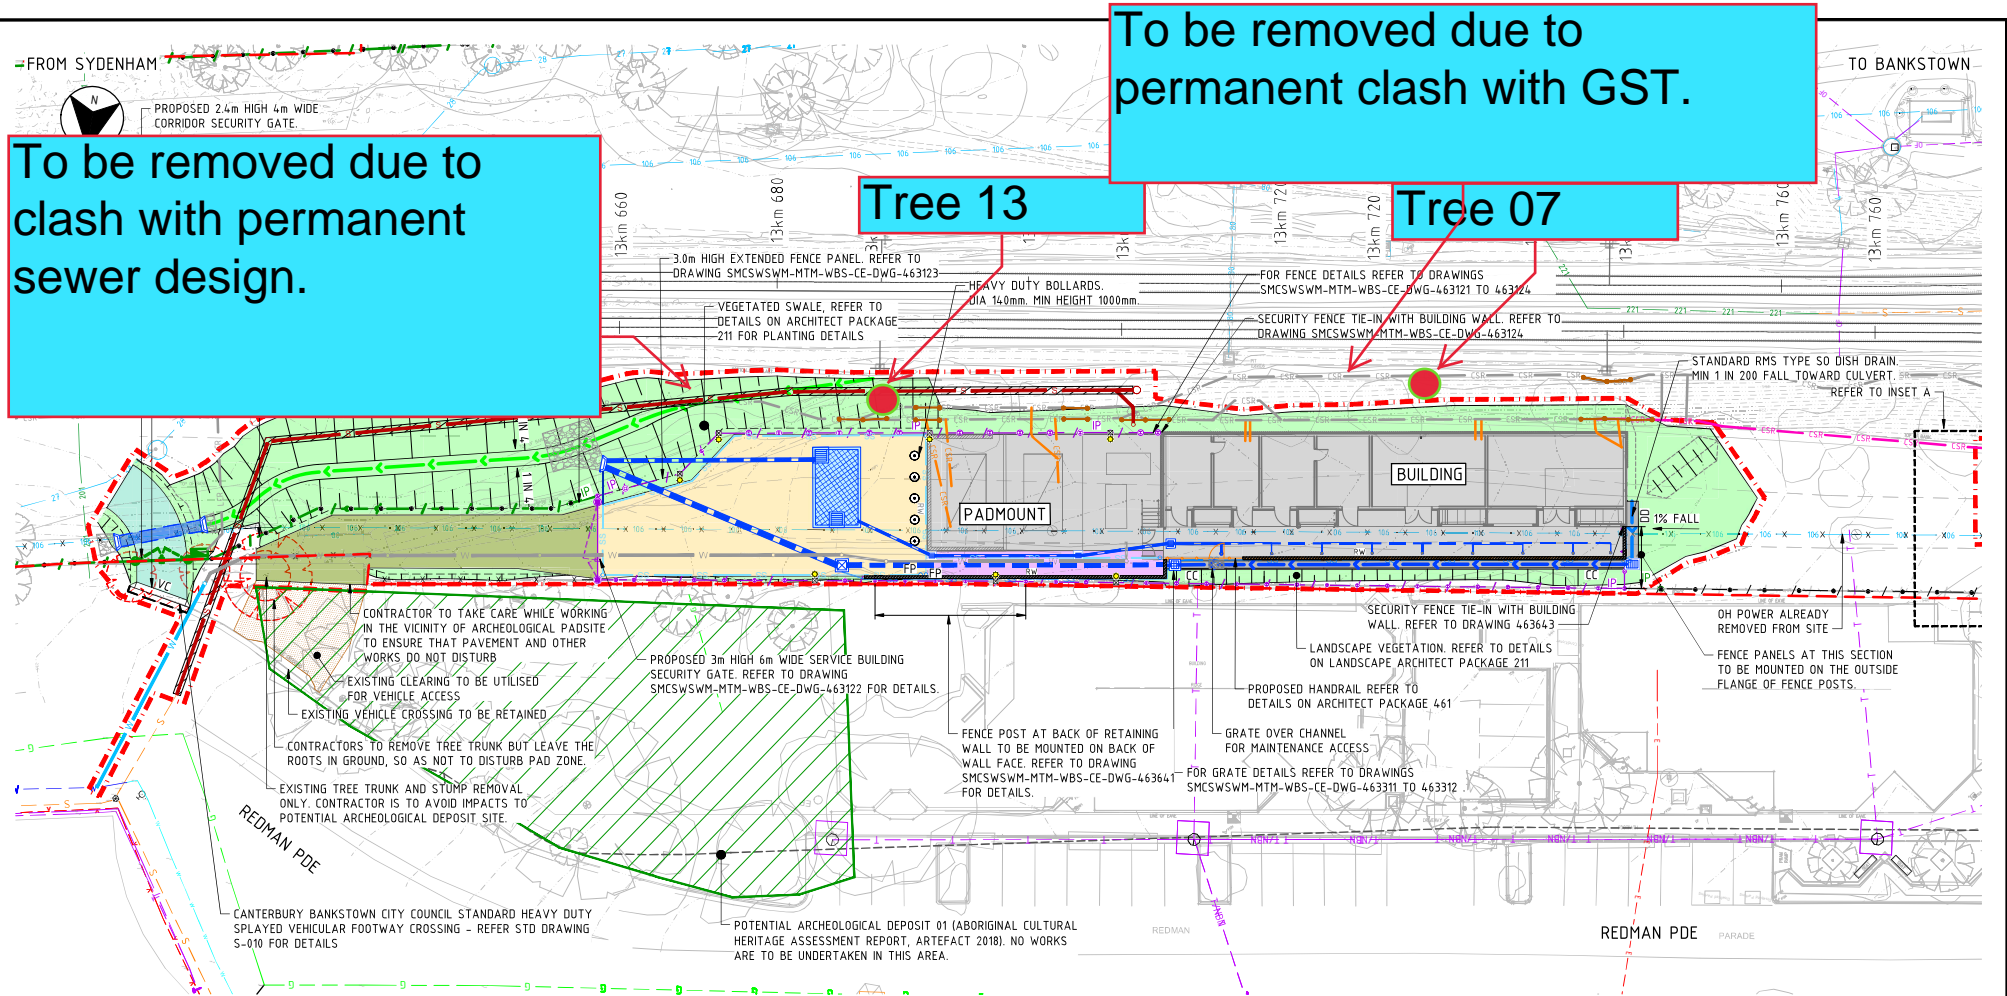
019: SMCSWSWM-MTH-WBS-CE-DWG-463111

To be removed due to clash with permanent sewer design.

To be removed due to permanent clash with GST.

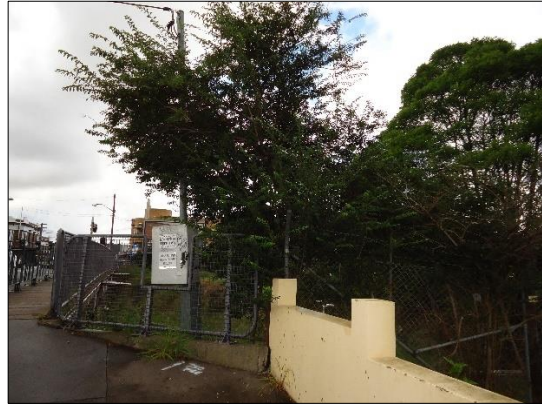
Photograph 1: Tree 1 *Ligustrum sinensis* (Small-leafed Privet) to be removed for pilling works adjacent rail bridge.

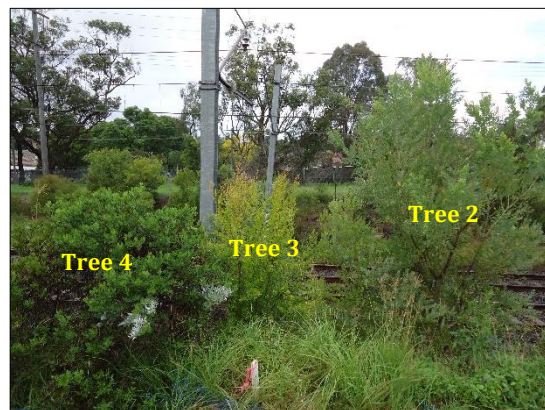
Photograph 2: Trees 2 *Acacia* sp (Wattle), 3 *Leptospermum* sp (Tee Tree) and 4 Unknown species to be removed for MSB works.

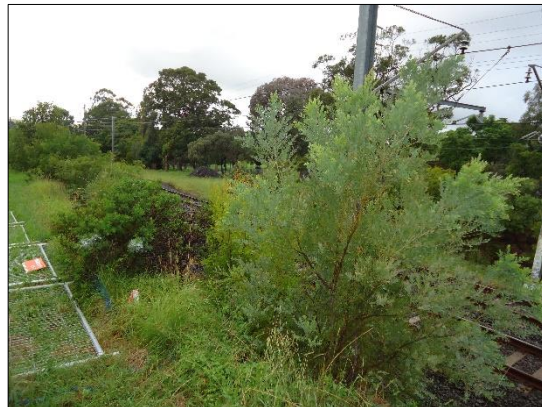
Photograph 3: Tree 5 *Acacia* sp (Wattle) to be selectively pruned for clearance along the embankment.

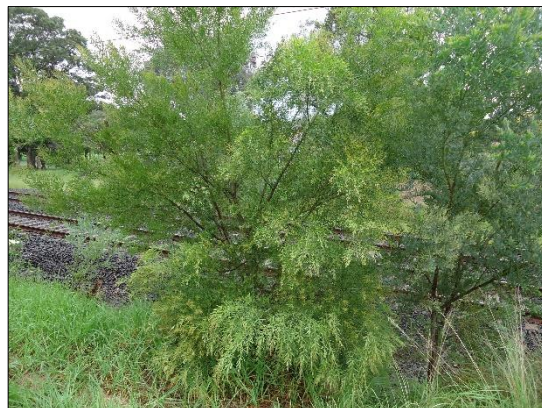
Photograph 4: Tree 6 *Acacia* sp (Wattle) to be removed for MSB works.

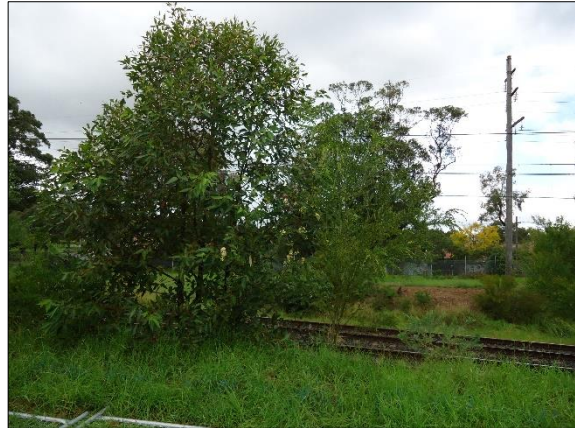
Photograph 5: Tree 7 *Eucalyptus robusta* (Swamp Mahogany) to be removed to accommodate the new GST alignment.

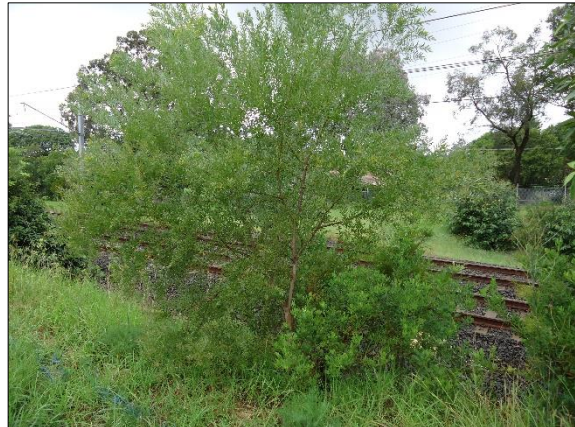
Photograph 6: Tree 8 *Acacia* sp (Wattle) to be removed for MSB works.

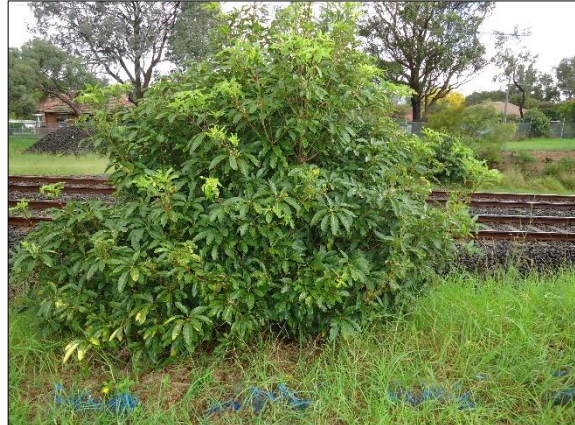
Photograph 7: Tree 9 *Pittorporum undulatum* (Sweet Pittosporum) to be removed for MSB works.

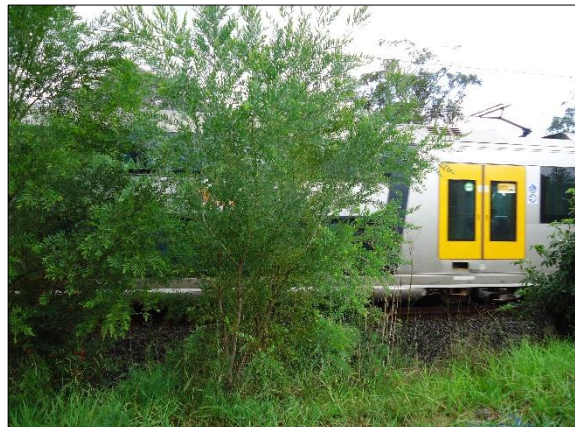
Photograph 8: Tree 10 *Acacia* sp (Wattle) to be removed for MSB works.

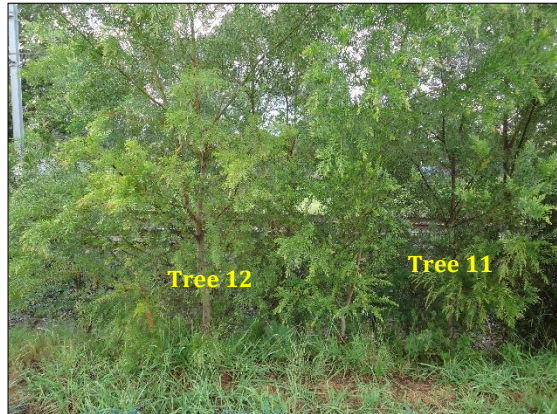
Photograph 9: Trees 11 and 12 *Acacia* sp (Wattle) to be removed for MSB works.

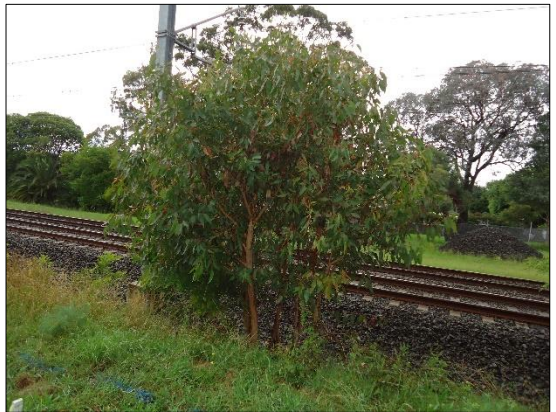
Photograph 10: Tree 13 *Eucalyptus robusta* (Swamp Mahogany) to be removed to accommodate the new sewer alignment.

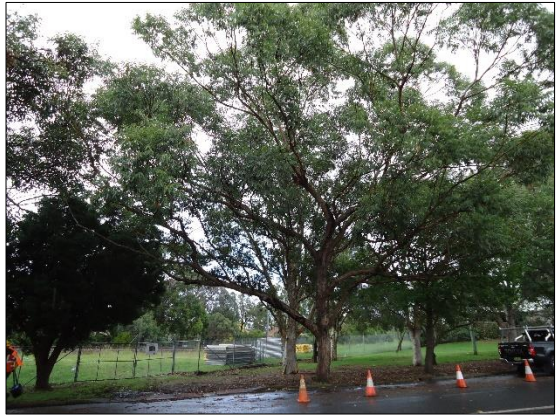
Photograph 11: Tree 14 *Eucalyptus robusta* (Swamp Mahogany) located within road reserve to be selectively pruned for site access clearances.

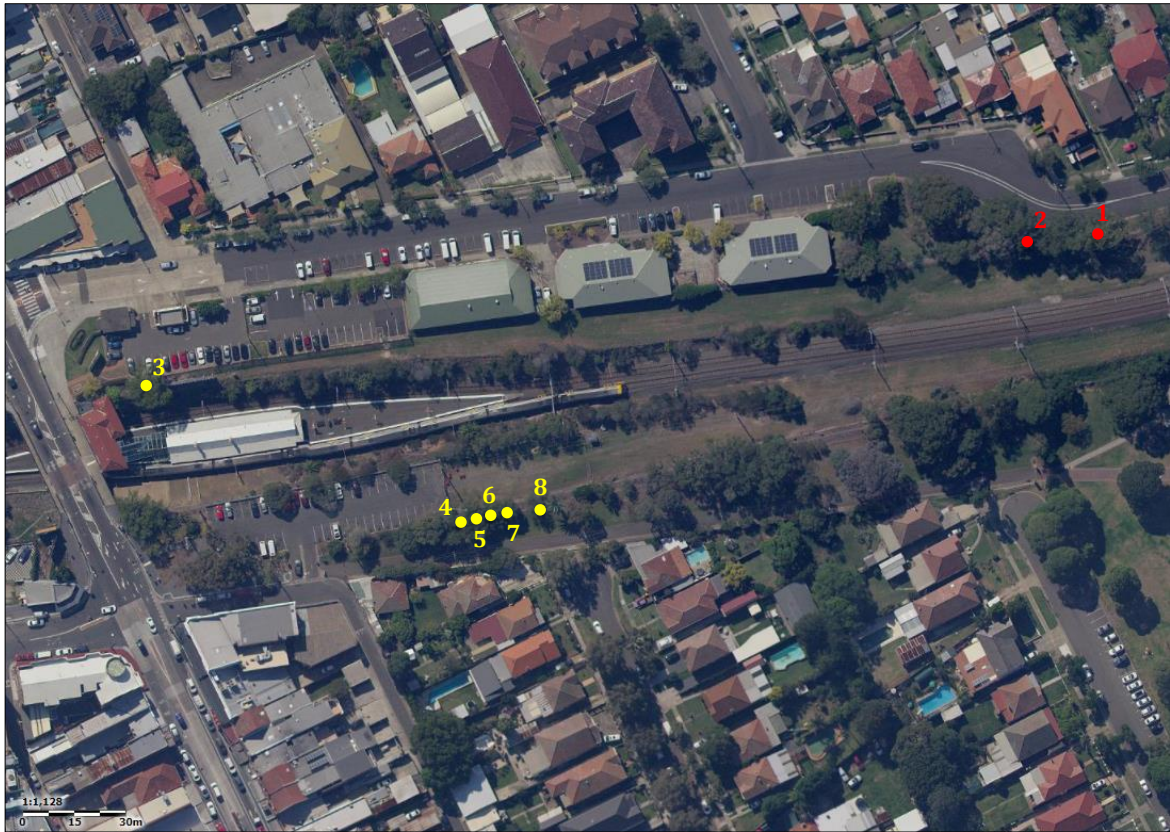
Eight additional trees were assessed with respects to the proposed works. Their locations are shown within Figure 1. Trees 1 and 2 have been identified for removal. Trees 3, 4, 5, 6, 7 and 8 have been identified for selective pruning works. Additional controls with respects to undertaking excavation works within the TPZ of tree 3 have been provided. Tree data can be found as Appendix 1 of this report.

Image 1: Aerial image of Belmore station showing the approximate locations of assessed trees. (Source: Six Maps accessed 20/05/2021).

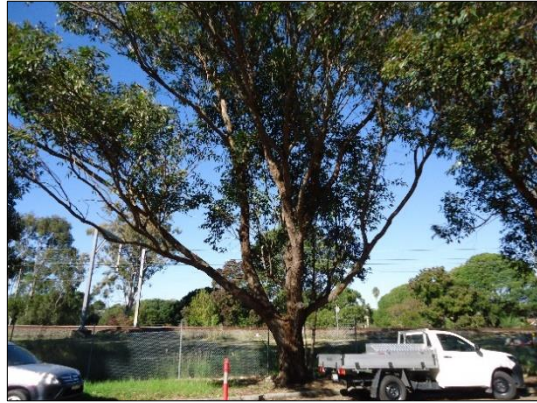
Photograph 1: Tree 1 *Eucalyptus robusta* (Swamp Mahogany) to be removed due to direct clash with permanent design access road to MSB.

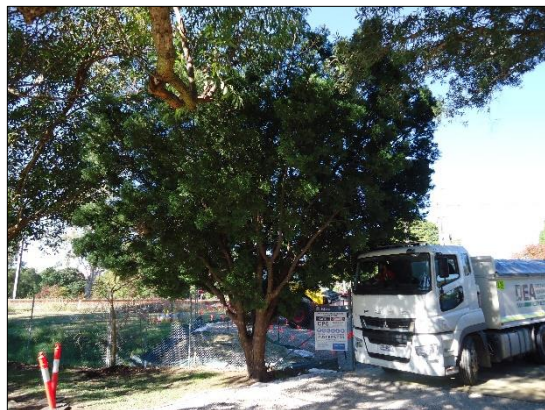
Photograph 2: Tree 2 *Podocarpus elatus* (Brown Pine) to be removed due to direct clash with permanent design access road to MSB.

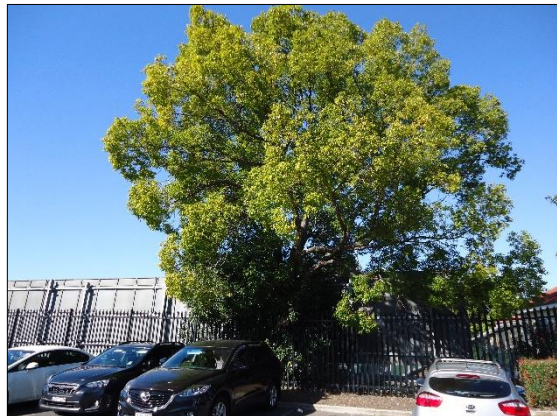
Photograph 3: Tree 3 *Cinnamomum camphora* (Camphor Laurel) within northern side of rail corridor.

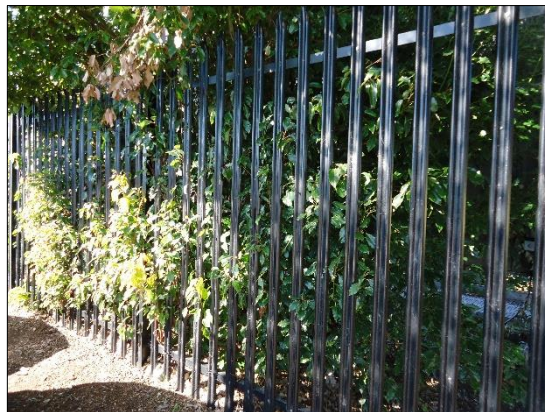
Photograph 4: Suckering around the base of tree 3 is to be removed to allow for the proposed alignment of the new GST.

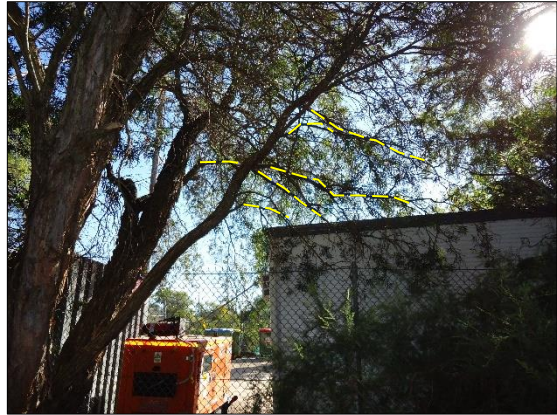
Photograph 5: Tree 4 *Callistemon slaignus* (Weeping Bottlebrush) to be selectively pruned to clear site sheds.

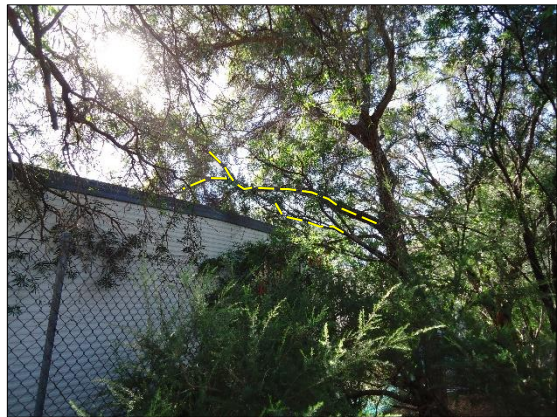
Photograph 6: Tree 5 *Leptospermum petersonii* (Lemon-scented Tee Tree) to be selectively pruned to clear site sheds.

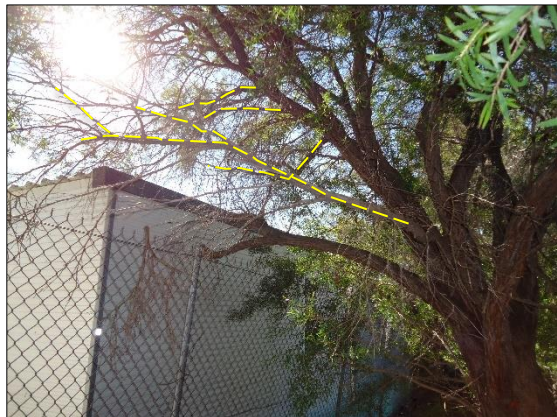
Photograph 7: Tree 6 *Leptospermum petersonii* (Lemon-scented Tee Tree) to be selectively pruned to clear site sheds.

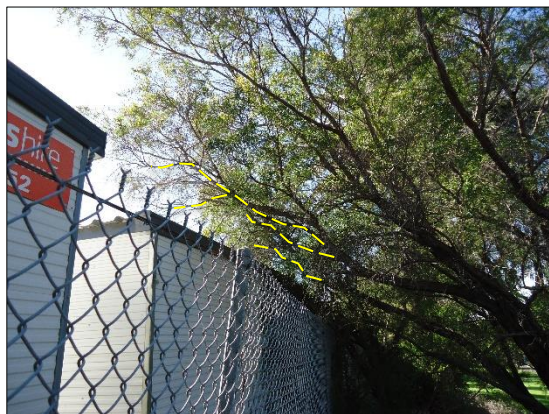
Photograph 8: Tree 7 *Leptospermum petersonii* (Lemon-scented Tee Tree) to be selectively pruned to clear site sheds. Additional pruning shall be required to provide clearances to new over head cabling.

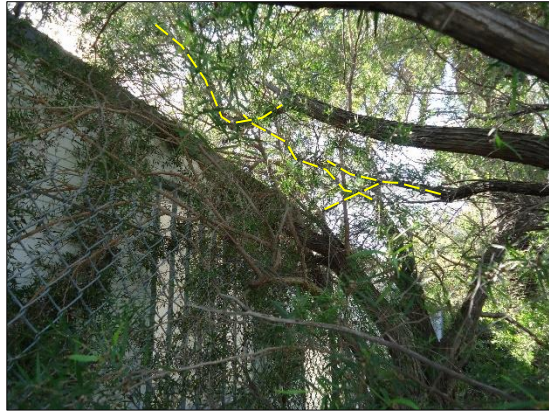
Photograph 9: Tree 8 *Leptospermum petersonii* (Lemon-scented Tee Tree) to be selectively pruned to clear site sheds.

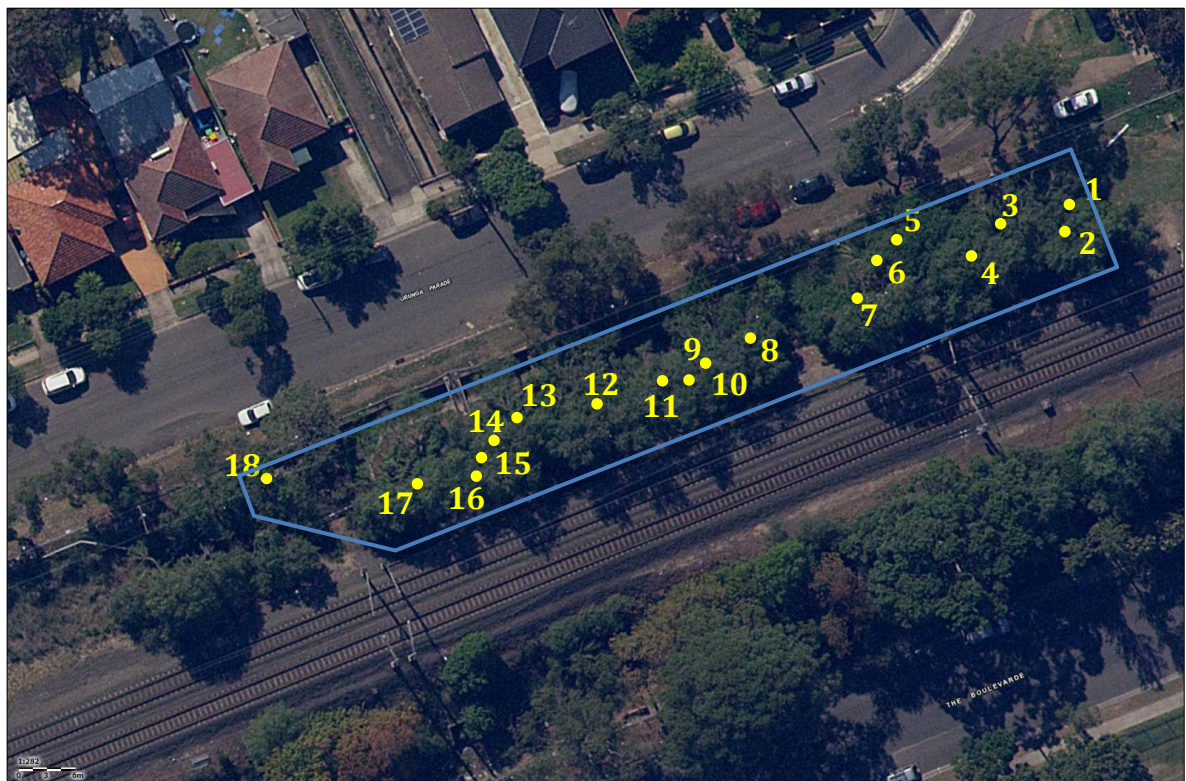
The additional tree removals where there is a direct design clash and 100% encroachment into the TPZ and SRZ consist of seventeen *Schinus molle* (Peppercorn Tree), one *Eucalyptus scoparia* (Wallangarra White Gum) which constitute the significant trees within the site. Understorey plants totaling sixty-two individual specimens were also identified. All trees are located along the rail embankment adjacent Urunga Parade. Image 1 shows the area of assessment and approximate locations of significant trees (trees 1-18). The Peppercorn trees are typically arranged in a line suggesting a landscape planting. The Wallangarra White Gum is likely to be a self-seeded specimen.

Image 1: Aerial image showing the proposed vegetation clearance area (blue outline) and approximate locations of significant trees (1 to 18).

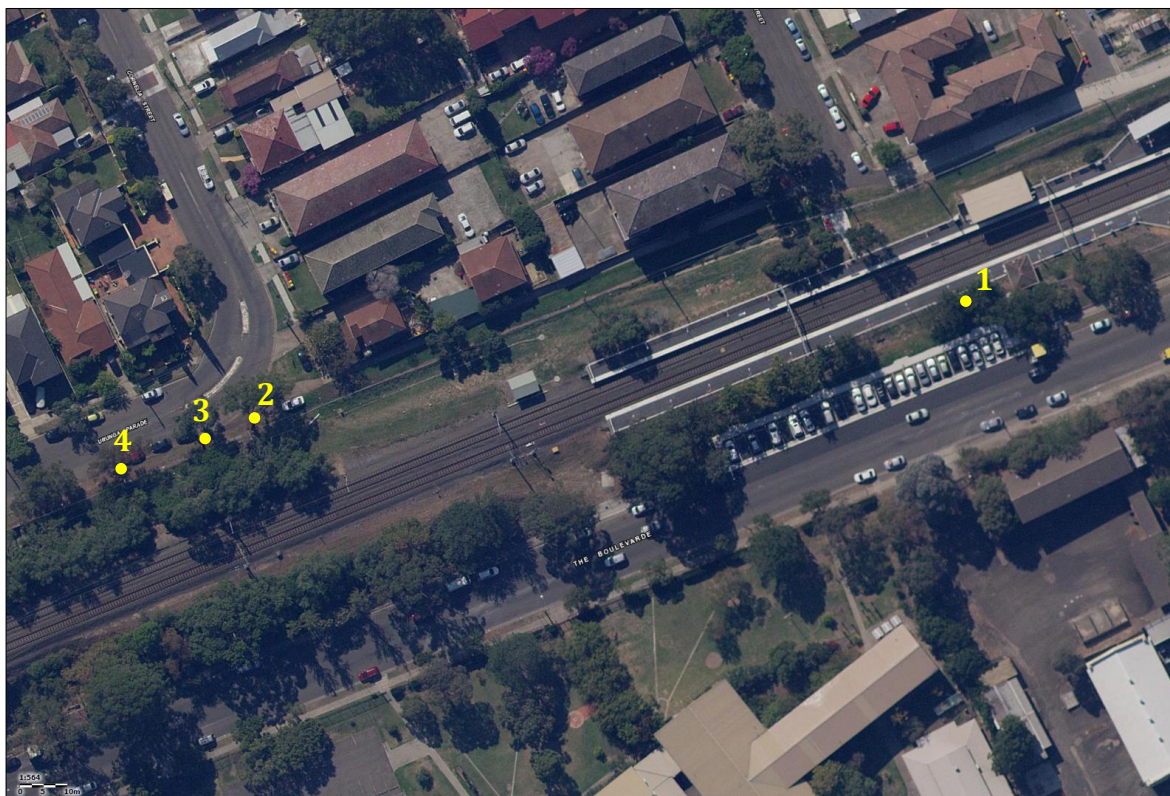
Image 1: Aerial image of Wiley Park Station Station showing the location of additional trees to be removed.

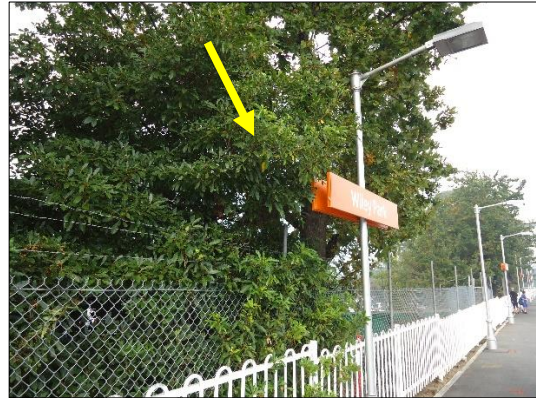
Photograph 1: Tree 1 *Pittosporum undulatum* (Sweet Pittosporum) identified for removal to accommodate Station Services Building adjacent platform 2.

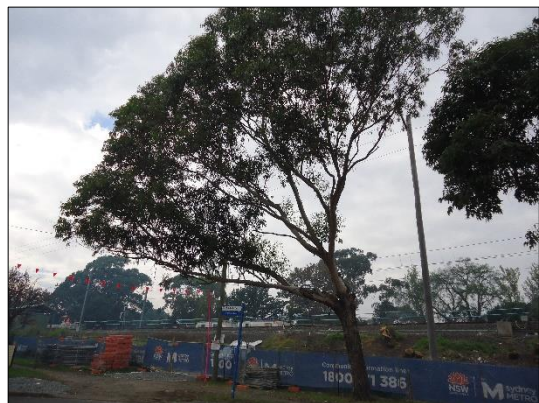
Photograph 2: Tree 2 *Eucalyptus pilularis* (Blackbutt) identified for removal to accommodate Metro services Building driveway and access.

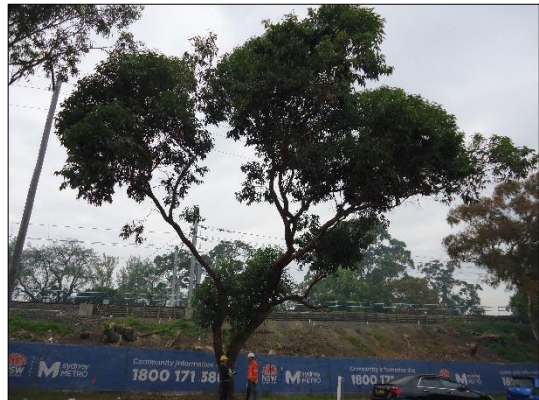
Photograph 3: Tree 3 *Eucalyptus robusta* (Swamp Mahogany) identified for removal to accommodate ULX and permanent fencing.

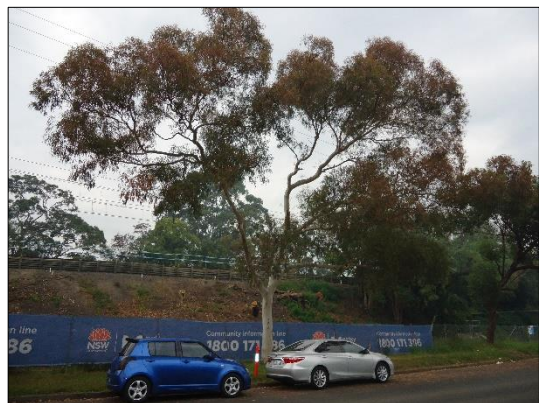
The Wallangarra White Gum (tree 4) is listed as Endangered under the Biodiversity Conservation Act 2016 and Vulnerable under the Environmental Protection Biodiversity Conservation Act 1999. However, the subject specimen is located outside of its naturally occurring range and appears to have been planted as part of the streetscape.

Photograph 4: Tree 4 *Eucalyptus scoparia* (Wallangarra White Gum) identified for removal to accommodate ULX and permanent fencing.

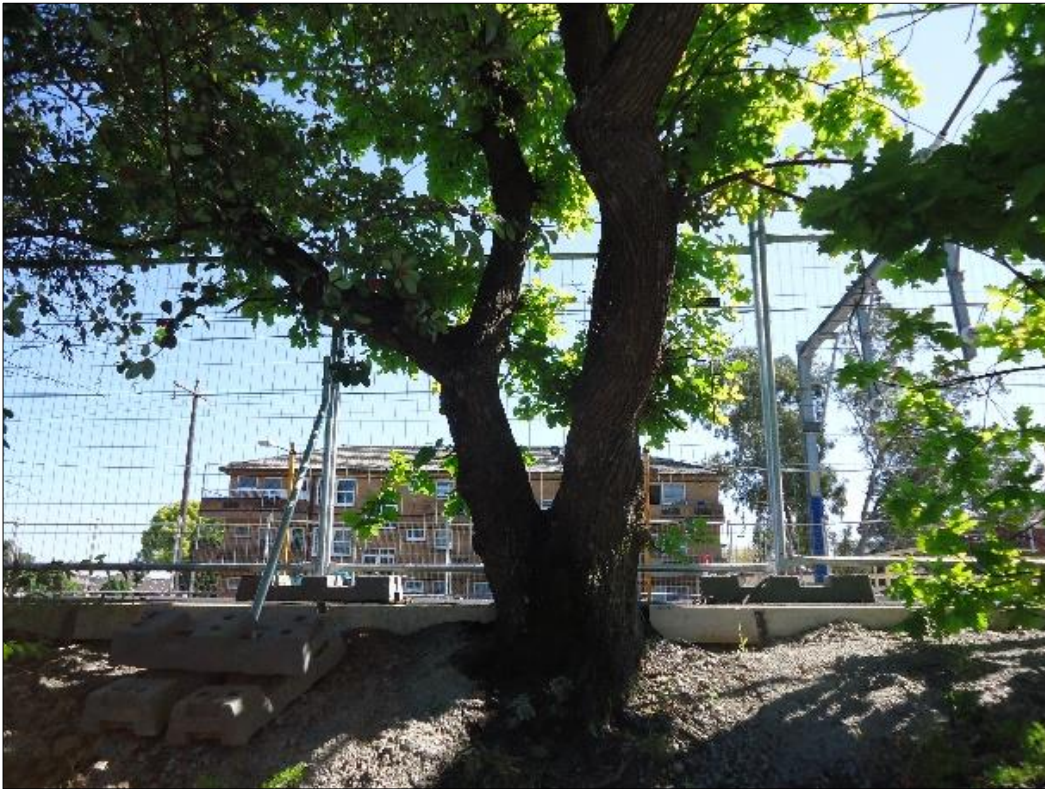
Photograph 1: Tree 711 *Quercus robur* (Common Oak).

Tree number	Tree name	Tree dimensions				Vigour	Condition	Age class	ULE	Amenity and Visual Value	Native or Exotic	TPZ (m)	SRZ (m)	Comments	Remove or Retain
	Botanical name Common name	Height (m)	Spread (m)	D.B.H. (mm)	D.A.B. (mm)										
711	Quercus robur (Common Oak)	15-10	4x4	220 240 240	500	N	G	M	L	M	F	4.9	2.5	Trunk of tree located within the footprint of the permanent Platform 2 and the platform security fence.	Remove

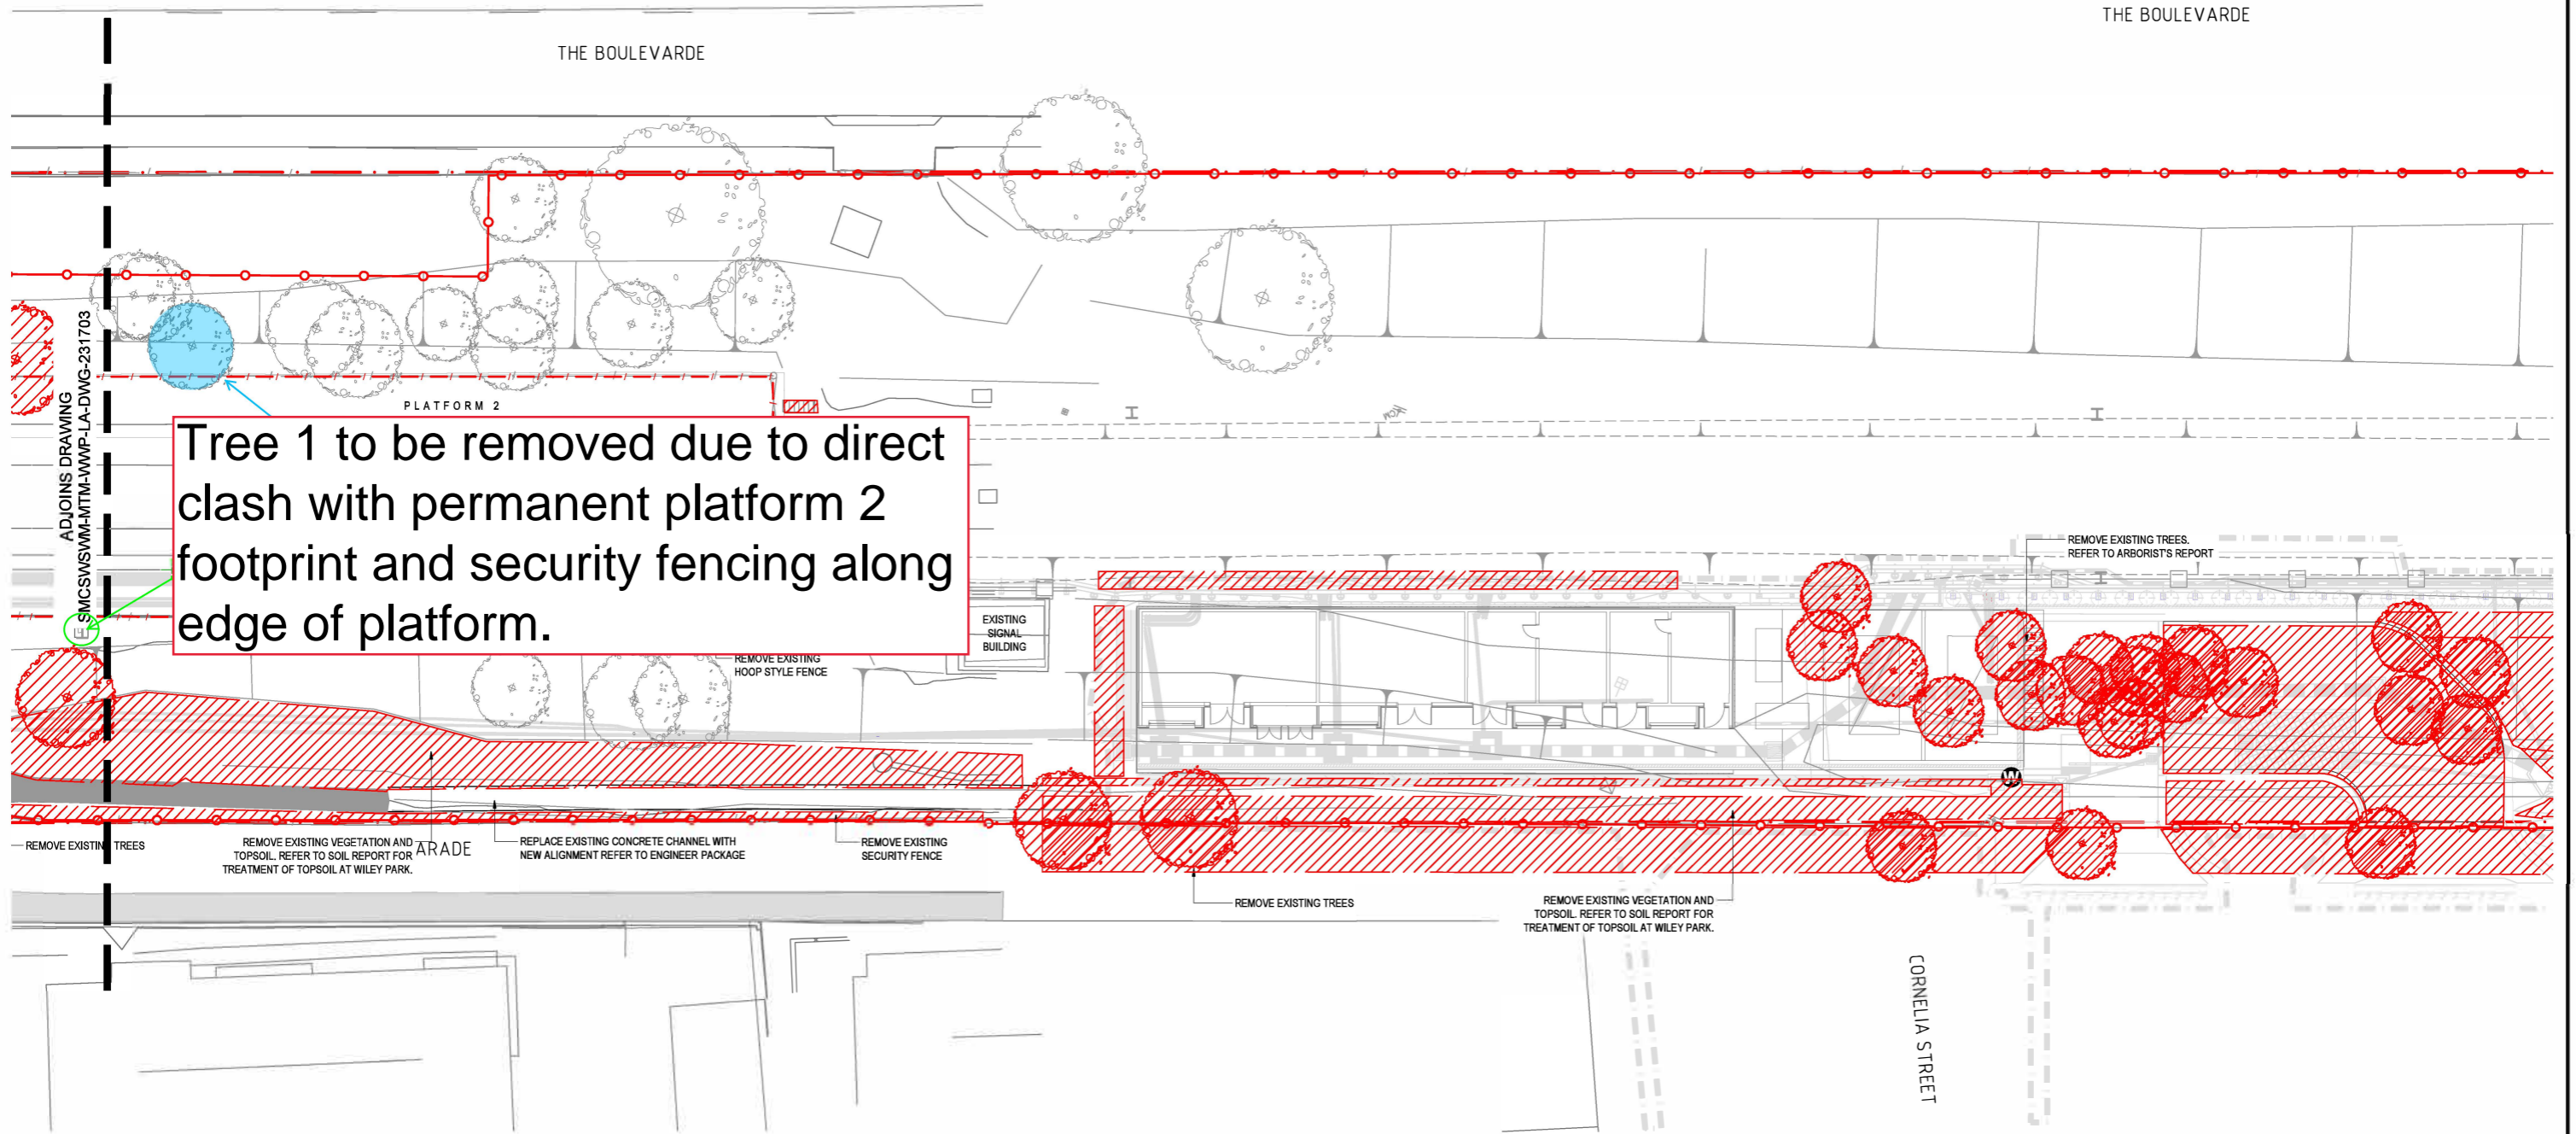
Tree 1 to be removed due to direct clash with permanent platform 2 footprint and security fencing along edge of platform.

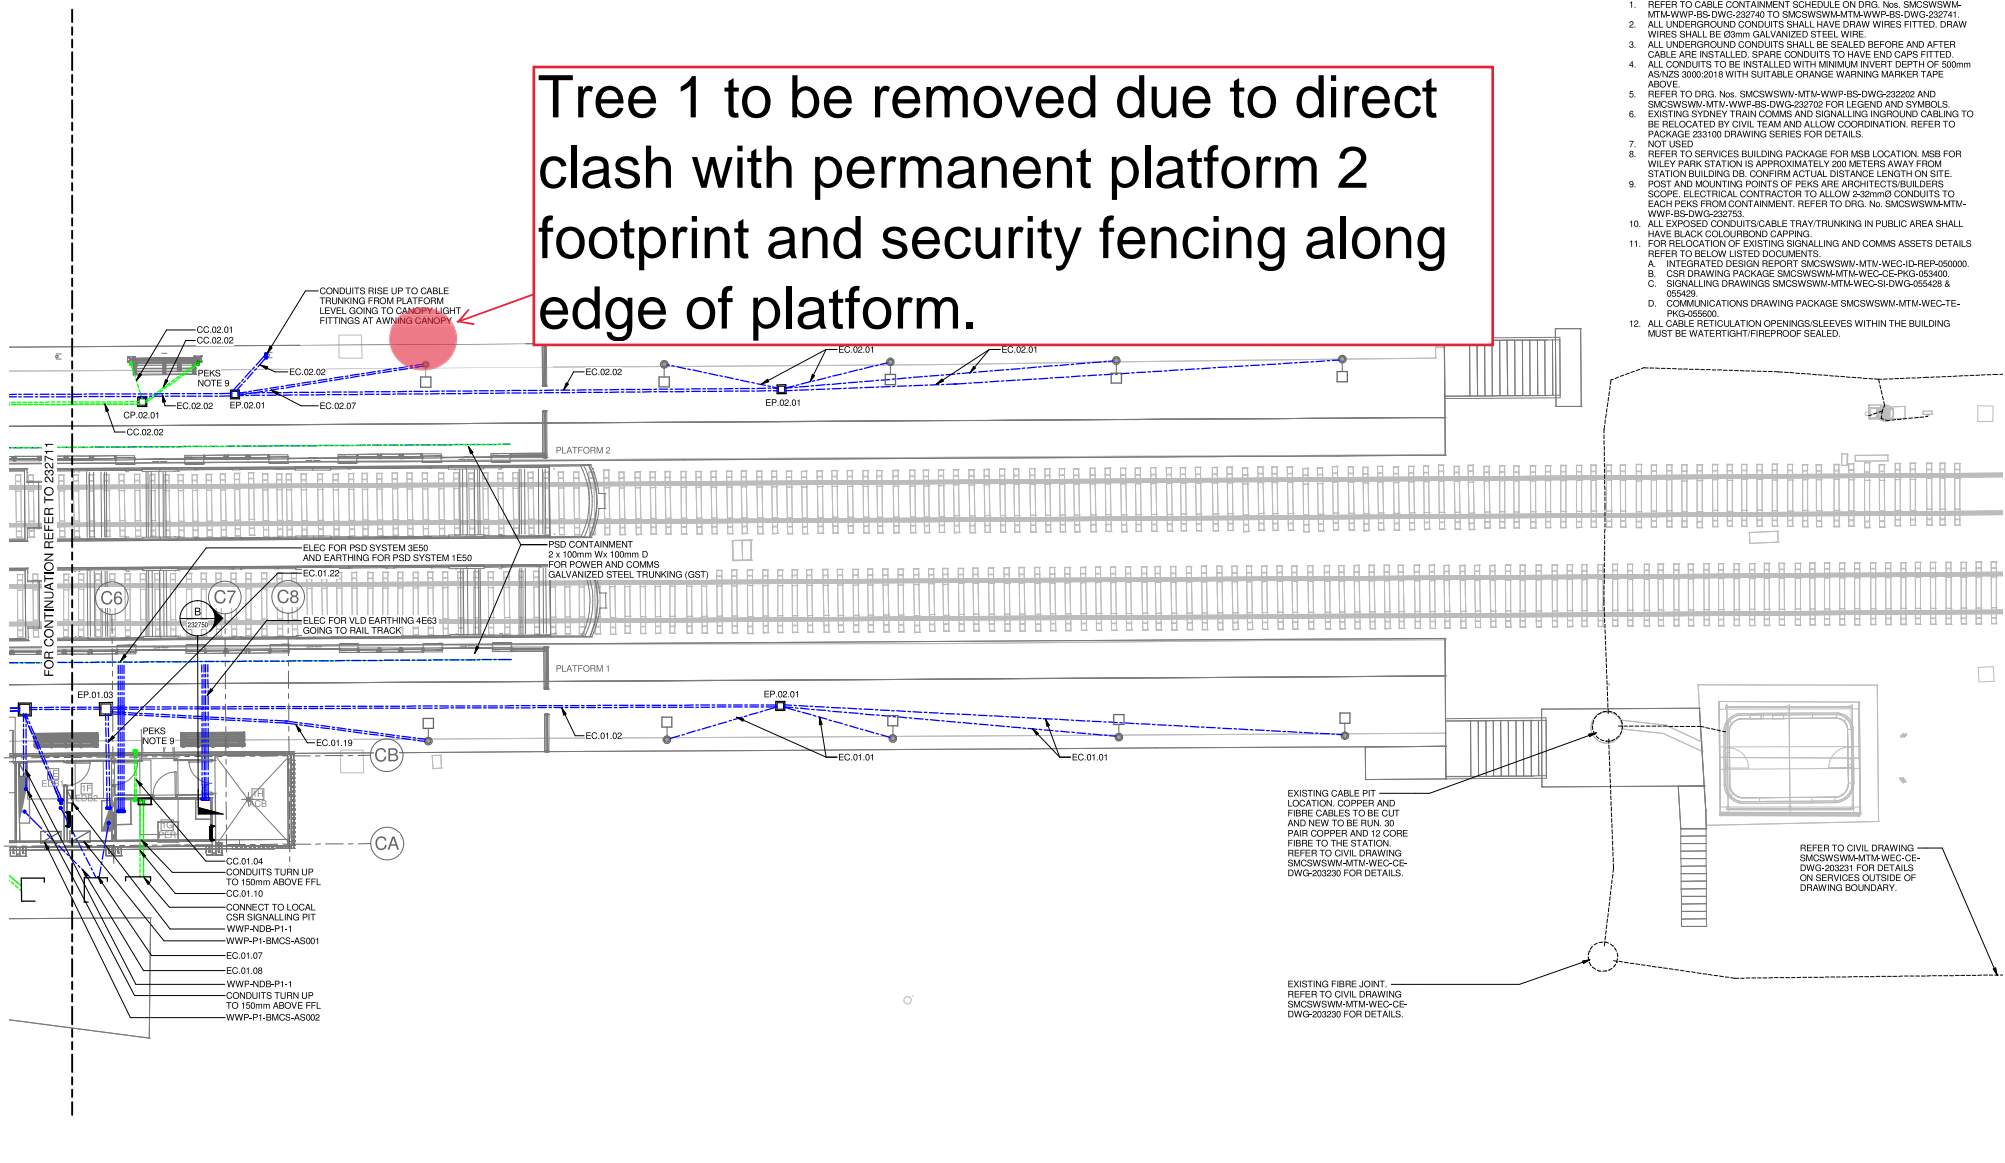
Tree 1 to be removed due to direct clash with permanent platform 2 footprint and security fencing along edge of platform.
