Tree Impact Assessment Report

City and Southwest Metro Station Upgrade Works Package 5 & 6

P5 Document No. SMCSWSW5-DEW-WEC-EM-REP-000542

P6 Document No. SMCSWSW6-DEW-WEC-EM-REP-000632

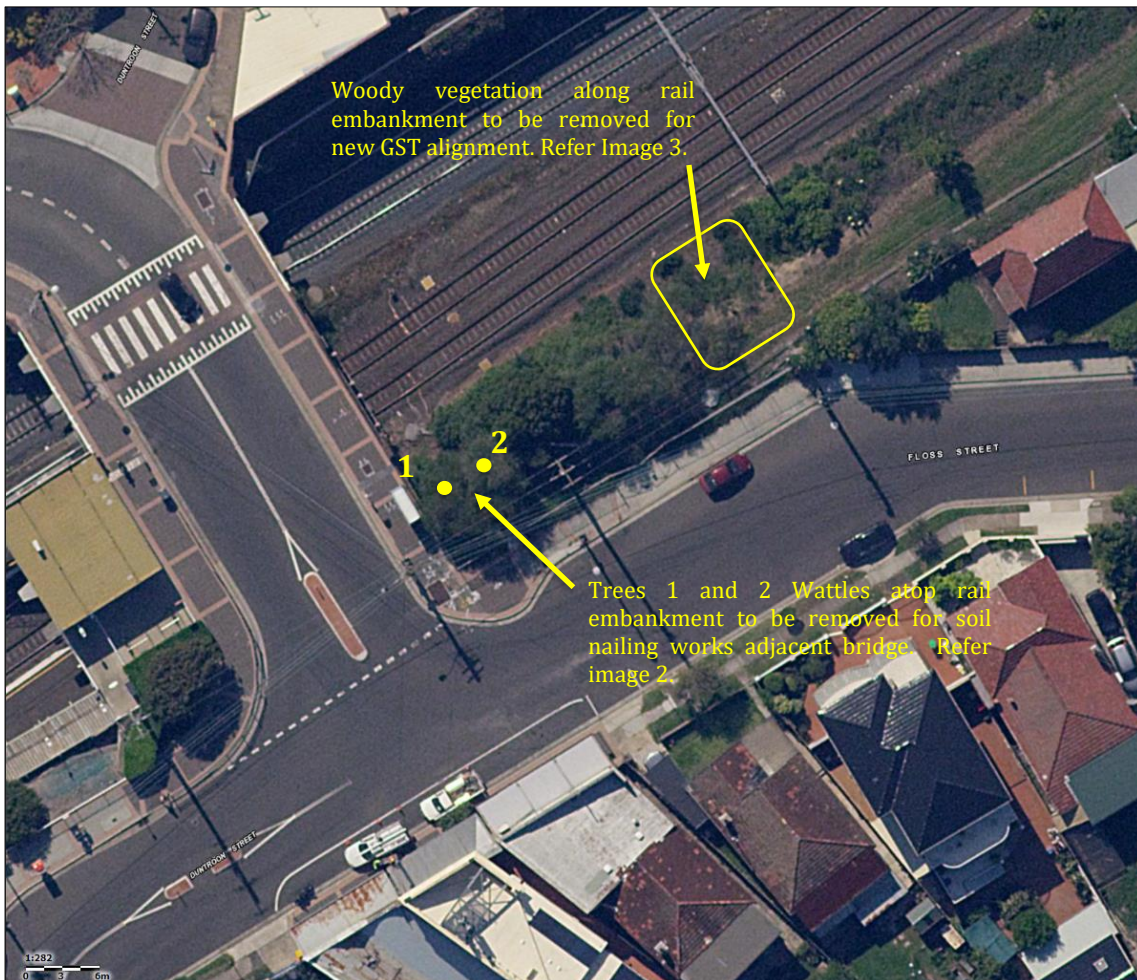
Additional tree and vegetation removal adjacent Floss Street involves two Wattles, trees 1 and 2, located adjacent the bridge and woody vegetation along the rail embankment. Image 1 shows their location.

Image 1: Aerial image of Hurlstone Park Station adjacent Floss Street showing additional tree and vegetation removal. (Source Six Maps accessed 10/03/2021).

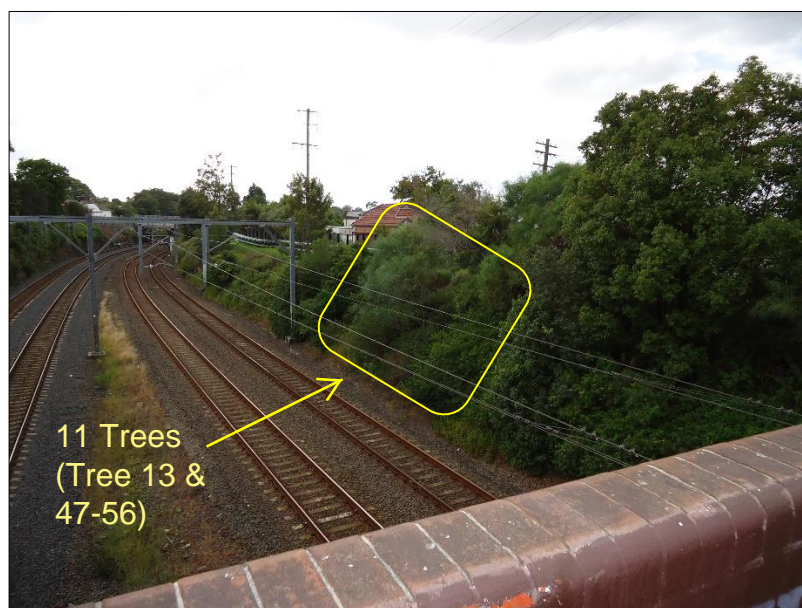
Woody vegetation located along the rail embankment was identified for removal to align the new GST. No access was gained to the rail corridor to assess the vegetation, but it has been confirmed in consultation with the project Ecologist to consist of; one *Pittosporum undulatum* (Sweet Pittosporum) tree 13, seven *Acacia saligna* (Golden Wreath Wattle) trees 47 to 53, one *Grevillea* sp (Grevillea), tree 54 and two *Yucca* sp (Yucca) trees 55 and 56. The vegetation is considered to have a short useful life expectancy and low landscape significance given its location within the rail corridor. Image 3 shows the approximate area to be cleared.

Image 3: Approximate area of woody vegetation along the rail embankment to be cleared to align the new GST.

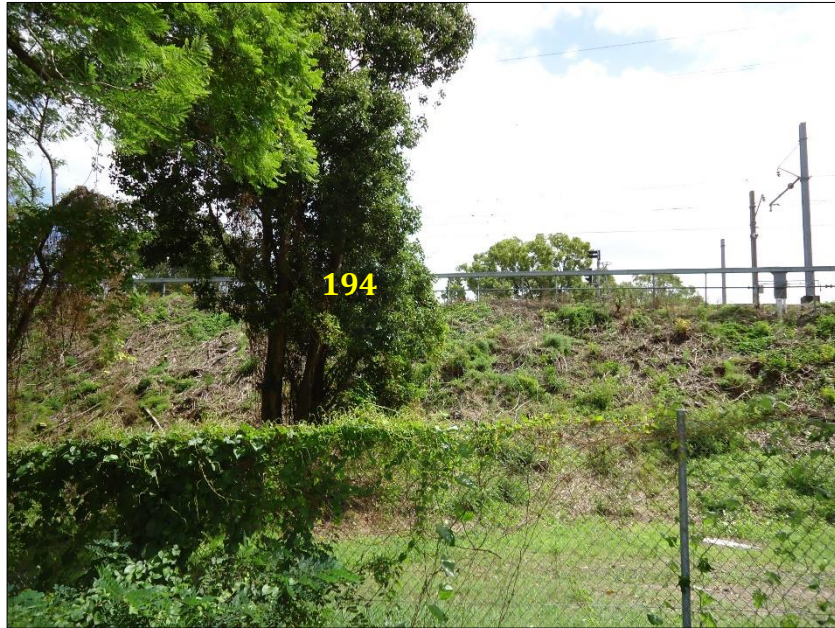
Additional tree removals were identified within the rail corridor associated with the construction of the Metro Services Building. A concrete pad is to be relocated from adjacent trees 166 and 167 to overlay the position of tree 194 *Cinnamomum camphora* (Camphor Laurel) requiring its removal. The tree has been identified for removal on demolition documentation viewed during the on-site inspection. Image 4 shows the tree.

Image 4: Tree 194 as identified within the AIA report shall require removal to accommodate the relocation of the concrete pad. Note the rail embankment to the rear of the tree has been cleared of woody vegetation.

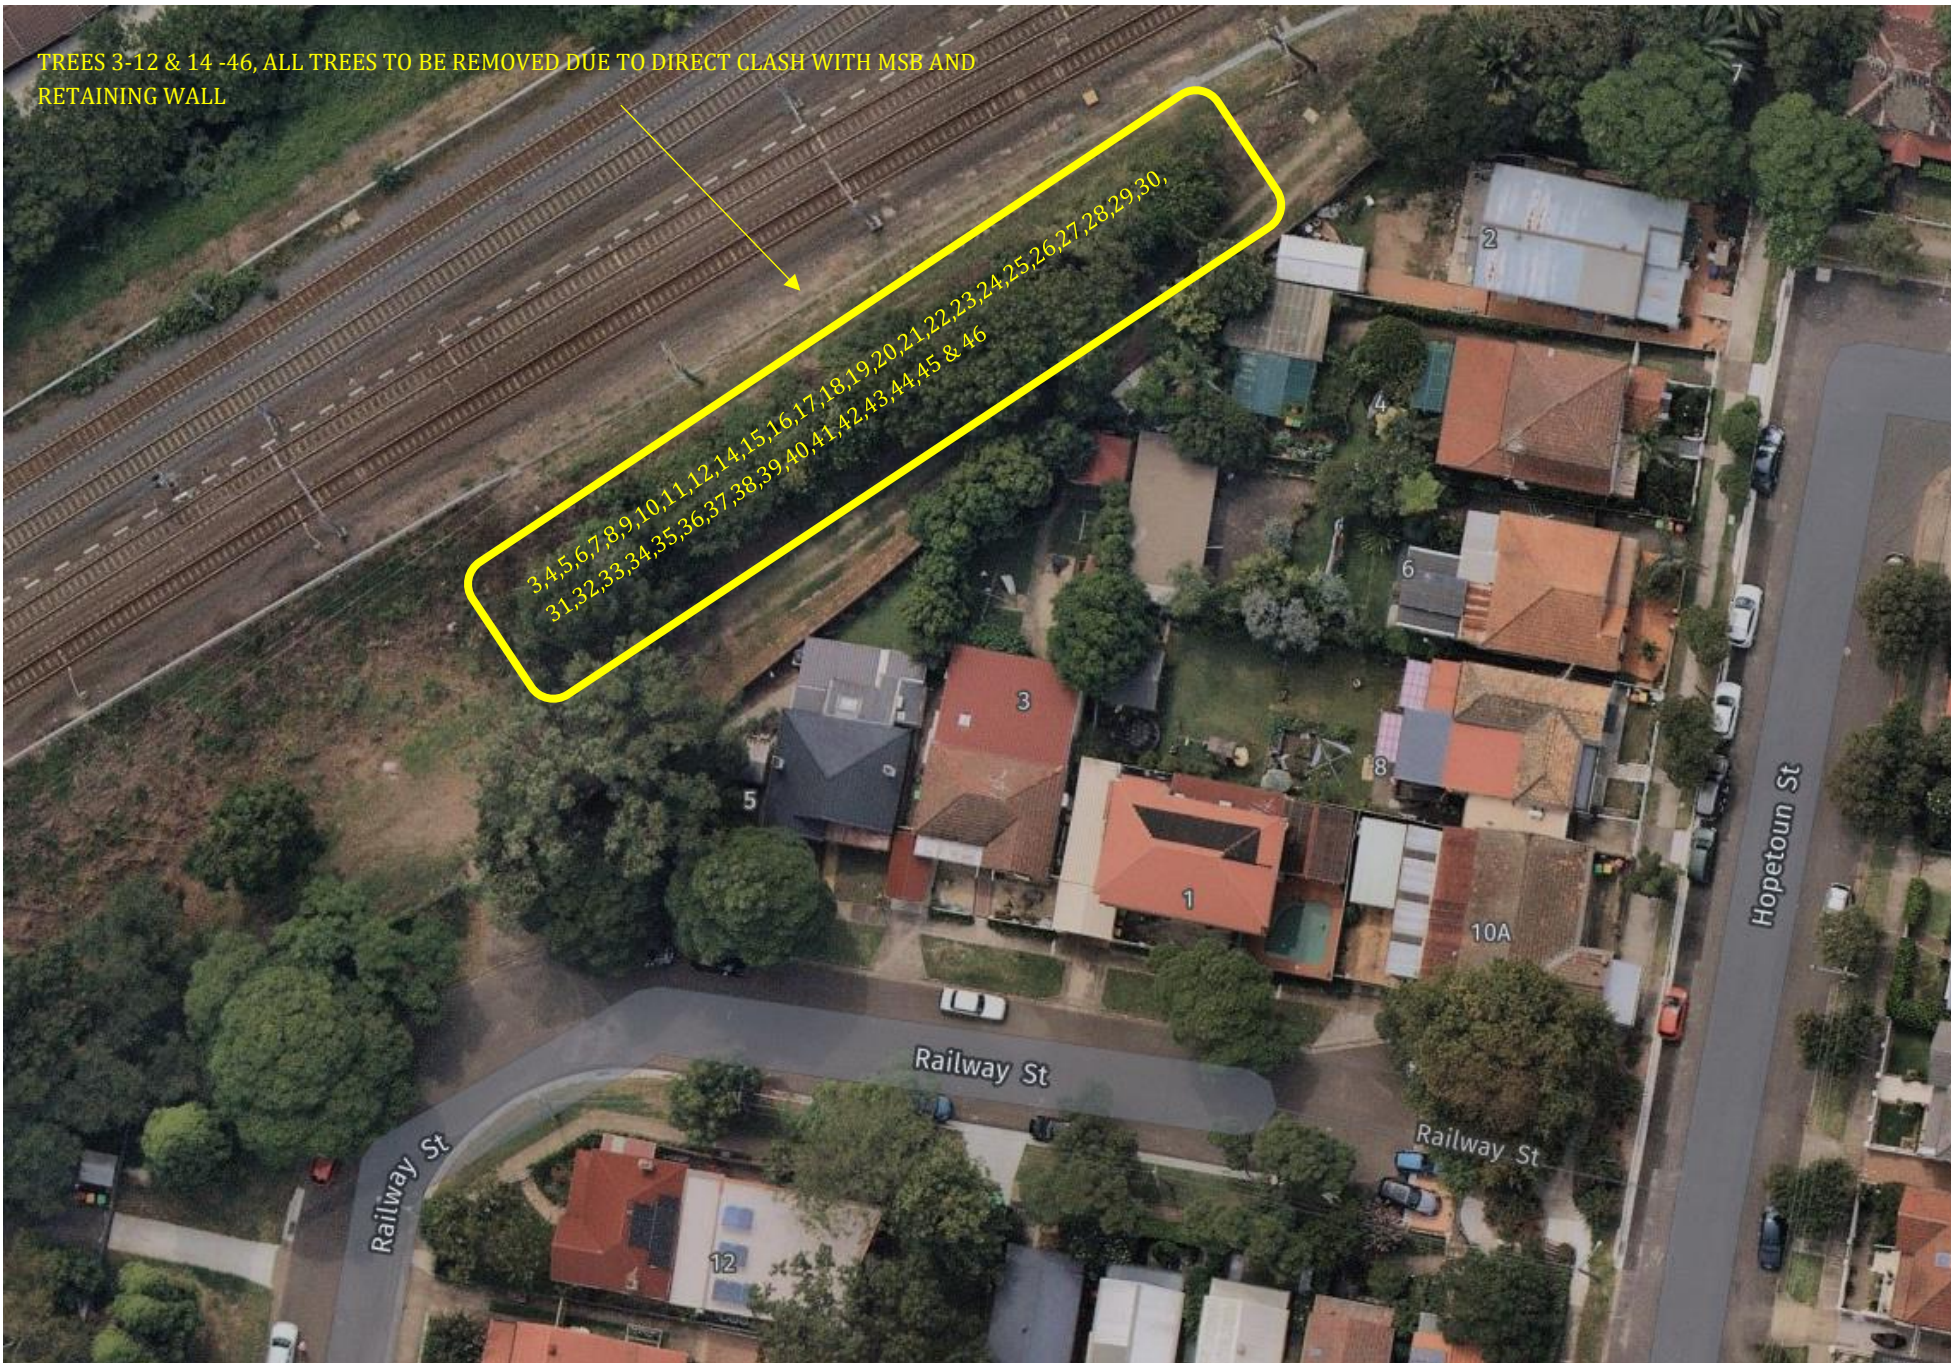
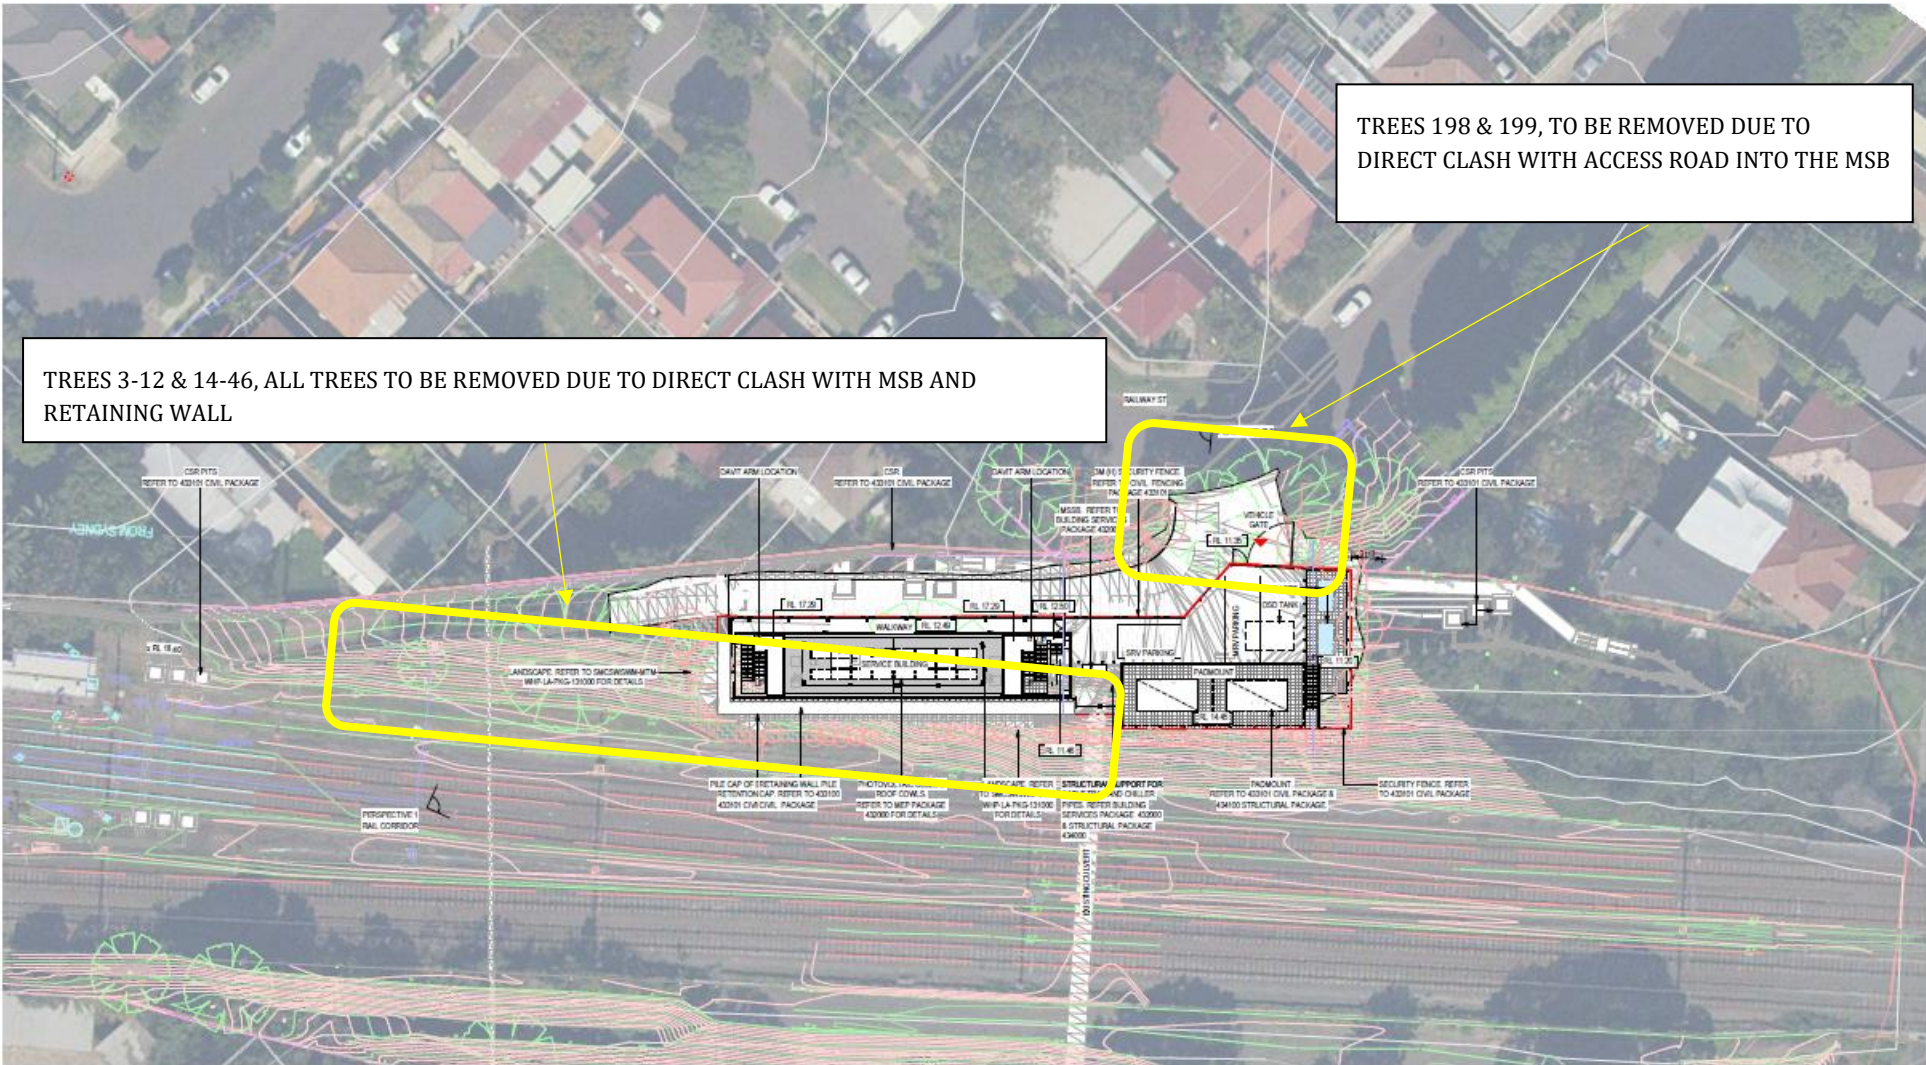
TREES 3-12 & 14-46, ALL TREES TO BE REMOVED DUE TO DIRECT CLASH WITH MSB AND RETAINING WALL

TREES 198 & 199, TO BE REMOVED DUE TO DIRECT CLASH WITH ACCESS ROAD INTO THE MSB

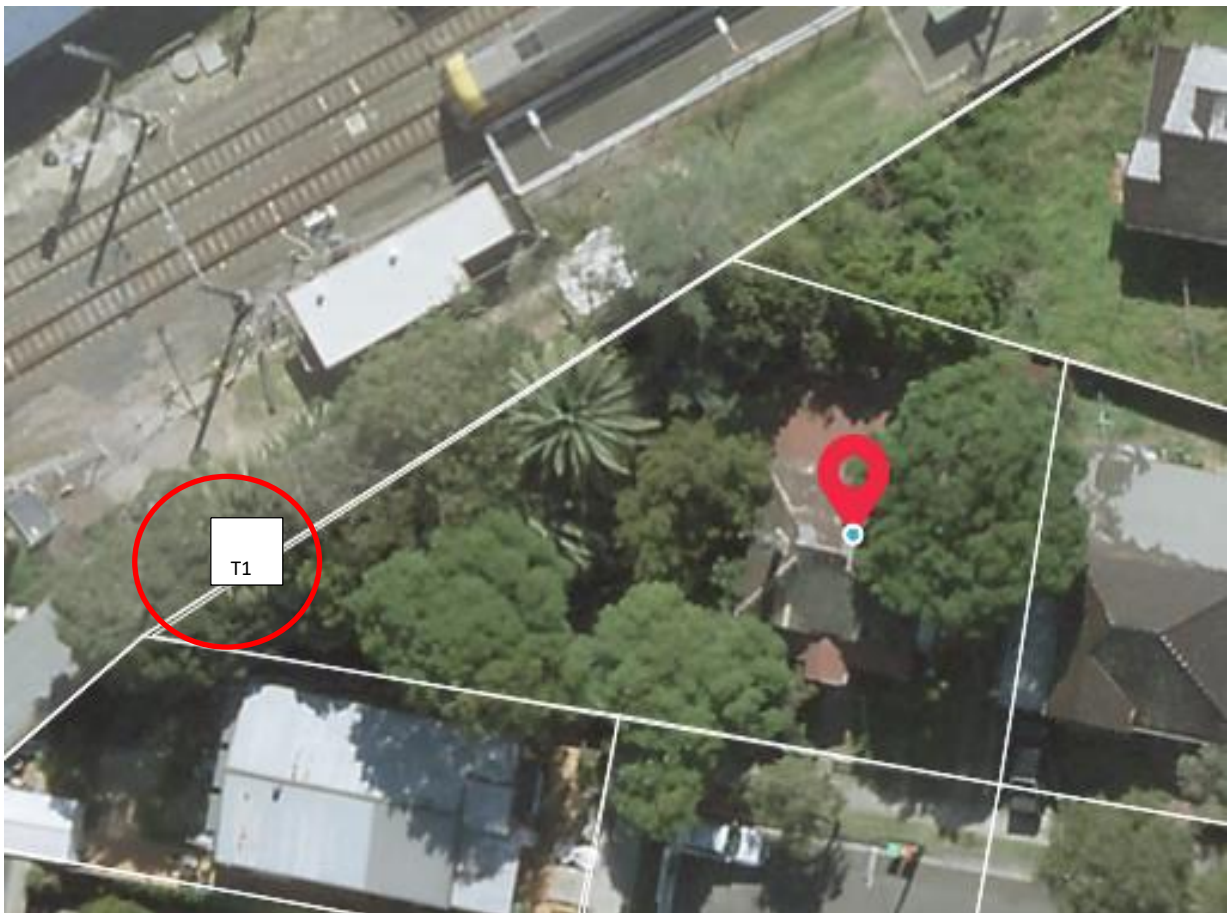
Figure 1

- 2.1 The subject tree are located in the rear yard of 7 Commons St, Hurlstone Park 2193. The tree can be seen in figure 1 below, numbered and outlined in red.

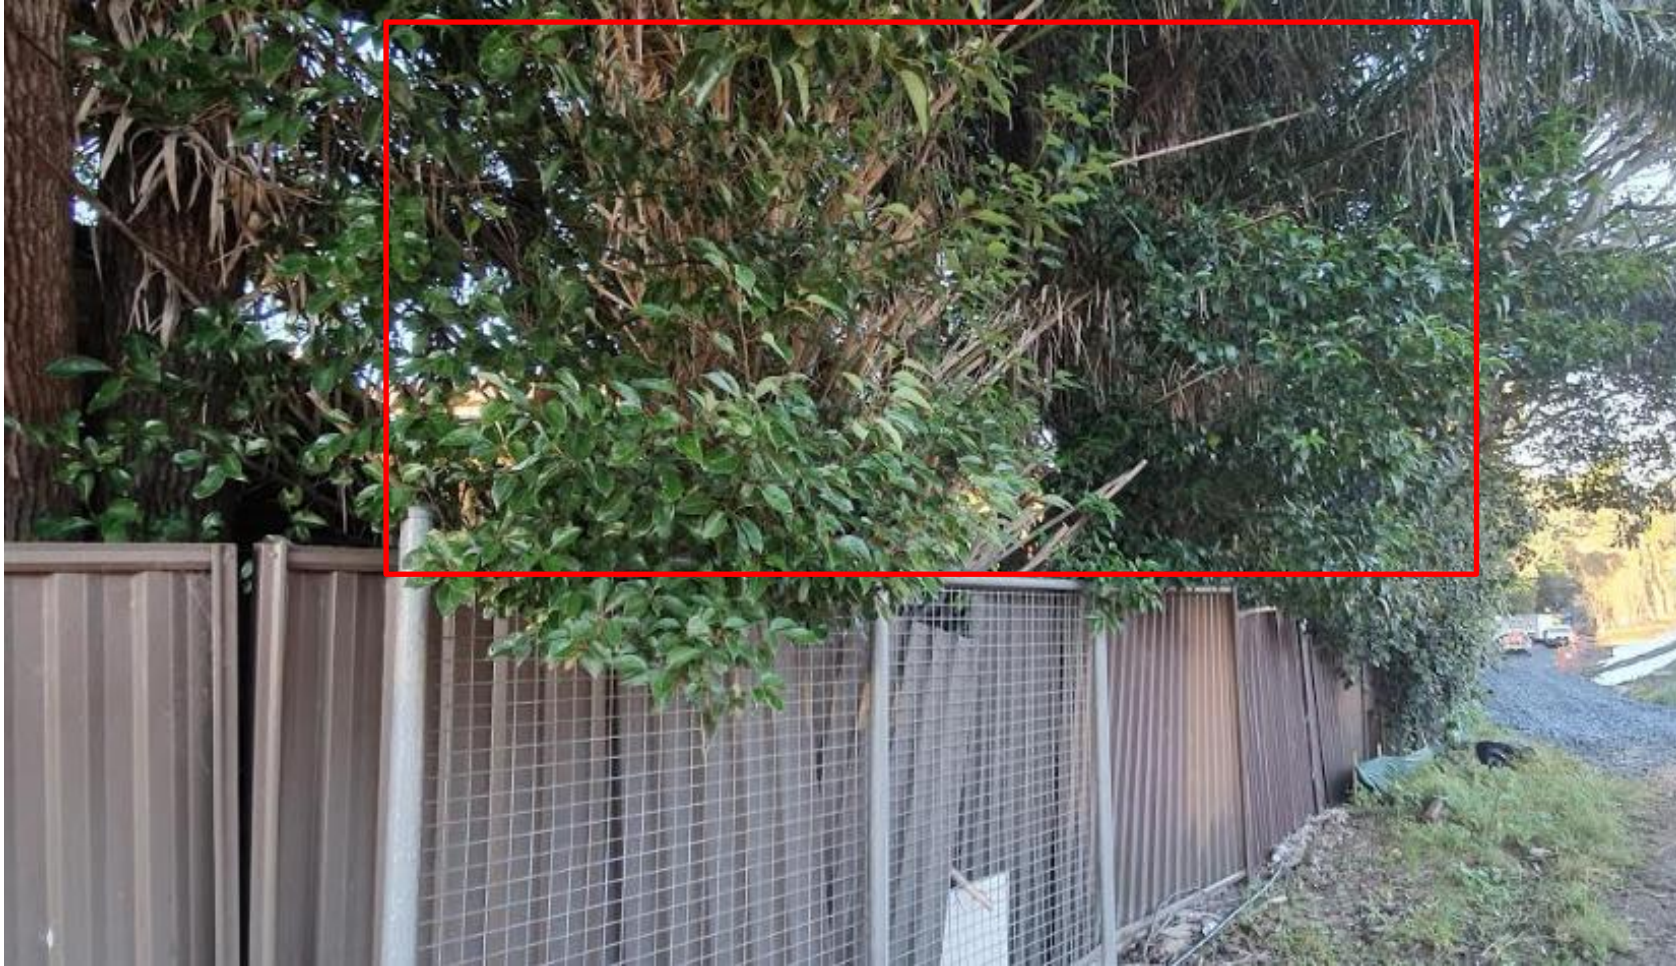
3 7 Commons St, Hurlstone Park 2193.

This area of foliage is minor regrowth from weed species and is requested to be pruned back to the fence line.

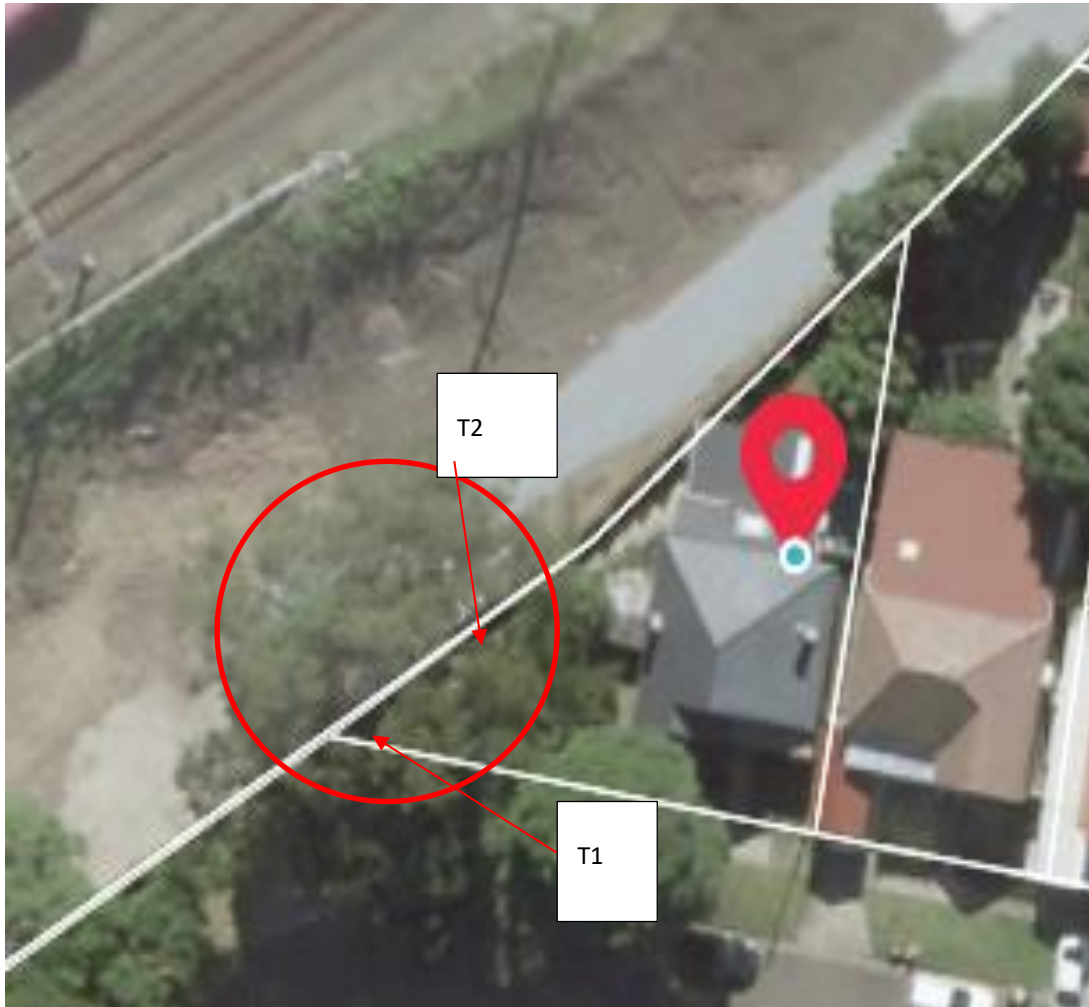
Figure 1

- 2.1 The subject trees are located in the rear yard of 5 Railway St, Hurlstone Park 2193. These trees can be seen in figure 1 below, numbered and outlined in red.

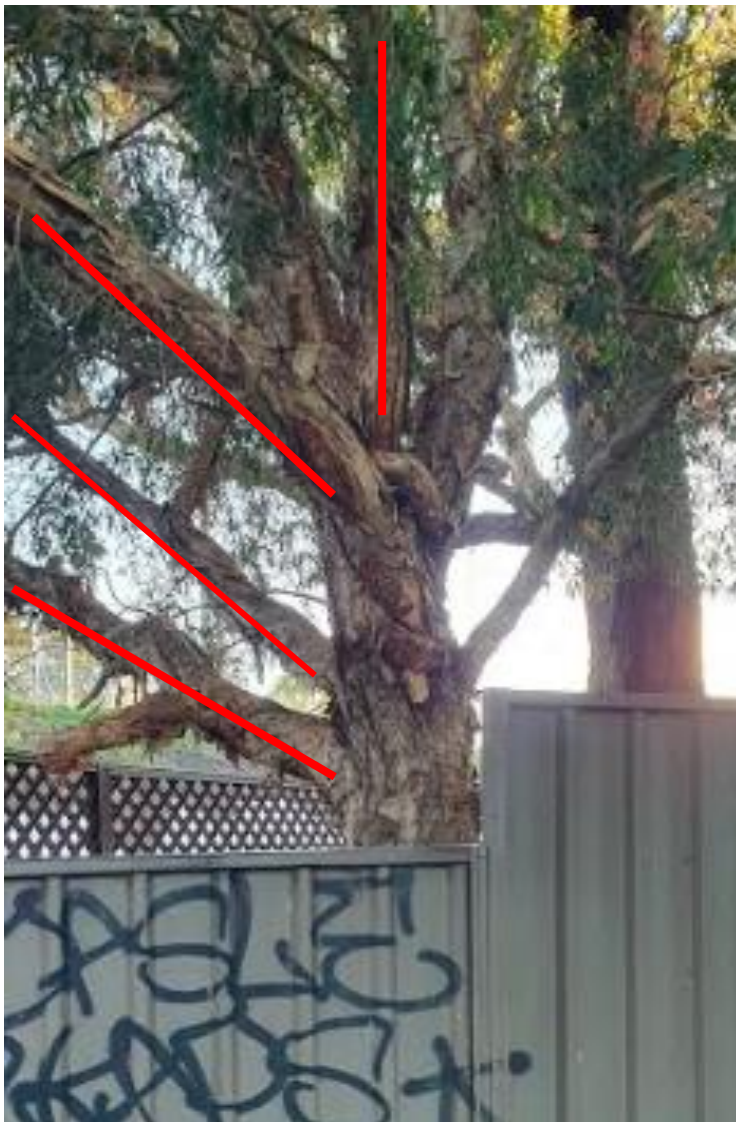
2 5 Railway S, Hurlstone Park 2193.

3.1 TREE 1 – WILLOW BOTTLE BRUSH (*CALLISTEMON SALIGNUS*) SEE FIGURE 2

Branch No #	Branch / Stem Height (Mts)	Branch / Stem Diameter (mm)	Branch Order	Pruning Class	Canopy Percentage
1	2	150	1st	7.2.4, Selective	4%
2	2.1	120	1st	7.2.4, Selective	4%
3	2.3	100	1st	7.2.4, Selective	4%
4	2.5	80	1st	7.2.4, Selective	3%

Figure 2:Limbs to be pruned marked in red.

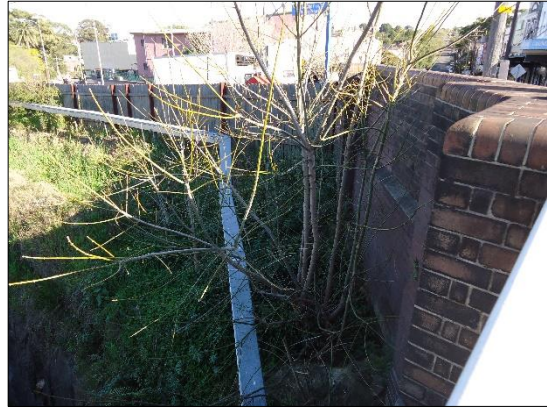
Tree 1 consists of a self-seeded multi-stemmed *Acer negundo* (Box Elder), refer Appendix 2 photograph 1. It has been assessed as having a short useful life expectancy and low landscape value. The wider Southwest Metro Package works require three 300mm diameter piles to be excavated at the location of the tree to

enable the construction of a materials throw screen. As such, the tree cannot be retained.

Photograph 1: Tree 1 *Acer negundo* (Box Elder) growing adjacent rail bridge wall on the northern side of the rail corridor.

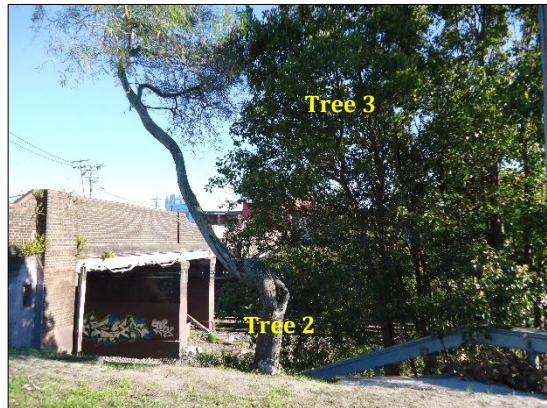
Photograph 4: Trees 2 and 3 as seen from the rail bridge.

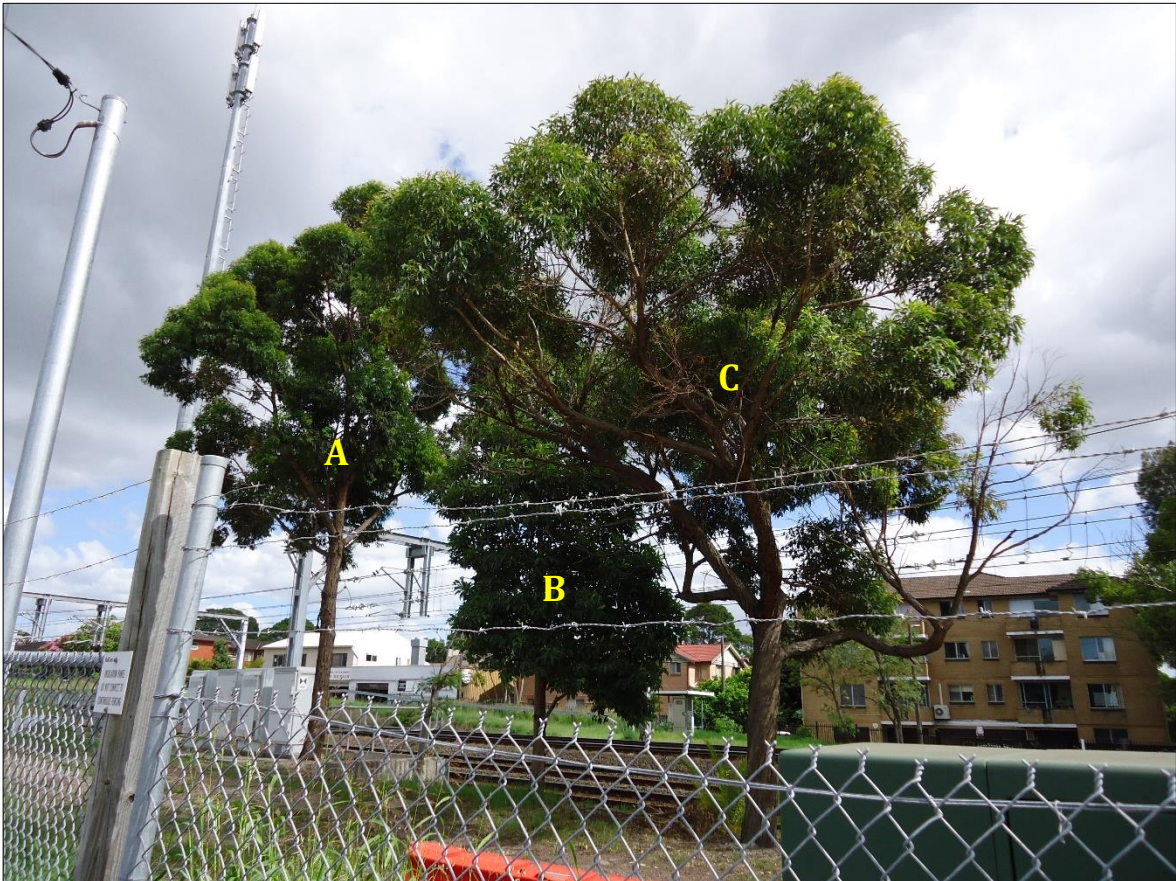
Trees A, Tallowwood and B Brush Box were found to be in good health and condition. They are considered to have a medium useful life expectancy and landscape significance. Tree C Tallowwood was found to have normal vigour and fair condition. Deadwood and canopy dieback was observed within the tree indicating a possible decline in health and condition. As such the tree is considered to have a short useful life expectancy. Image 2 shows the subject trees. The trees provide some screening and relief from the rail corridor and associated infrastructure along Lillian Street.

Image 2: The three additional trees identified for removal as part of the Southwest Metro Package works.

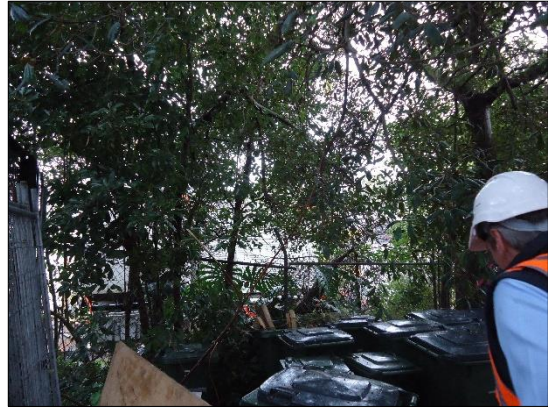
Photograph 2: Tree 632 *Callistemon viminalis* (Bottlebrush) identified for removal to accommodate the new GST alignment.

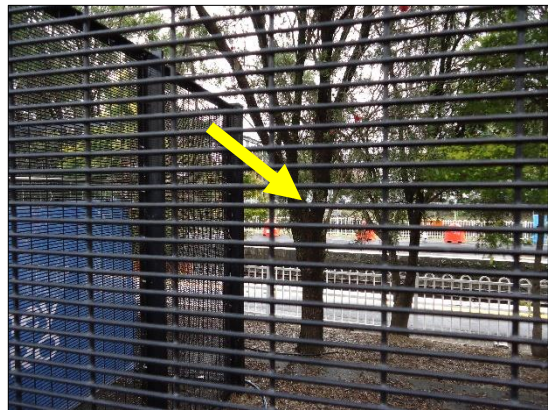
Photograph 3: Tree 627 *Leptospermum petersonii* (Lemon-scented Teatree) identified for selective pruning works create clearances to allow for the new GST alignment.

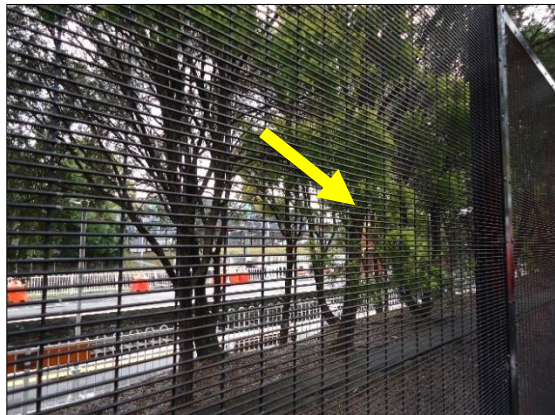
Photograph 4: Tree 614 *Sapium sebiferum* (Chinese Tallowwood) identified for removal to accommodate the new GST alignment.

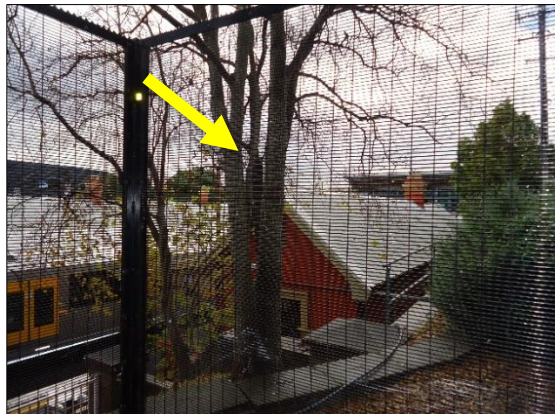
Photograph 5: Tree 6 *Celtis sinensis* (Hackberry) located within rail corridor. Tree to be removed to accommodate the new GST alignment. The surrounding Lantana along the rail embankment is also to be removed.

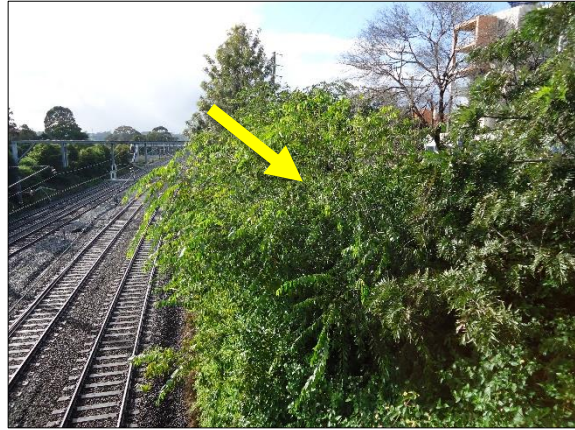
Photograph 6: Tree 7 *Celtis sinensis* (Hackberry) located within rail corridor. Tree to be removed to accommodate the new GST alignment.

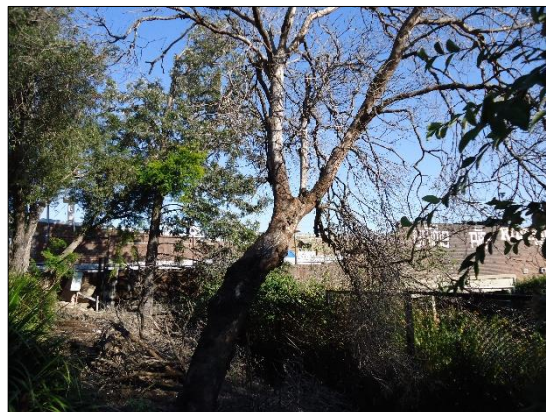
Photograph 4: Tree 519 *Callistemon viminalis* (Weeping Bottlebrush) located adjacent the northern side of South Parade.

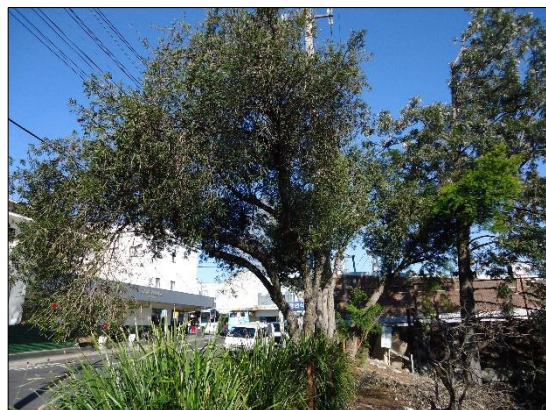
dead. Tree 615 was also found to be in a state of declining health and beyond reasonable attempts to remediate. The AIA report also identifies trees 615 and 620 as being exempt from local tree preservation controls. The additional trees to be removed are not representative of an endangered or threatened species or ecological community. Photographs of the assessed trees have been attached to the rear of this report as Appendix 2 Site Photographs.

Photograph 5: Tree 615 *Acacia podalyrifolia* (Queensland Silver Wattle) located adjacent Platform 2. The adjacent Queensland Silver Wattle's are near dead.

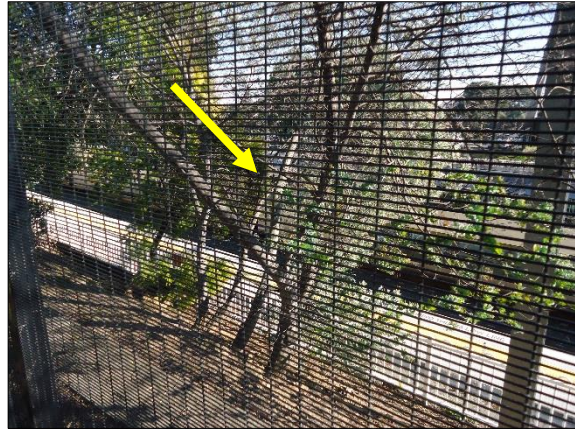
Photograph 6: Tree 5 *Melaleuca bracteata* (Black Teatree) located adjacent Platform 2.

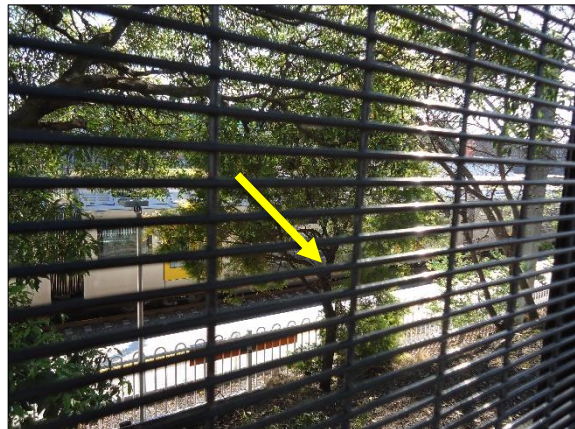
Photograph 7: Showing trees adjacent Platform 2. Tree 621 *Syncarpia glomulifera* (Turpentine) is shown for reference.

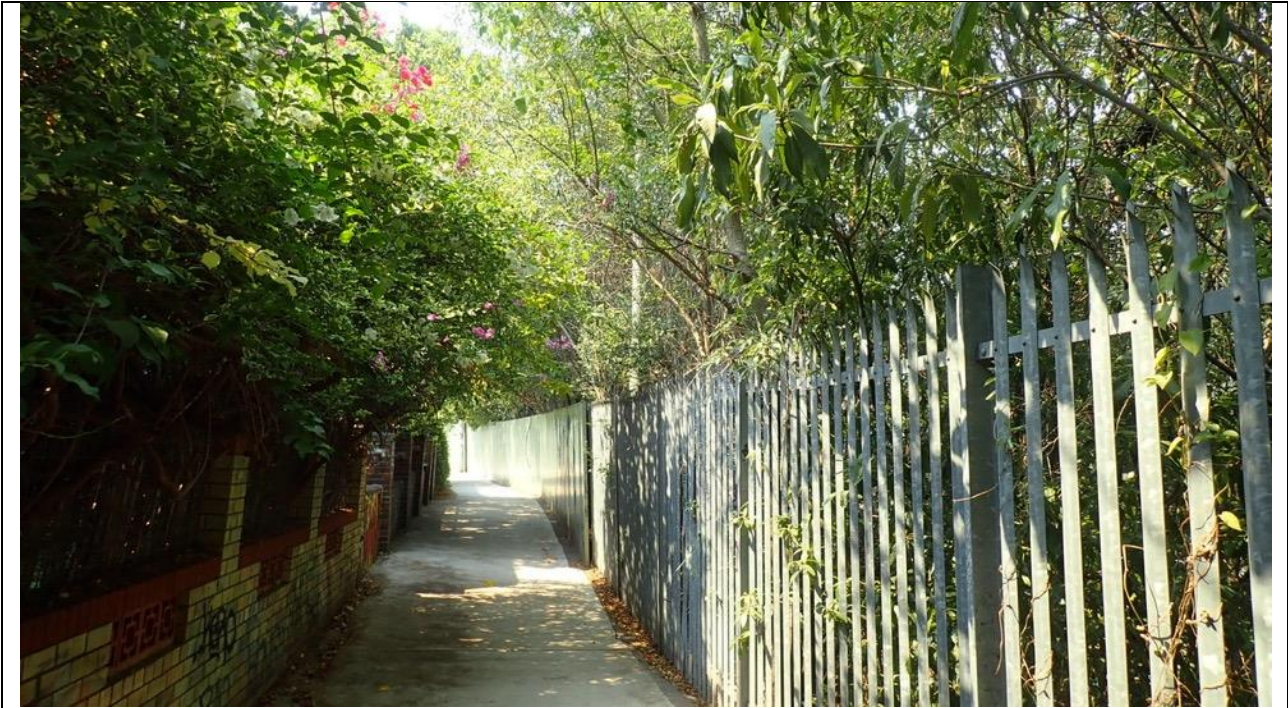
Image 1: Looking South East towards the public footpath where pole top lighting is proposed G12 is to the right of the photograph behind the fencing.

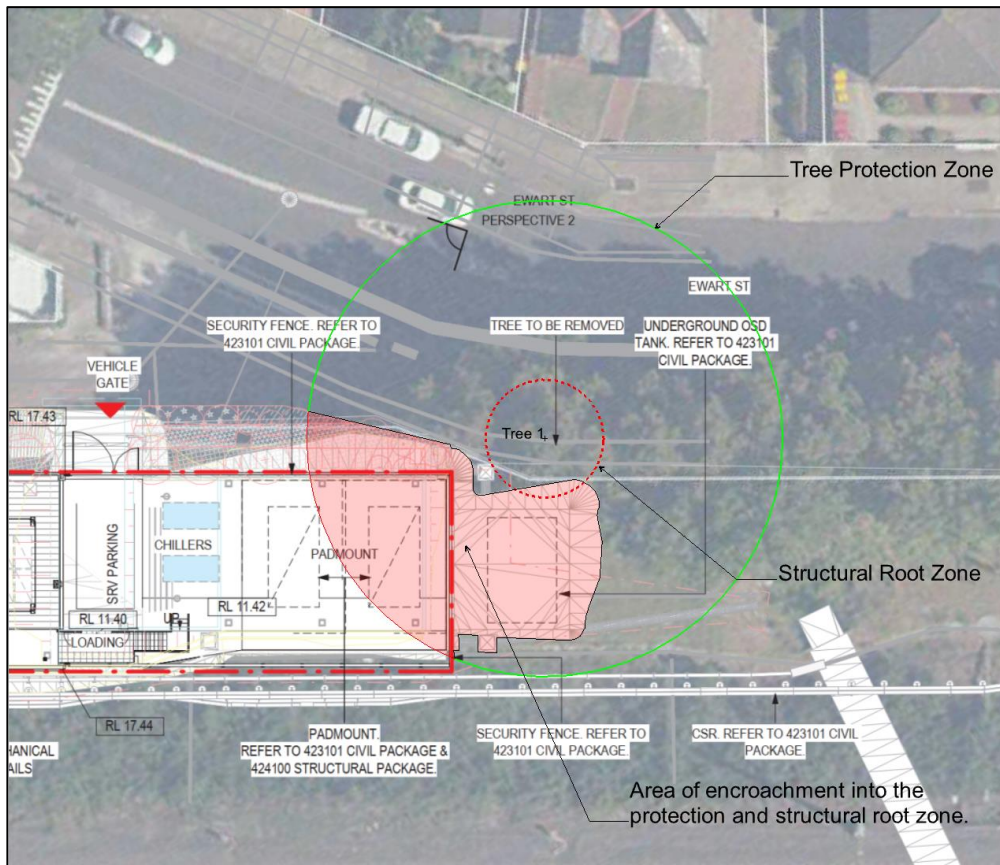
The additional tree removals consist of one *Platanus x acerifolia* (London Plane) tree 1, one *Cupaniopsis anacardioides* (Tuckeroo) tree 2 and four *Callistemon viminalis* (Bottlebrush) trees 4 to 7 where there is direct design clash and 100% impact to the TPZ and SRZ requiring removal. The Overall Arrangement Site Plan – Service Building, drawing SMCSWSWM-MTM-WDH-AT_DWG-421120 shows the position of the service building and associated features with respect to tree 1. The alignment of the Padmount and underground OSD tank pose a significant (35%) encroachment into its TPZ and SRZ requiring its removal, refer to Image 2.

Image 2: Extract from Overall Arrangement Site Plan – Service Building showing the encroachment into the TPZ and SRZ of tree 1.

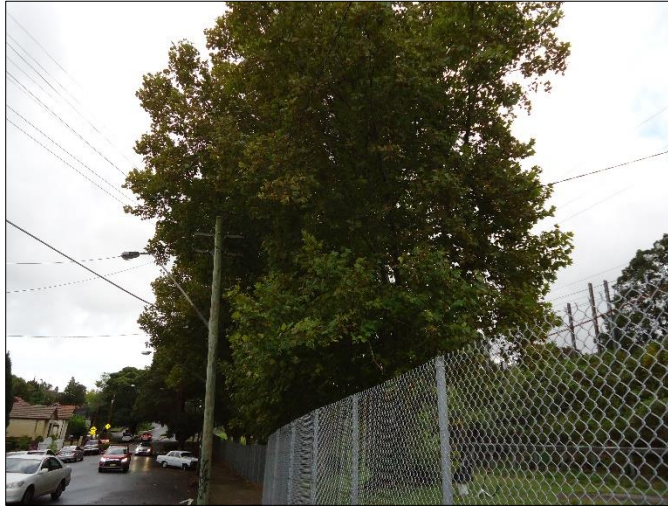
Photograph 1: Tree 1 *Platanus x acerifolia* (London Plane) to be removed.

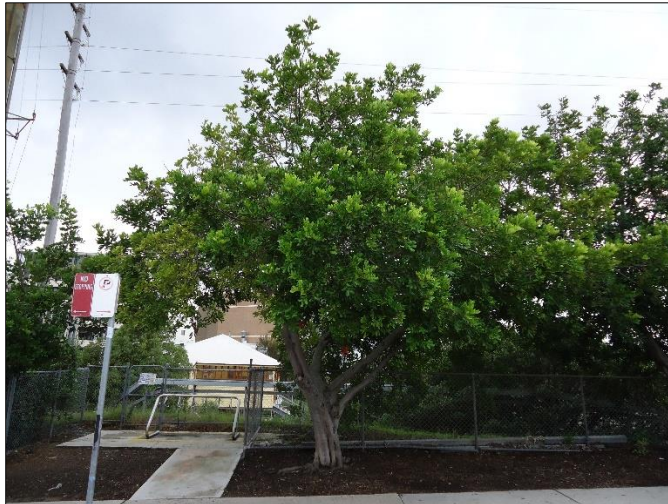
Photograph 2: Tree 2 *Cupaniopsis anacardioides* (Tuckeroo) to be removed.

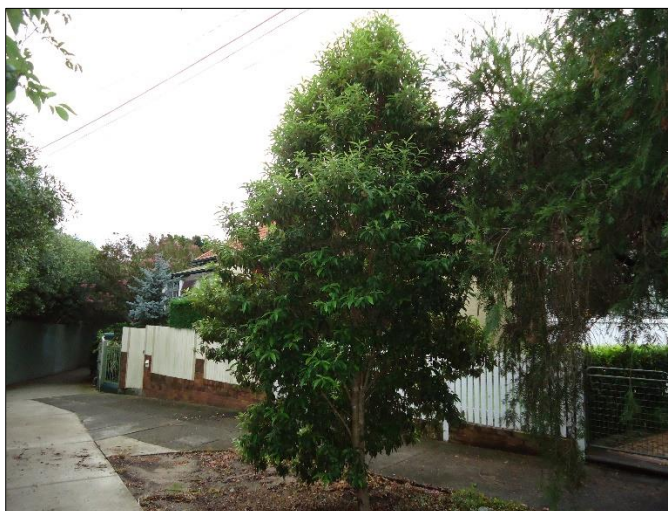
Photograph 3: Tree 3 *Backhousia citriodora* (Lemon-scented Myrtle). Tree is to be transplanted on the site.

One *Backhousia citriodora* (Lemon-scented Myrtle) tree 3, has been identified for transplanting and relocation on the site. As identified within the provided plans the Inner West Council is to advise of its relocation position. The locations of the additional assessed trees are shown within Image 1.

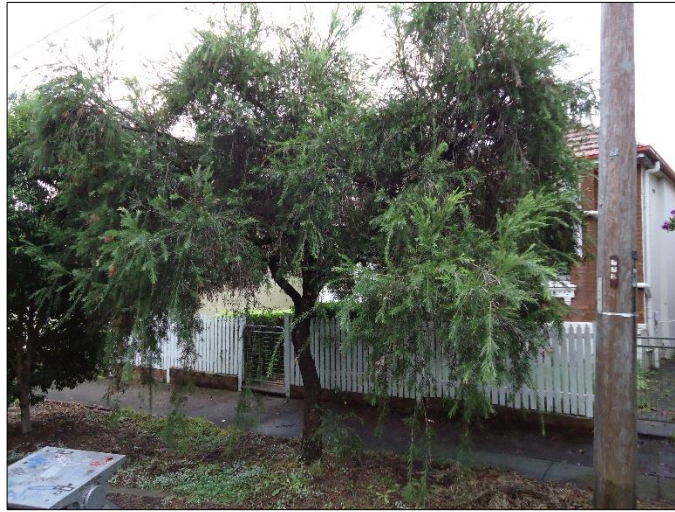
Photograph 4: Tree 4 *Calistemon viminalis* (Bottlebrush) to be removed.

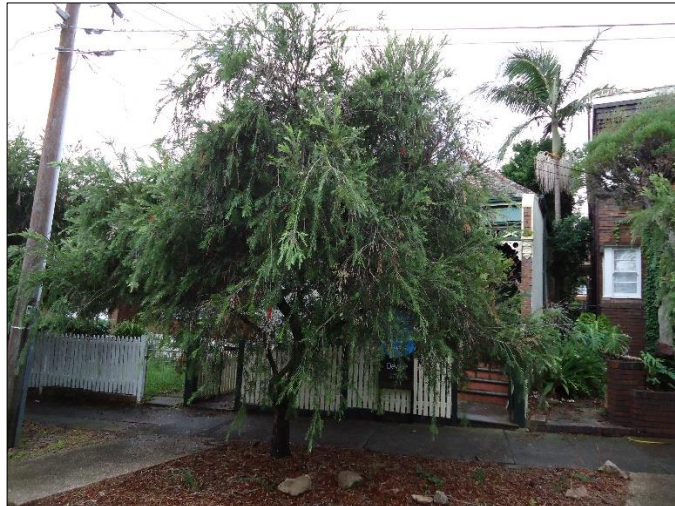
Photograph 5: Tree 5 *Calistemon viminalis* (Bottlebrush) to be removed.

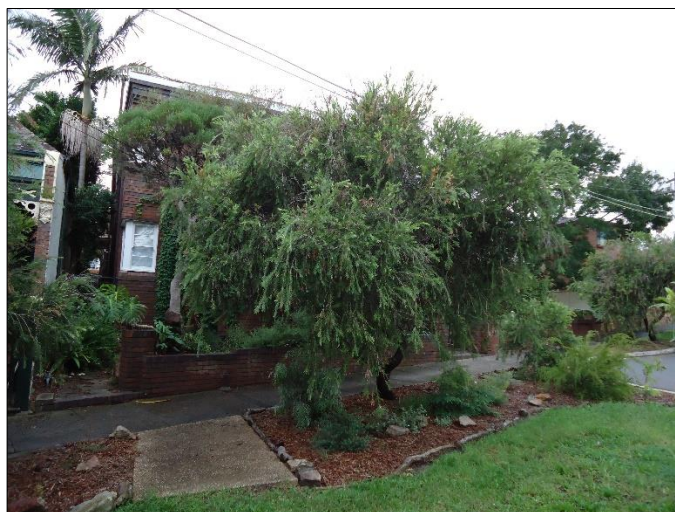
Photograph 6: Tree 6 *Calistemon viminalis* (Bottlebrush) to be removed.

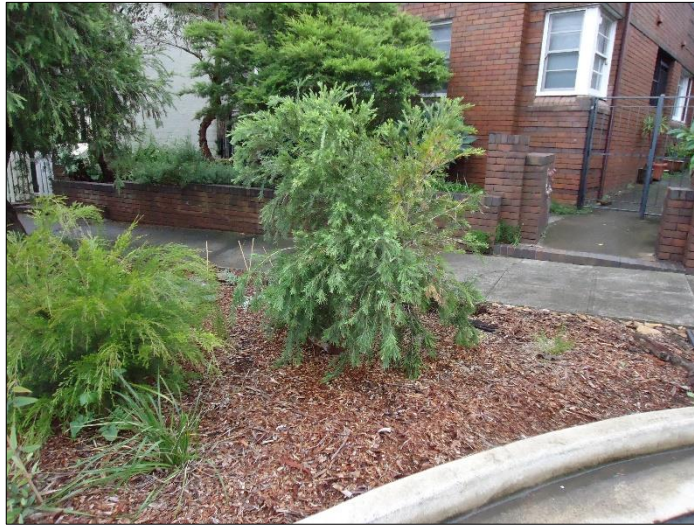
Photograph 7: Tree 7 *Calistemon viminalis* (Bottlebrush) to be removed. Does not meet the criteria for being a tree under *Sydney Metro City & Southwest Sydenham to Bankstown Instrument of Approval* due to height. Currently considered a sapling.
