Tree Impact Assessment Report

City and Southwest Metro Station Upgrade Works Package 5 & 6

P5 Document No. SMCSWSW5-DEW-WEC-EM-REP-000542

P6 Document No. SMCSWSW6-DEW-WEC-EM-REP-000632

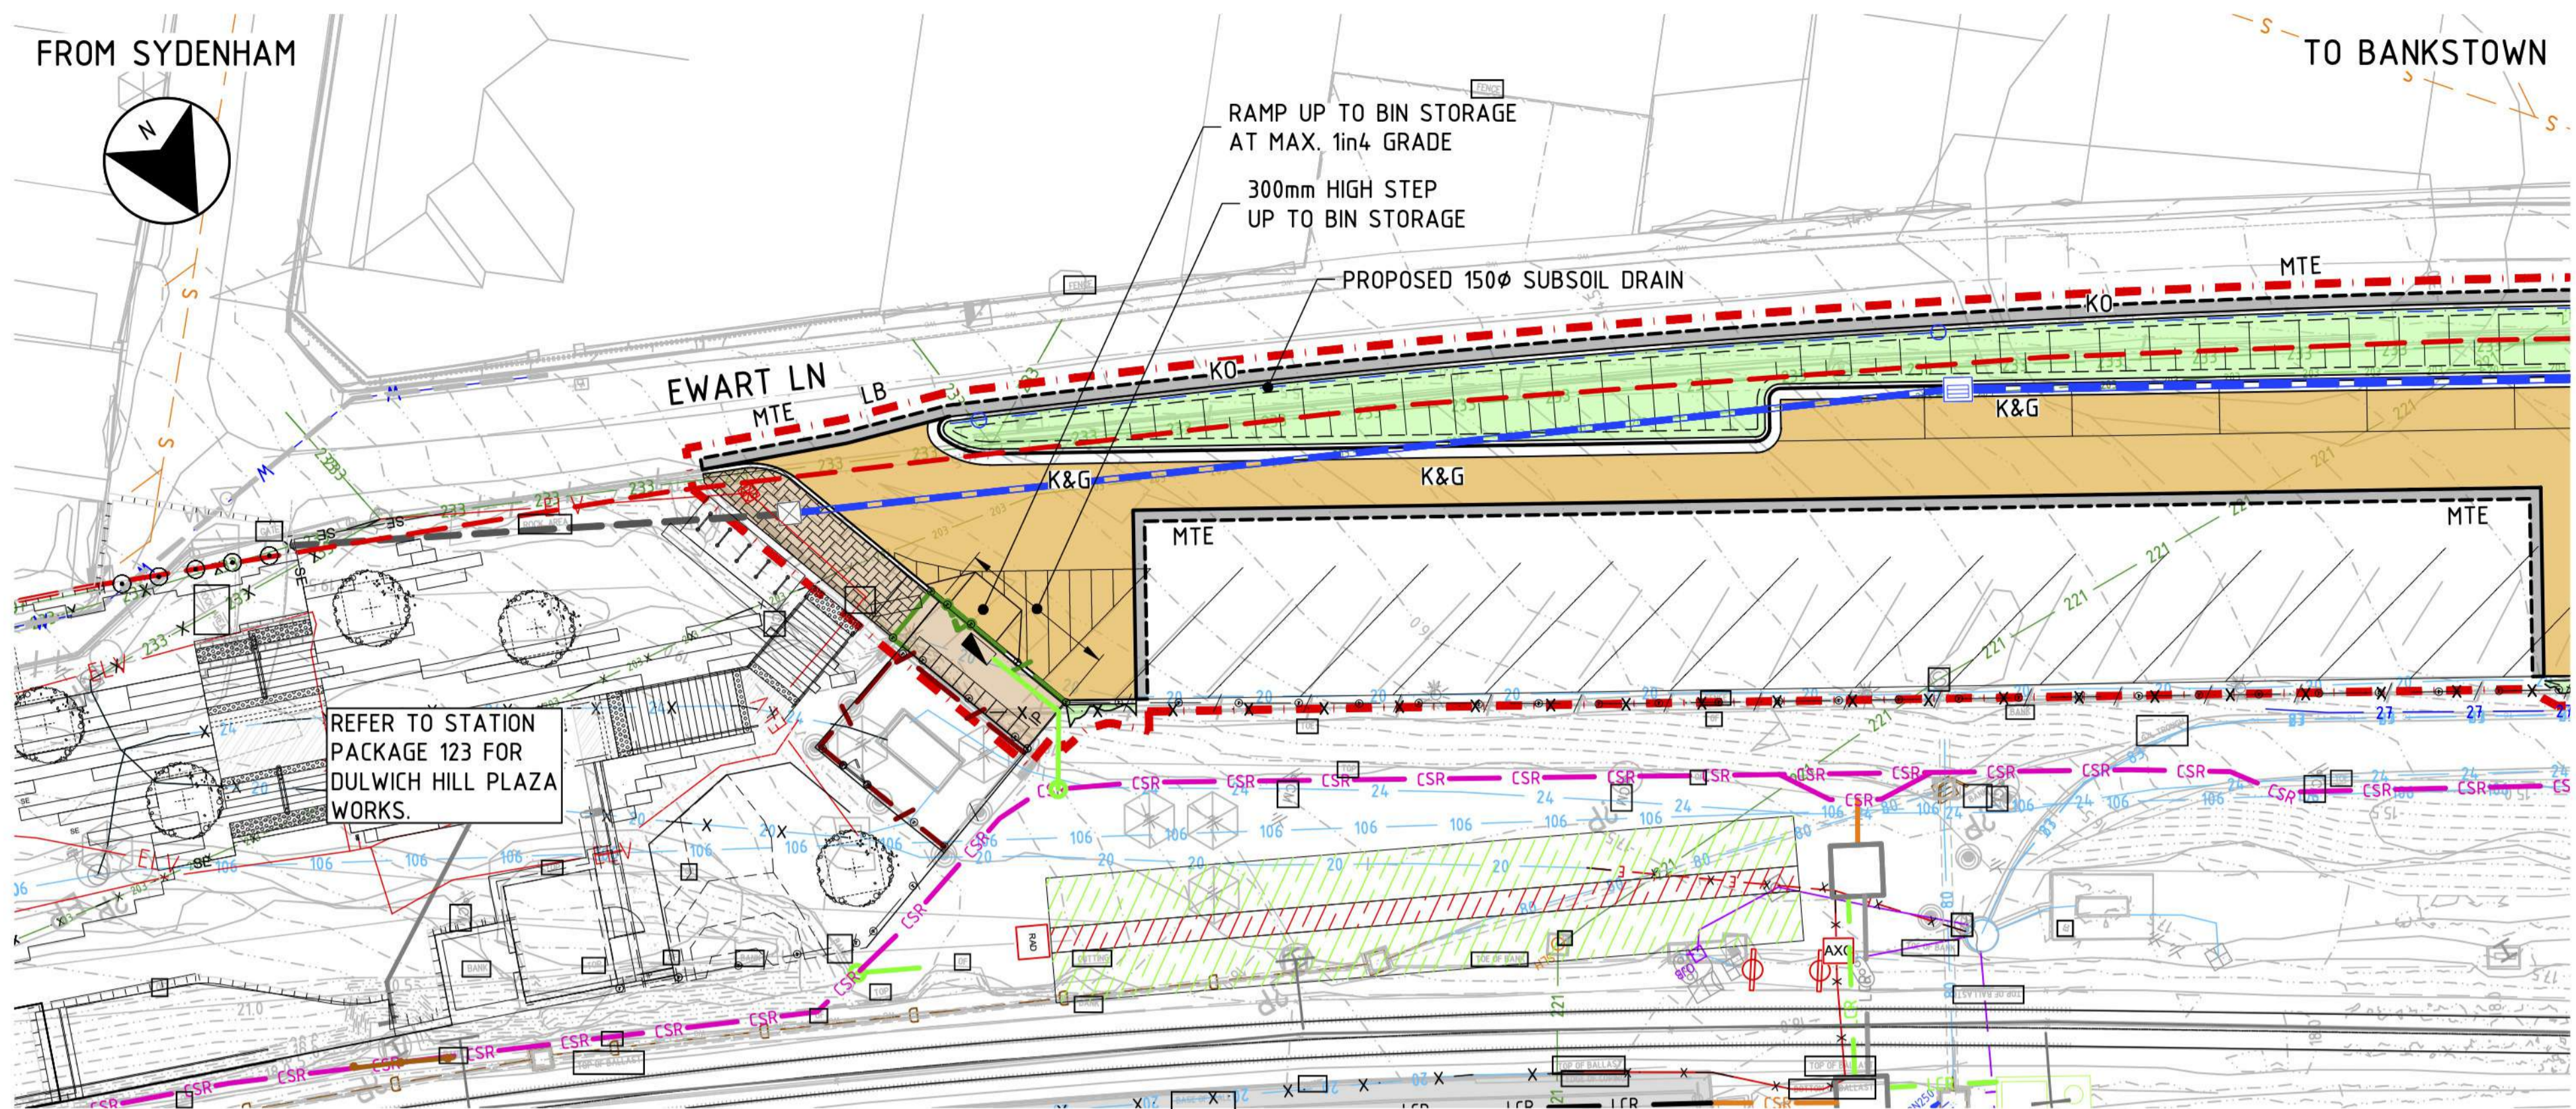
PLAN
SCALE 1:200

To be cleared due to clash with permanent drainage design. Drainage design indicted by blue and white dotted line.

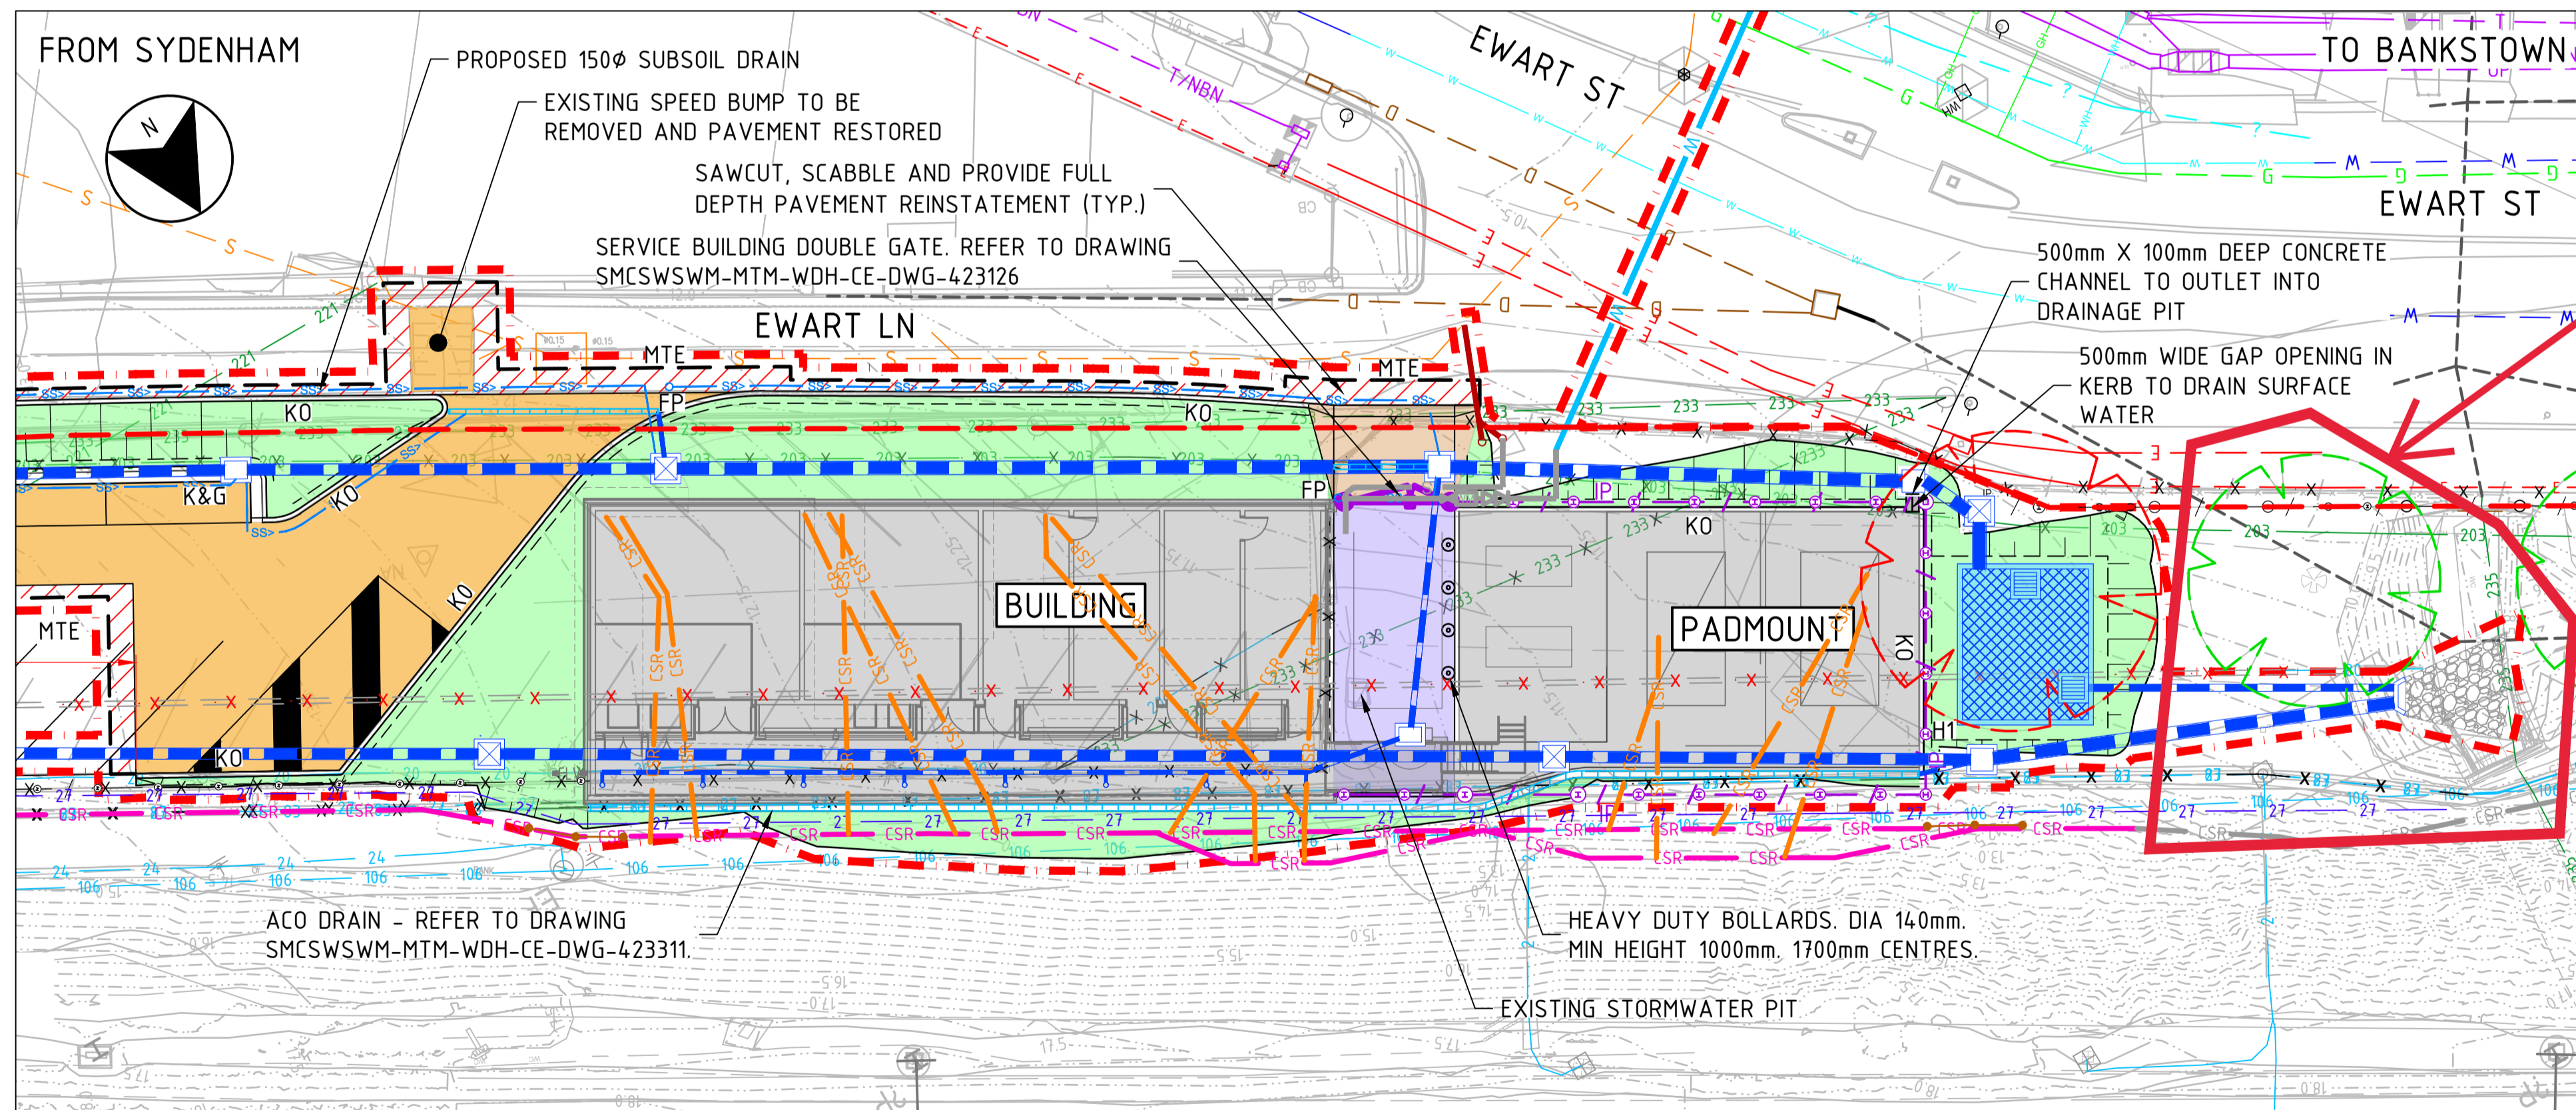
PLAN
SCALE 1:200

To be cleared due to clash with permanent drainage design. Drainage design indicted by blue and white dotted line.

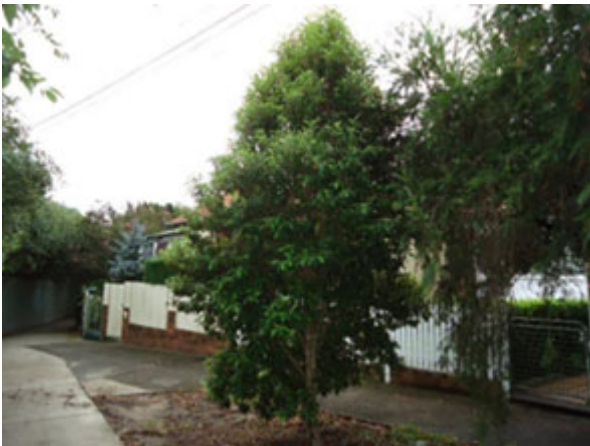
During the phone call with your colleague, it was noticed that the original photo was actually the wrong tree nominated to be relocated (refer to below correct image). Irrespective, the below correspondence is still relevant and we are seeking advise from Inner West Council whether they wish to retain the tree and transplant locally or shall the project add it to the tree offset planting requirements.

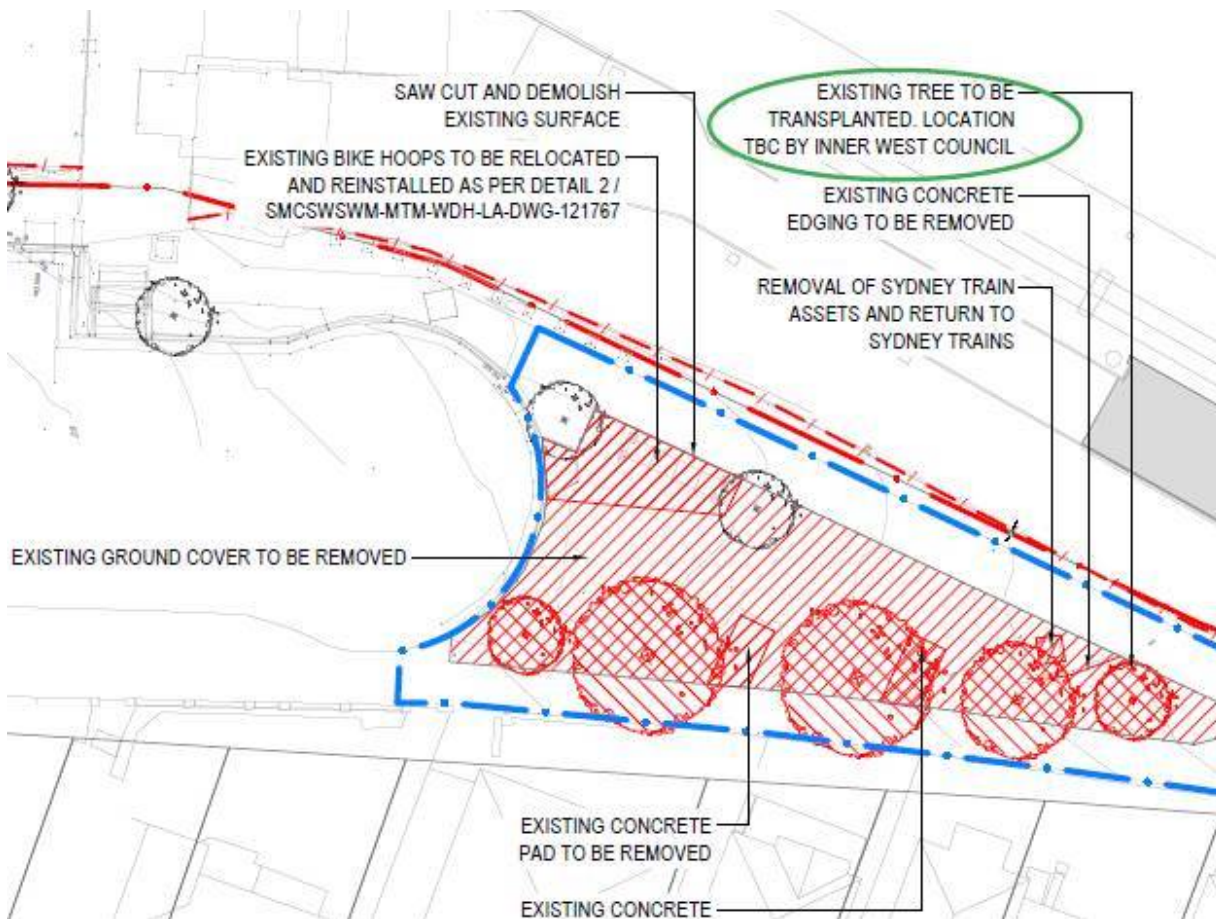
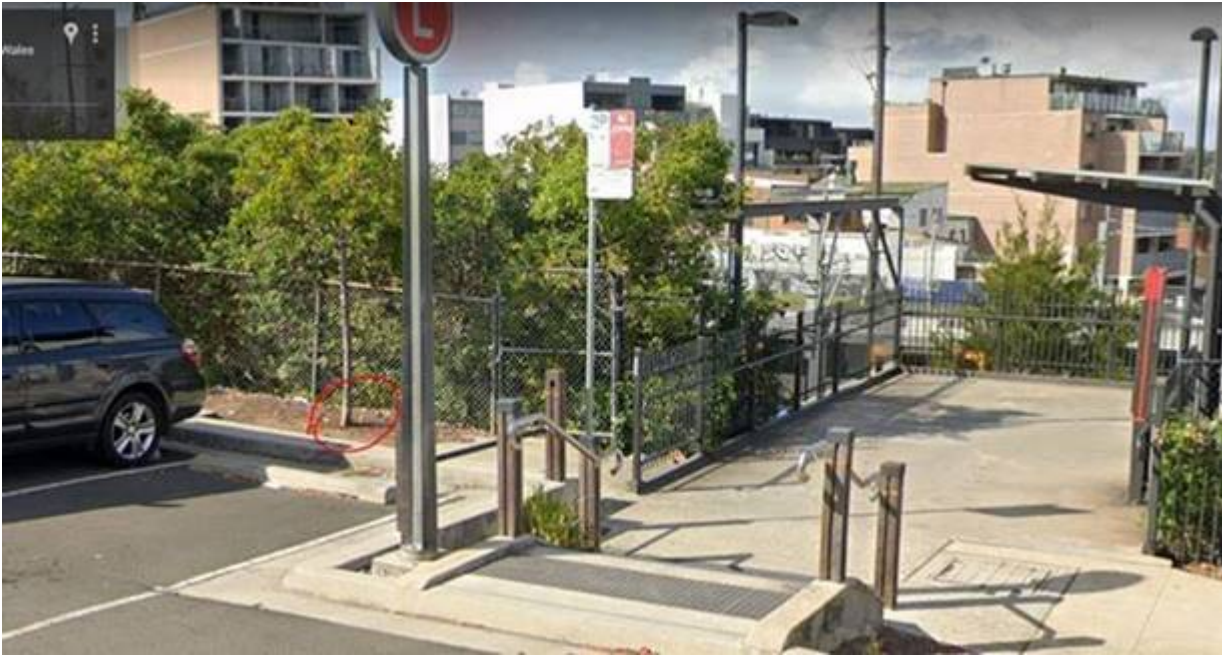
In short, the design has nominated a singular tree at Dulwich Hill Station to be relocated (see below design excerpt and street view image of tree circled in red). The tree is quite young and doesn't offer any significant value which leads me to ask whether IWC actually wish to retain the tree. Relocating the tree will pose a few logistical issues given that we (Downer) will need to remove the tree being in our PC and the transplant/ relocation works would need to be undertaken by IW Council given that the new location is likely to be outside of the project boundary.

The alternative to transplanting is for the project to remove the tree along with the remaining vegetation (separate tree clearance request) and add to the project tree offset planting. I believe this would be the most favourable option for both parties, however am seeking initial input from Inner West Council.

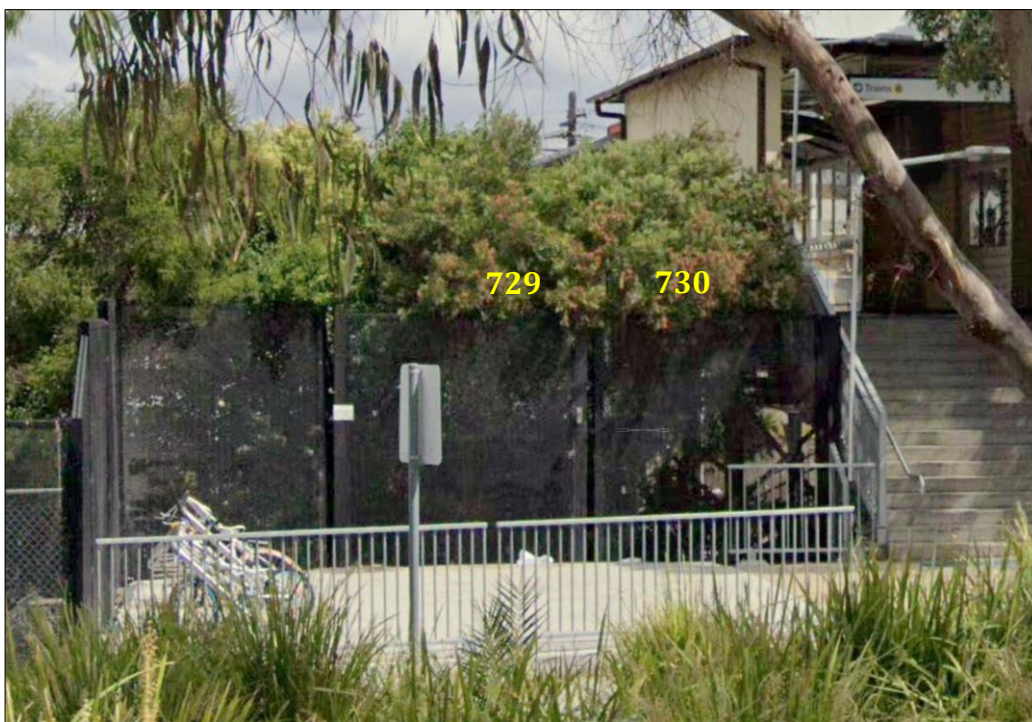
The trees are considered to be in good health and condition and provide minor screening of the rail corridor from the area adjacent the station entry. They are

Image 2: Trees 729 and 730 are to be removed to accommodate the lift shaft works.

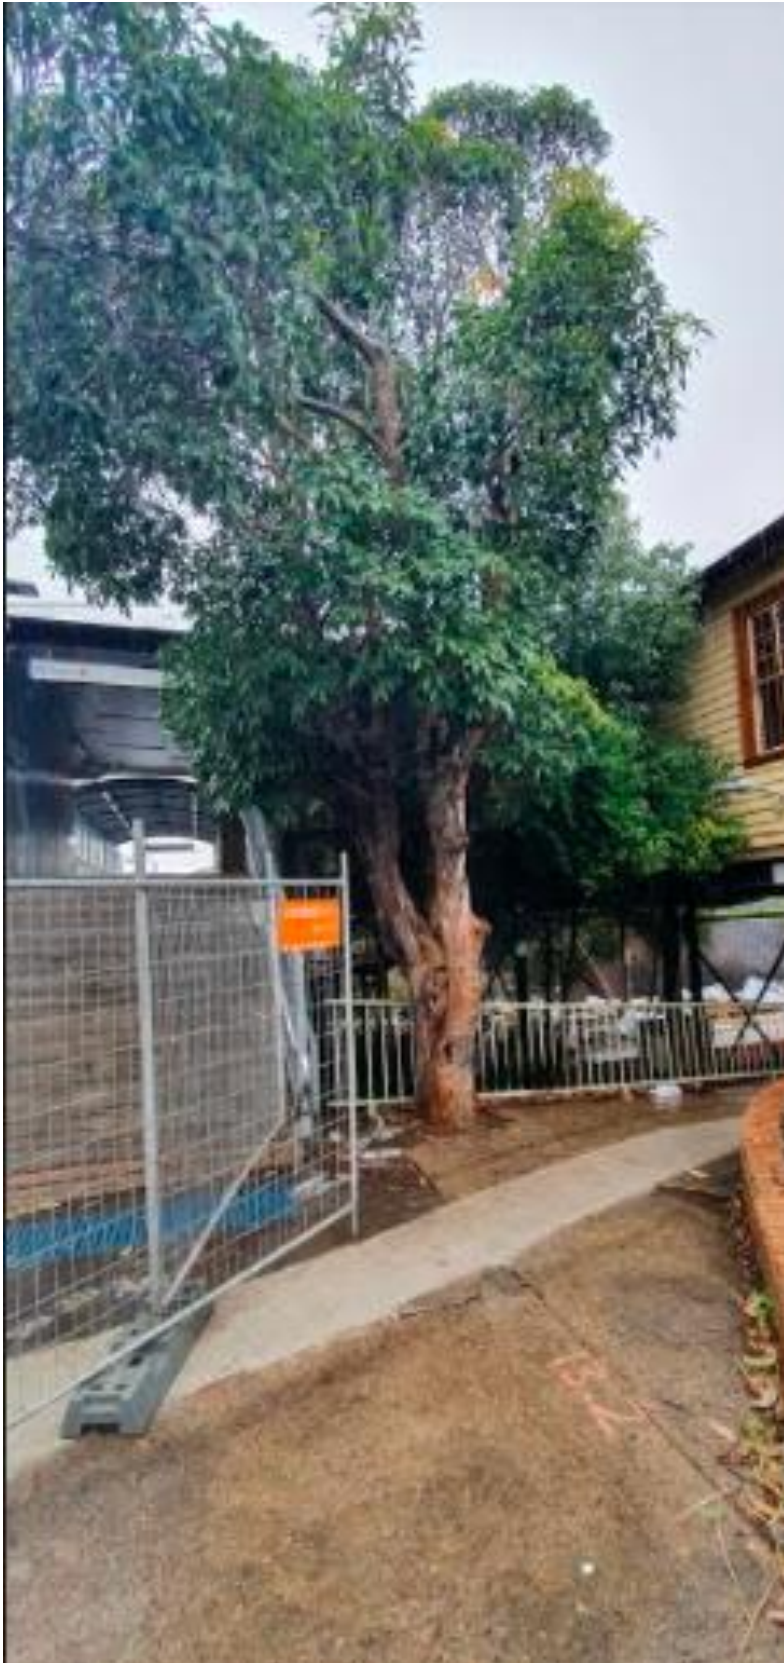
Image of the subject tree taken on the 29th June 2021.

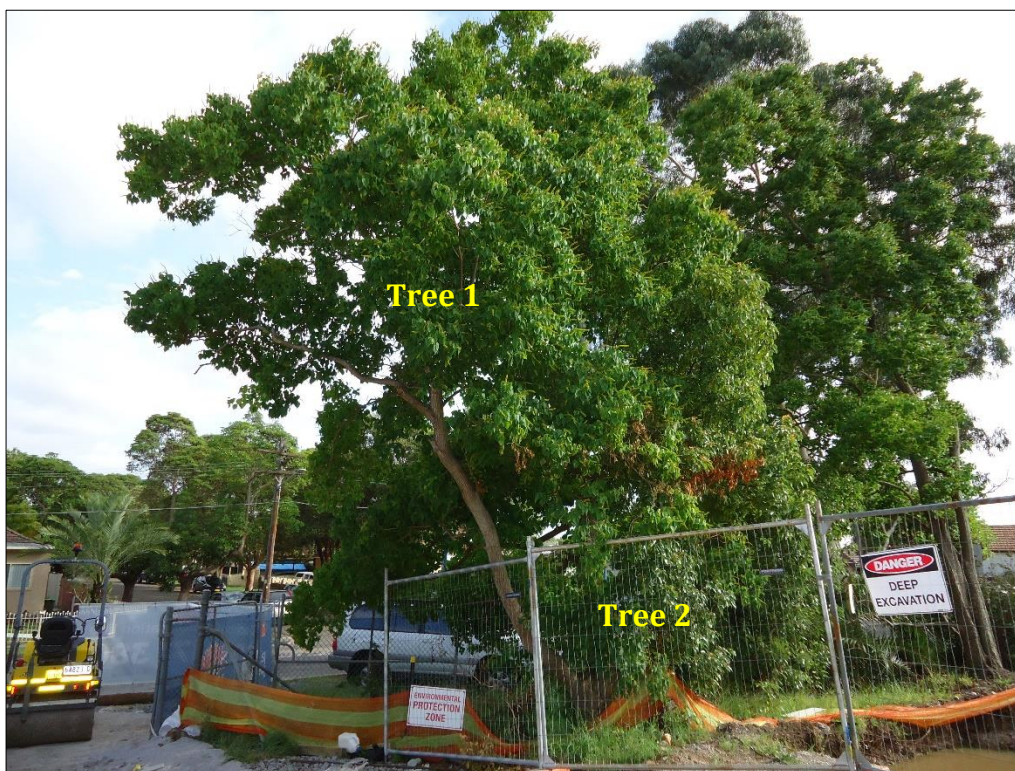
Photograph 1: The subject trees as seen from within the rail corridor. Tree 1 *Sapium sebiferum* (Chinese Tallowwood), tree 2 *Cinnamomum camphora* (Camphor Laurel).

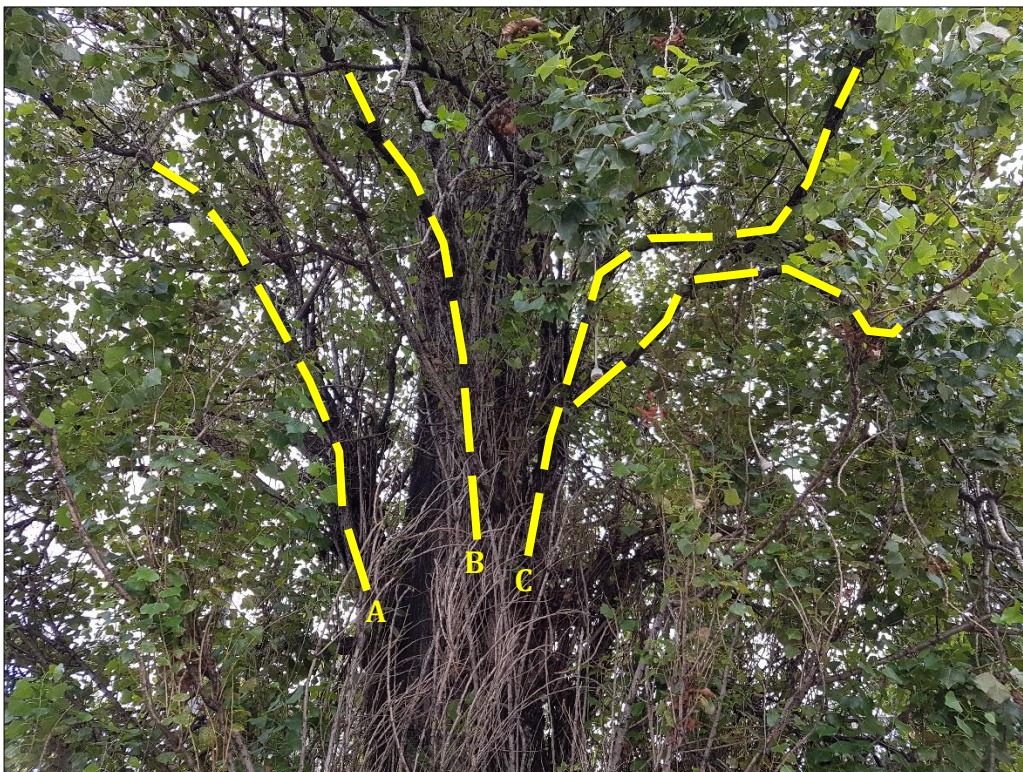
Photograph 2: Branches A, B and C identified for removal.

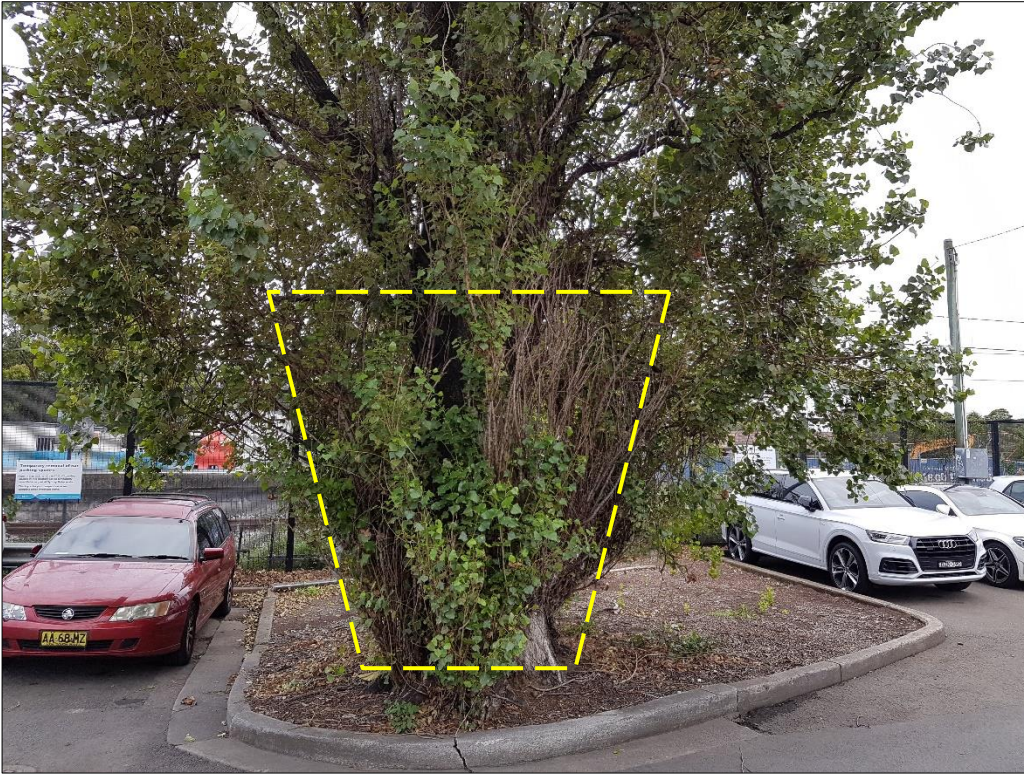
Photograph 3: Multiple epicormic shoots originating from the base of the trunk are to be removed.
