Tree Impact Assessment Report

City and Southwest Metro Station Upgrade Works Package 5 & 6

P5 Document No. SMCSWSW5-DEW-WEC-EM-REP-000542

P6 Document No. SMCSWSW6-DEW-WEC-EM-REP-000632

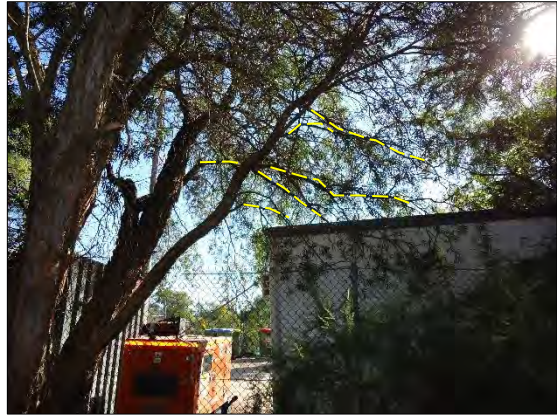
Photograph 5: Tree 4 *Callistemon slaignus* (Weeping Bottlebrush) to be selectively pruned to clear site sheds.

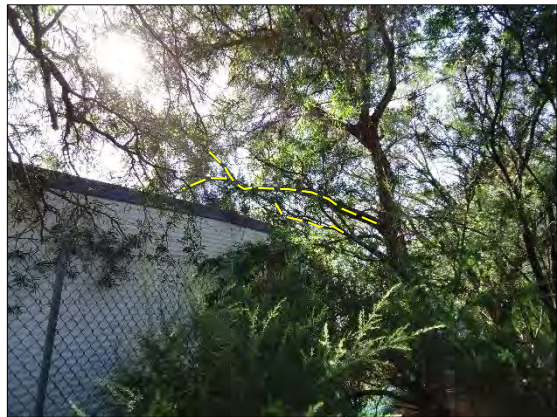
Photograph 6: Tree 5 *Leptospermum petersonii* (Lemon-scented Tee Tree) to be selectively pruned to clear site sheds.

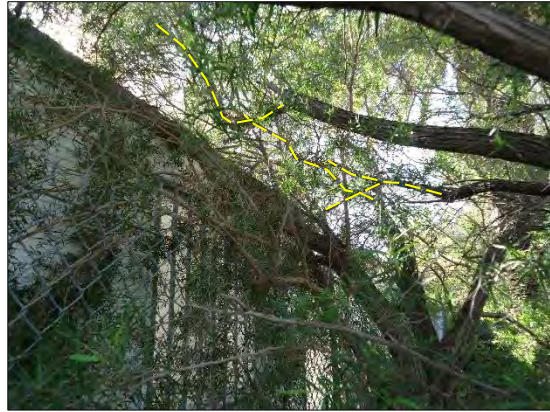
Photograph 9: Tree 8 *Leptospermum petersonii* (Lemon-scented Tee Tree) to be selectively pruned to clear site sheds.

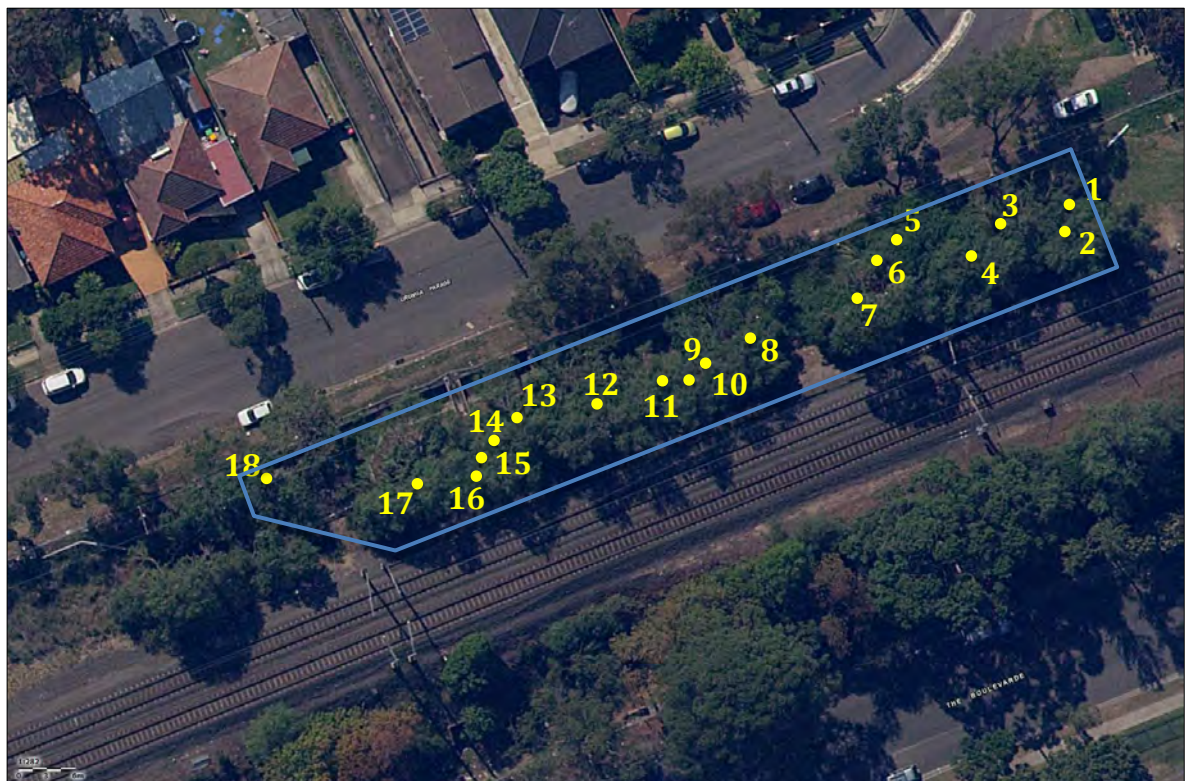
The additional tree removals where there is a direct design clash and 100% encroachment into the TPZ and SRZ consist of seventeen *Schinus molle* (Peppercorn Tree), one *Eucalyptus scoparia* (Wallangarra White Gum) which constitute the significant trees within the site. Understorey plants totaling sixty-two individual specimens were also identified. All trees are located along the rail embankment adjacent Urunga Parade. Image 1 shows the area of assessment and approximate locations of significant trees (trees 1-18). The Peppercorn trees are typically arranged in a line suggesting a landscape planting. The Wallangarra White Gum is likely to be a self-seeded specimen.

Image 1: Aerial image showing the proposed vegetation clearance area (blue outline) and approximate locations of significant trees (1 to 18).

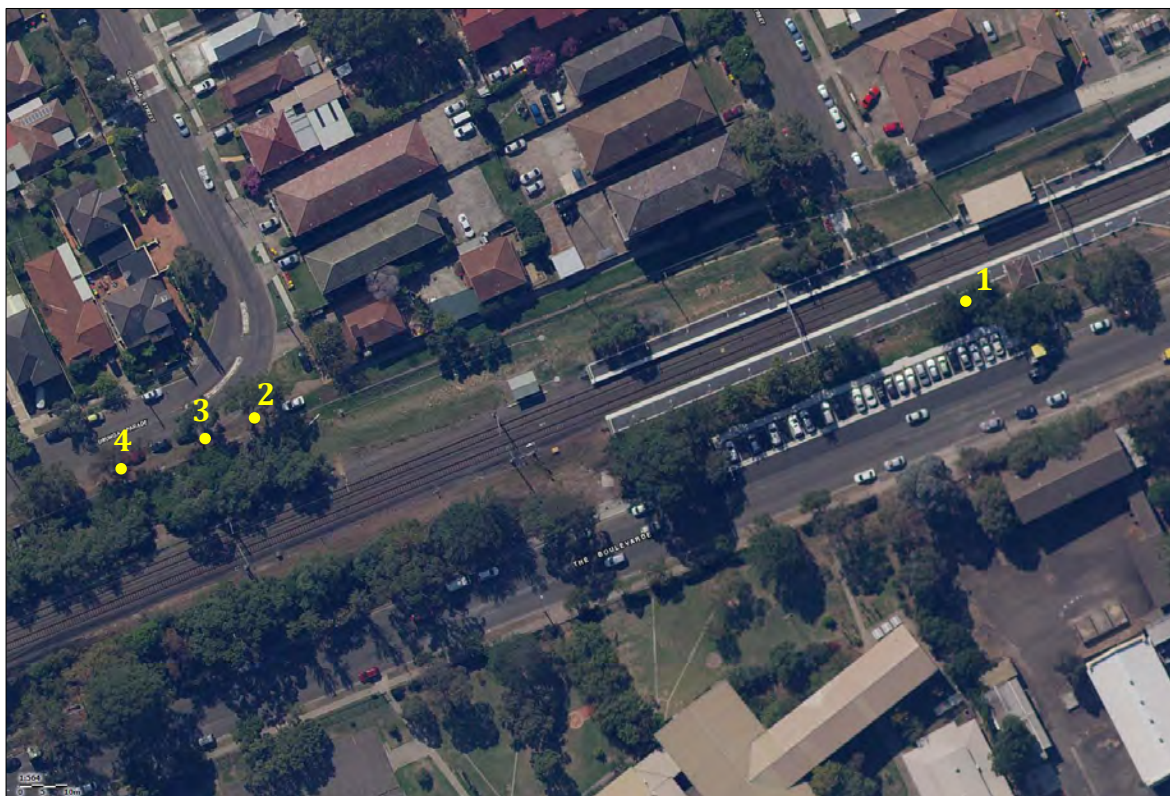
The Wallangarra White Gum (tree 4) is listed as Endangered under the Biodiversity Conservation Act 2016 and Vulnerable under the Environmental Protection Biodiversity Conservation Act 1999. However, the subject specimen is located outside of its naturally occurring range and appears to have been planted as part of the streetscape.

Image 1: Aerial image of Wiley Park Station Station showing the location of additional trees to be removed.

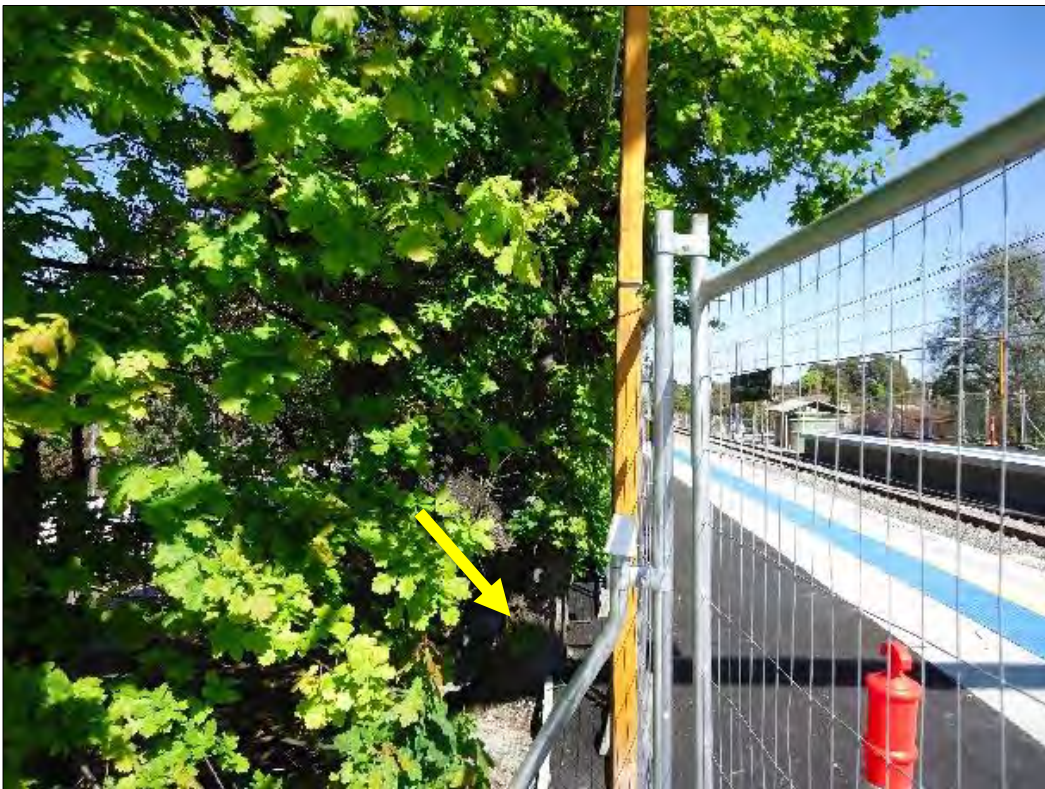
It was advised that the tree is located within the direct alignment of a proposed platform footprint & fence to be installed along the rear of Platform 2. As such, the tree cannot be retained under the current design. Its removal is not thought to pose a significant impact upon local amenity when taking into consideration the wider station upgrade works. Replacement planting with advanced tree stock is to be undertaken to offset the tree removals.

Photograph 2: The position of tree 711 with regards to the alignment of Platform 2 and proposed fence.

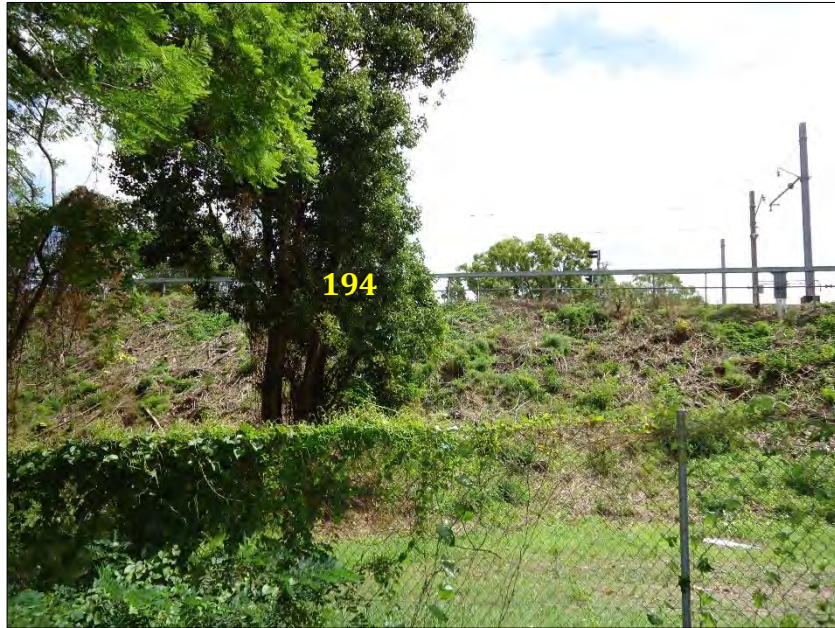
Additional tree removals were identified within the rail corridor associated with the construction of the Metro Services Building. A concrete pad is to be relocated from adjacent trees 166 and 167 to overlay the position of tree 194 *Cinnamomum camphora* (Camphor Laurel) requiring its removal. The tree has been identified for removal on demolition documentation viewed during the on-site inspection. Image 4 shows the tree.

Image 4: Tree 194 as identified within the AIA report shall require removal to accommodate the relocation of the concrete pad. Note the rail embankment to the rear of the tree has been cleared of woody vegetation.

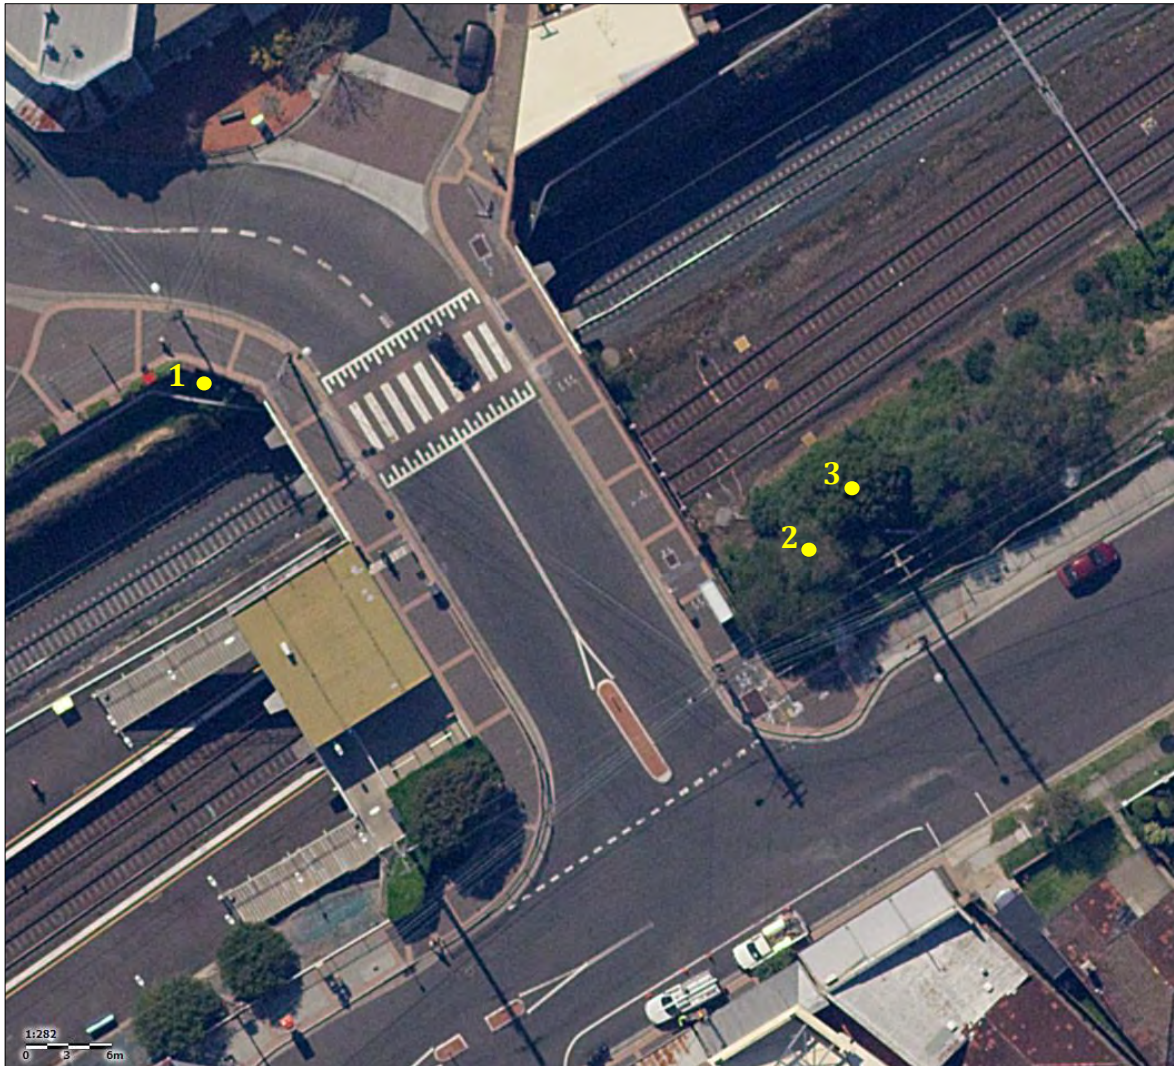
Image 1: Aerial image of Hurlstone Park Station showing the location of additional tree and vegetation removal. (Source Six Maps accessed 23/08/2021).
