Tree Impact Assessment Report

City and Southwest Metro Station Upgrade Works Package 5 & 6

**Project wide: Hurlstone Park, Wiley Park, Belmore,
Campsie, Dulwich Hill and Punchbowl**

P5 Document No. SMCSWSW5-DEW-WEC-EM-REP-000542

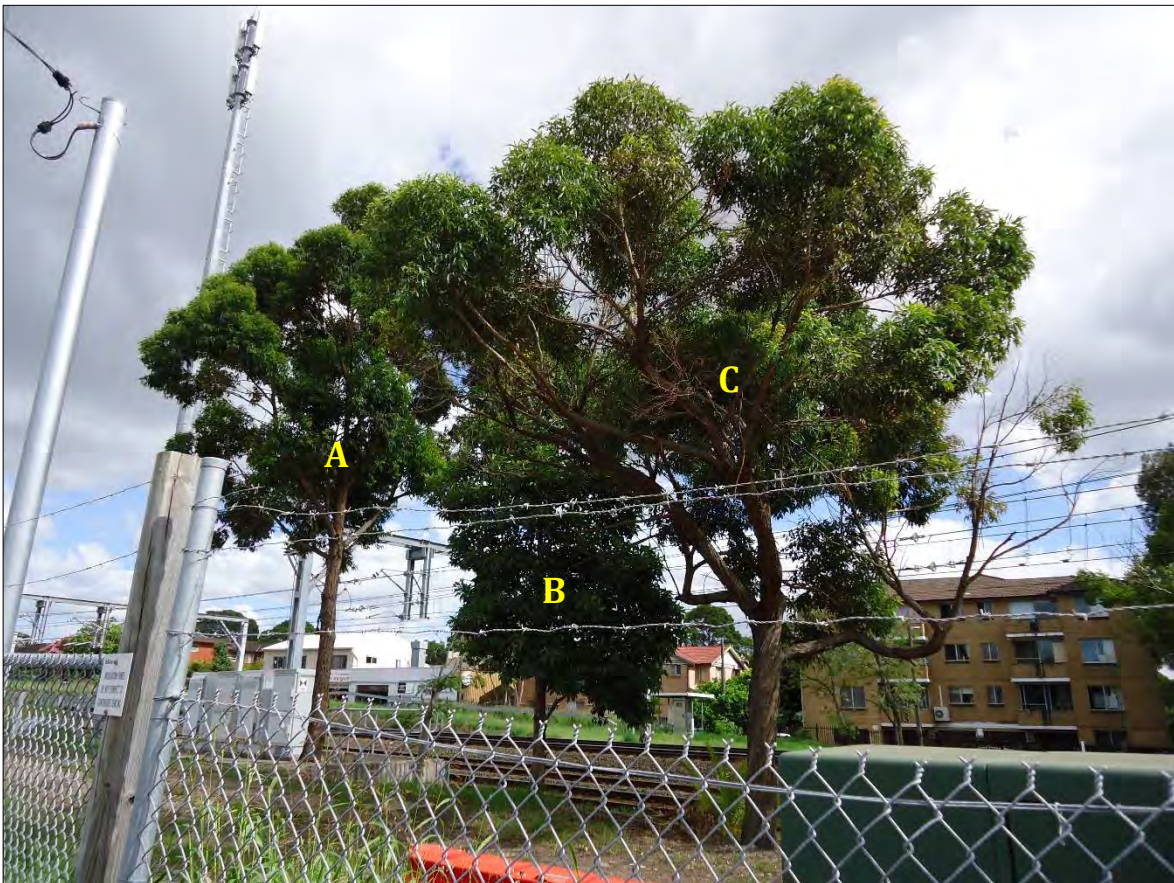
Trees A, Tallowwood and B Brush Box were found to be in good health and condition. They are considered to have a medium useful life expectancy and landscape significance. Tree C Tallowwood was found to have normal vigour and fair condition. Deadwood and canopy dieback was observed within the tree indicating a possible decline in health and condition. As such the tree is considered to have a short useful life expectancy. Image 2 shows the subject trees. The trees provide some screening and relief from the rail corridor and associated infrastructure along Lillian Street.

Image 2: The three additional trees identified for removal as part of the Southwest Metro Package works.

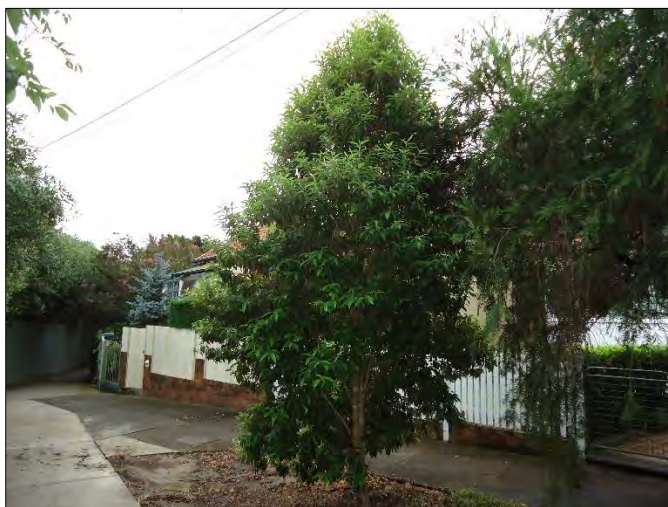
Photograph 3: Tree 3 *Backhousia citriodora* (Lemon-scented Myrtle). Tree is to be transplanted on the site.

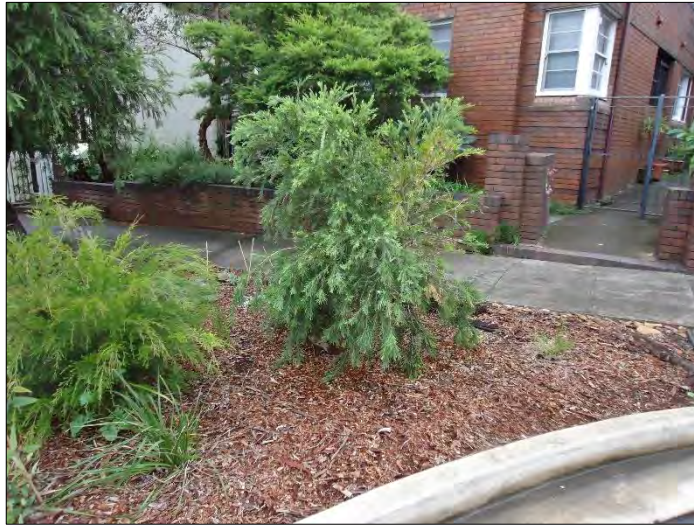
Photograph 7: Tree 7 *Calistemon viminalis* (Bottlebrush) to be removed. Does not meet the criteria for being a tree under *Sydney Metro City & Southwest Sydenham to Bankstown Instrument of Approval* due to height. Currently considered a sapling.

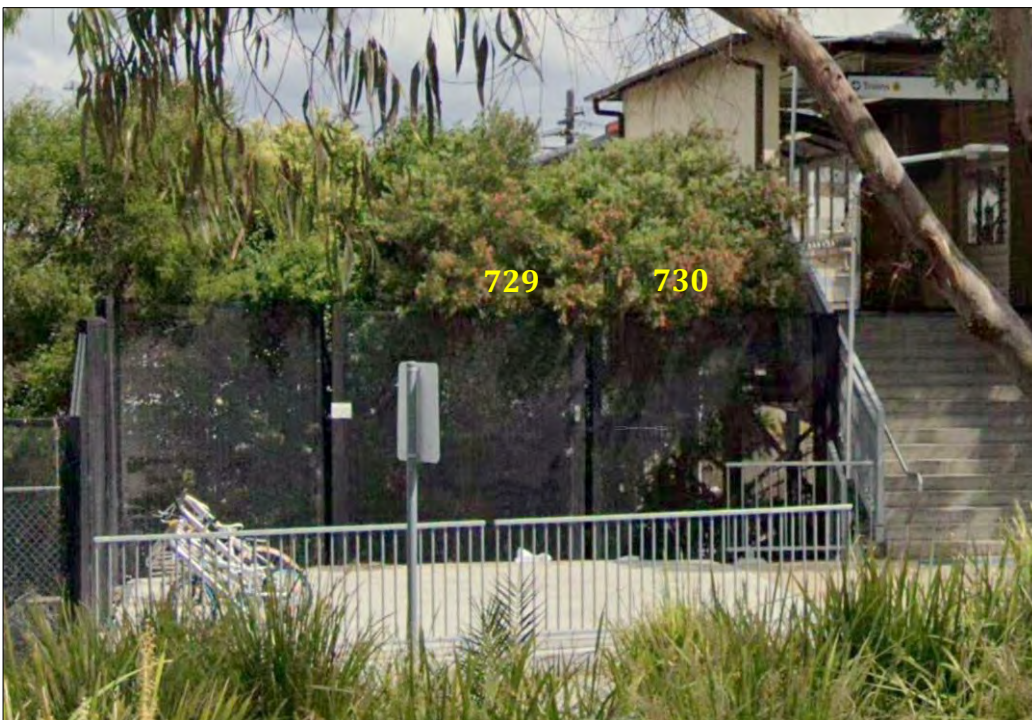
The trees are considered to be in good health and condition and provide minor screening of the rail corridor from the area adjacent the station entry. They are

Image 2: Trees 729 and 730 are to be removed to accommodate the lift shaft works.

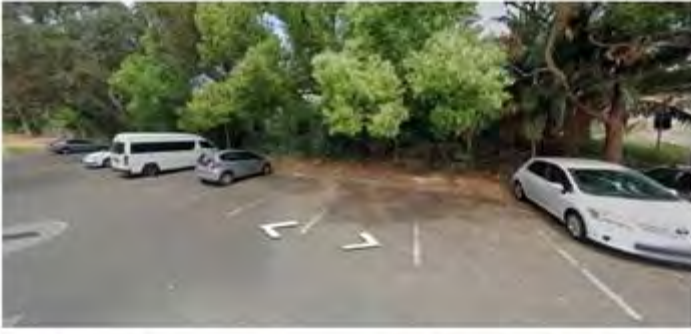
Figure 1: Street view of the subject trees taken from Urunga Parade, Punchbowl (neommap 2021).
