Tree Impact Assessment Report

City and Southwest Metro Station Upgrade Works Package 5 & 6

**Project wide: Hurlstone Park, Wiley Park, Belmore,
Campsie, Dulwich Hill and Punchbowl**

P5 Document No. SMCSWSW5-DEW-WEC-EM-REP-000542

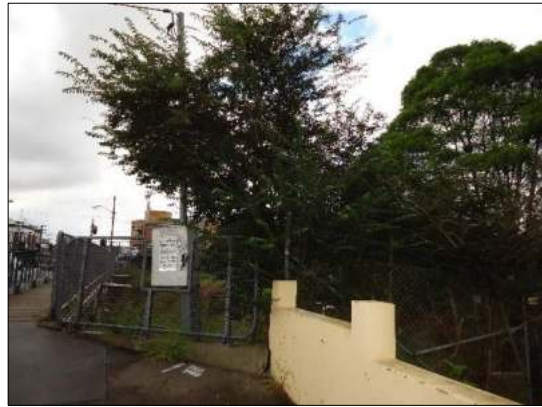
Photograph 1: Tree 1 *Ligustrum sinensis* (Small-leafed Privet) to be removed for pilling works adjacent rail bridge.

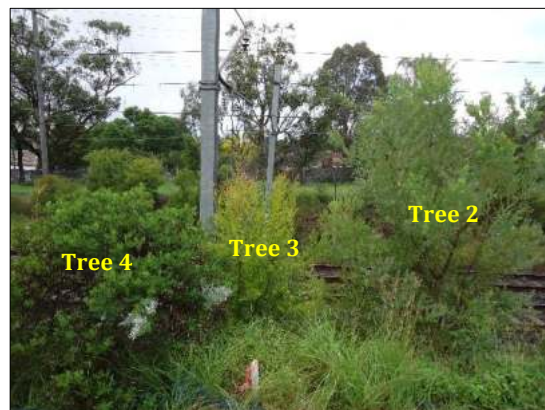
Photograph 2: Trees 2 *Acacia* sp (Wattle), 3 *Leptospermum* sp (Tee Tree) and 4 Unknown species to be removed for MSB works.

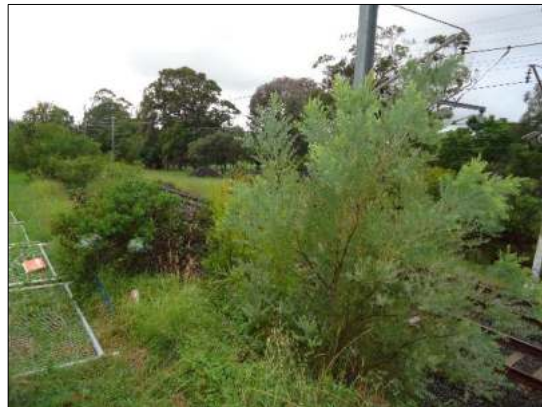
Photograph 3: Tree 5 *Acacia* sp (Wattle) to be selectively pruned for clearance along the embankment.

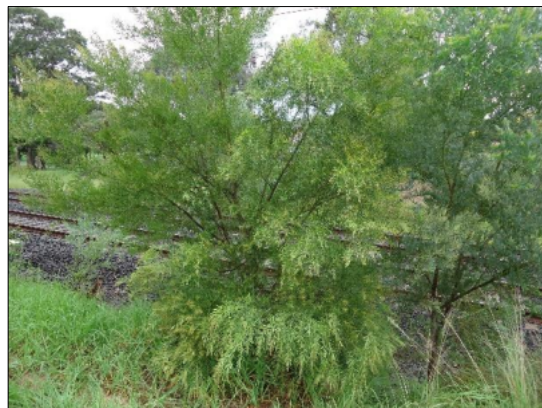
Photograph 4: Tree 6 *Acacia* sp (Wattle) to be removed for MSB works.

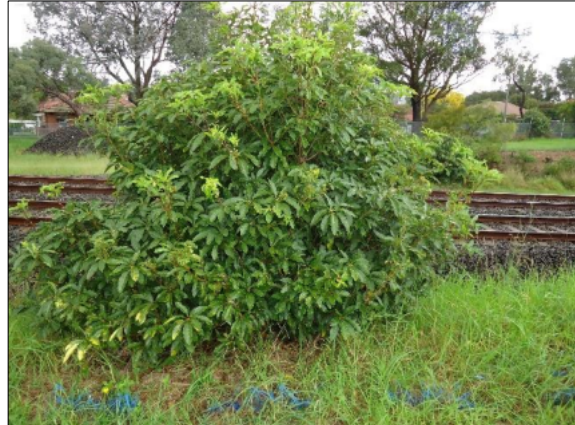
Photograph 7: Tree 9 *Pittorporum undulatum* (Sweet Pittosporum) to be removed for MSB works.

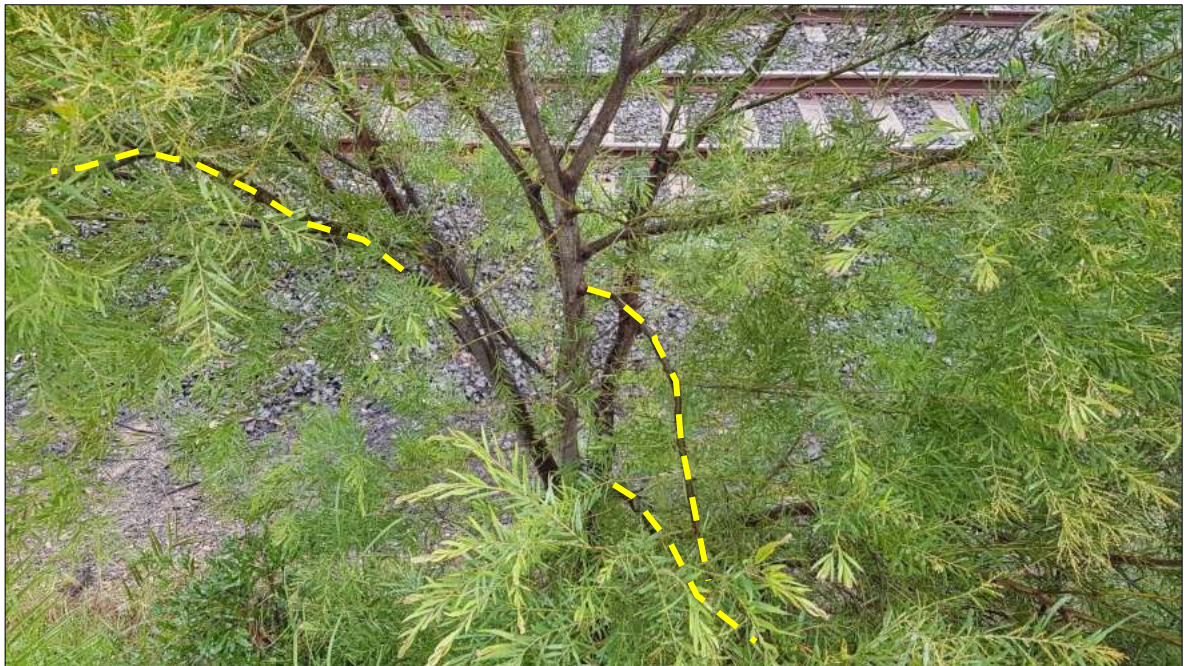
Appendix 3: Identified Selective Pruning Works

Tree 5 *Acacia* sp (Wattle) identified pruning involves the removal of approximately four branches up to 20mm in diameter and constitutes <10% of the total canopy volume. The pruning is not expected to have a significant impact upon the remaining stems.

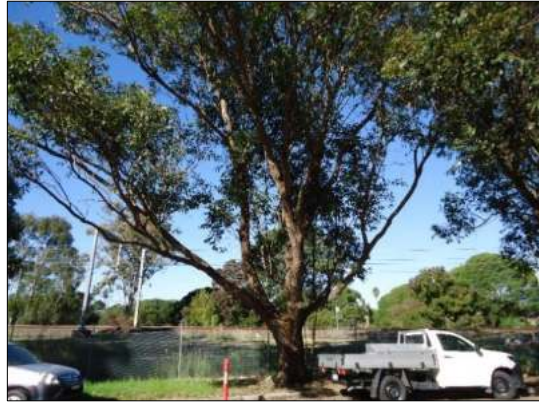
Photograph 1: Tree 1 *Eucalyptus robusta* (Swamp Mahogany) to be removed due to direct clash with permanent design access road to MSB.

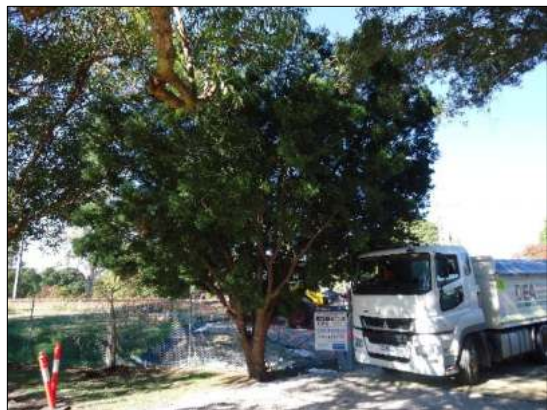
Photograph 2: Tree 2 *Podocarpus elatus* (Brown Pine) to be removed due to direct clash with permanent design access road to MSB.

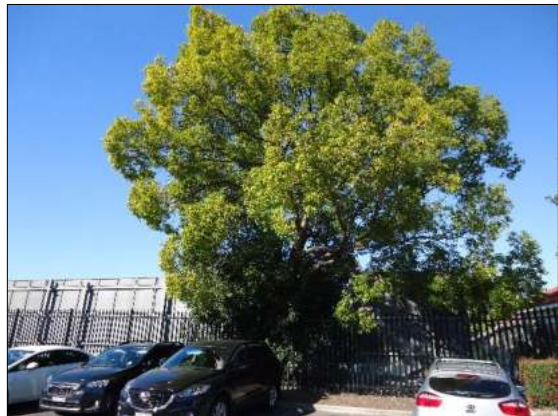
Photograph 3: Tree 3 *Cinnamomum camphora* (Camphor Laurel) within northern side of rail corridor.

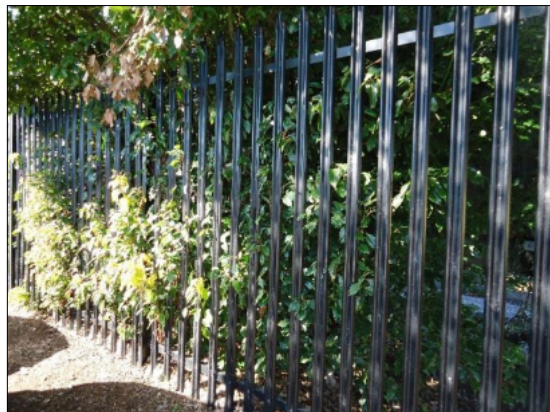
Photograph 4: Suckering around the base of tree 3 is to be removed to allow for the proposed alignment of the new GST.

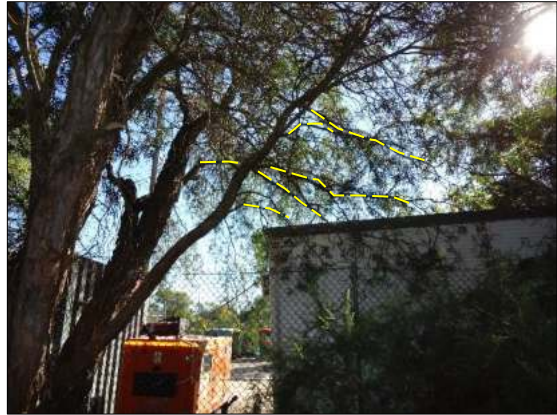
Photograph 5: Tree 4 *Callistemon slaignus* (Weeping Bottlebrush) to be selectively pruned to clear site sheds.

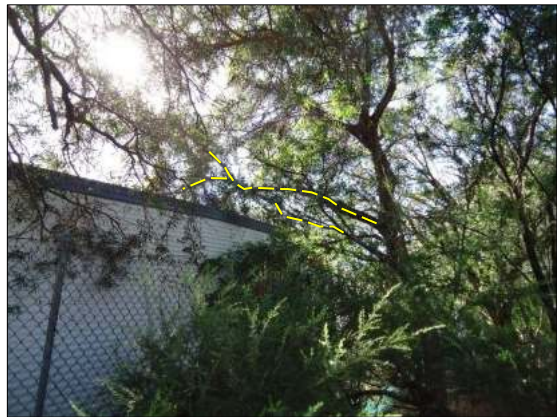
Photograph 6: Tree 5 *Leptospermum petersonii* (Lemon-scented Tee Tree) to be selectively pruned to clear site sheds.

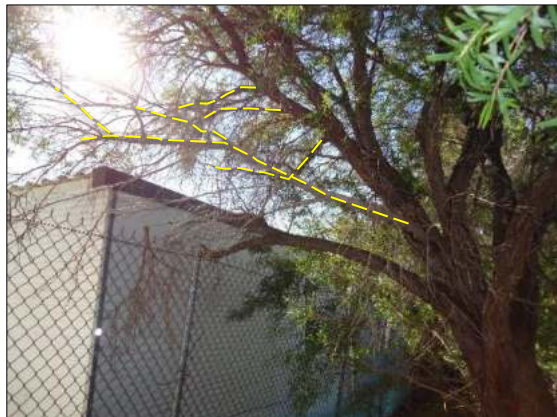
Photograph 7: Tree 6 *Leptospermum petersonii* (Lemon-scented Tee Tree) to be selectively pruned to clear site sheds.

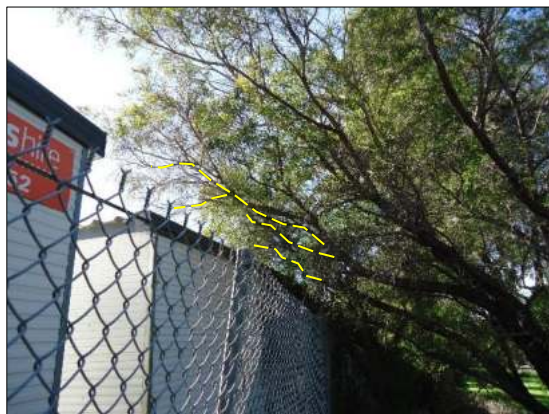
Photograph 8: Tree 7 *Leptospermum petersonii* (Lemon-scented Tee Tree) to be selectively pruned to clear site sheds. Additional pruning shall be required to provide clearances to new over head cabling.

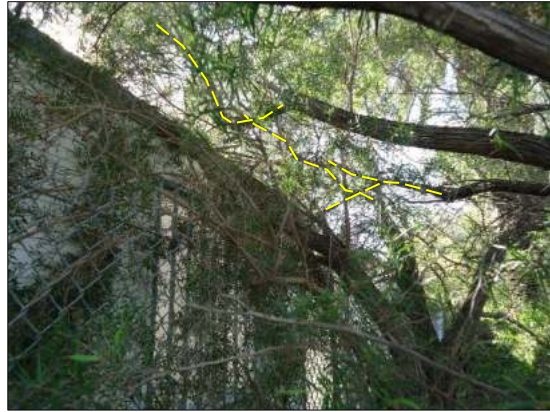
Photograph 9: Tree 8 *Leptospermum petersonii* (Lemon-scented Tee Tree) to be selectively pruned to clear site sheds.

50mm in diameter. The pruning works shall allow for the removal of the sheds upon completion of the project. Additional selective pruning works are expected to be required to tree 8 to accommodate the installation of overhead electrical services. These pruning works are to be undertaken upon installation of the new pole within the compound area to ensure correct clearance requirements are met. Only the minimal amount of pruning is to be undertaken to achieve the required outcome. Photographs 5 to 9 shows each tree to be pruned. Where possible branches have been identified for removal within the photographs.

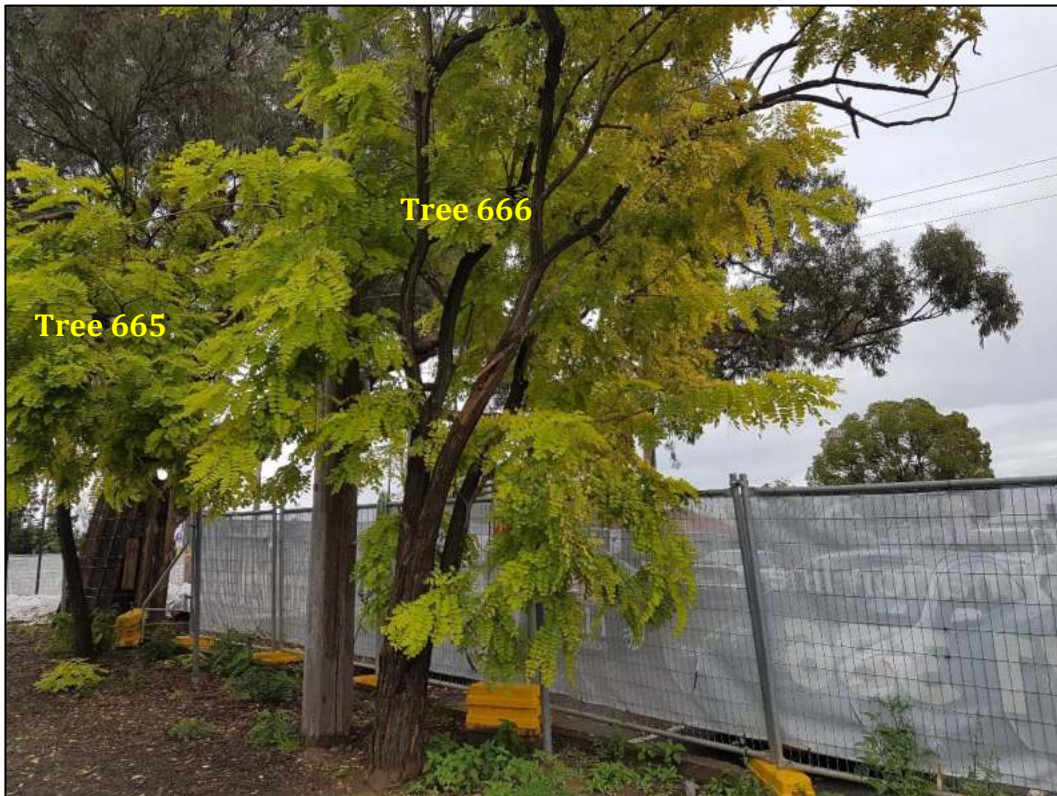
Photograph 1: Tree 665 and 666 as seen from within the site.

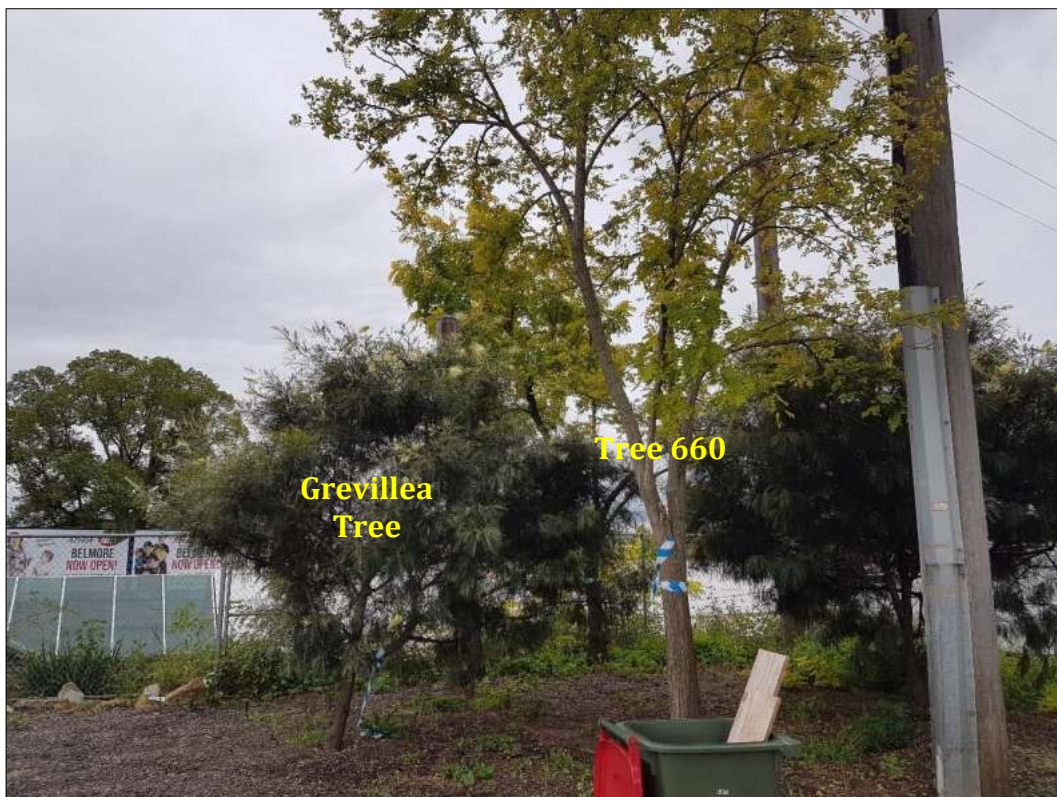
Photograph 2: Tree 660 and the Grevillea as seen from within the site.

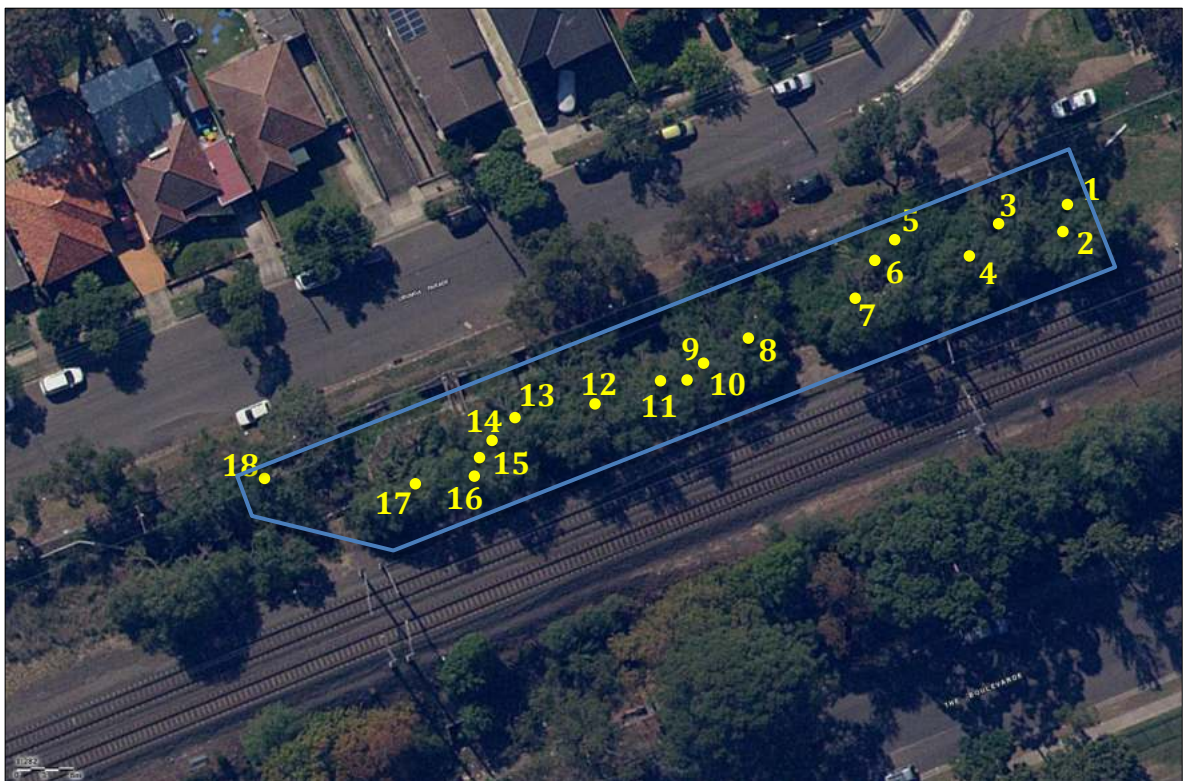
The additional tree removals where there is a direct design clash and 100% encroachment into the TPZ and SRZ consist of seventeen *Schinus molle* (Peppercorn Tree), one *Eucalyptus scoparia* (Wallangarra White Gum) which constitute the significant trees within the site. Understorey plants totaling sixty-two individual specimens were also identified. All trees are located along the rail embankment adjacent Urunga Parade. Image 1 shows the area of assessment and approximate locations of significant trees (trees 1-18). The Peppercorn trees are typically arranged in a line suggesting a landscape planting. The Wallangarra White Gum is likely to be a self-seeded specimen.

Image 1: Aerial image showing the proposed vegetation clearance area (blue outline) and approximate locations of significant trees (1 to 18).

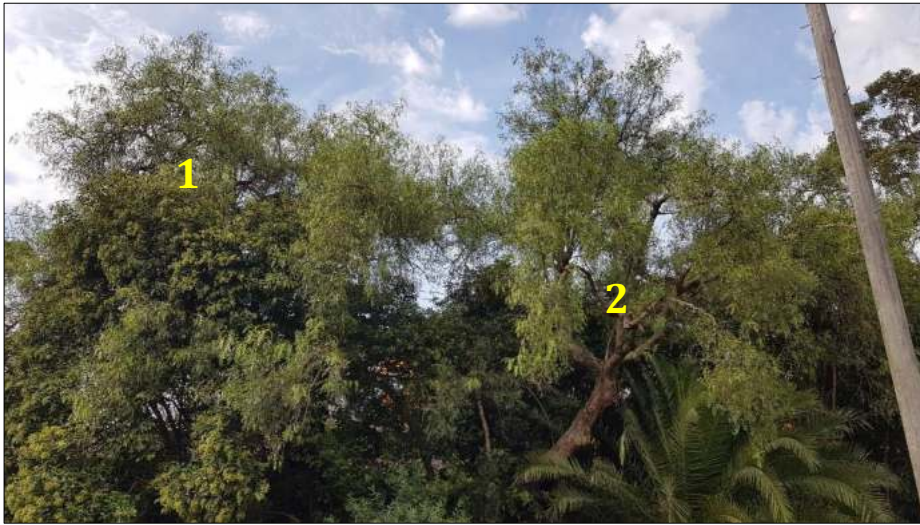
Photograph 1: Trees 1 and 2 *Schinus molle* (Peppercorn Tree) to be removed.

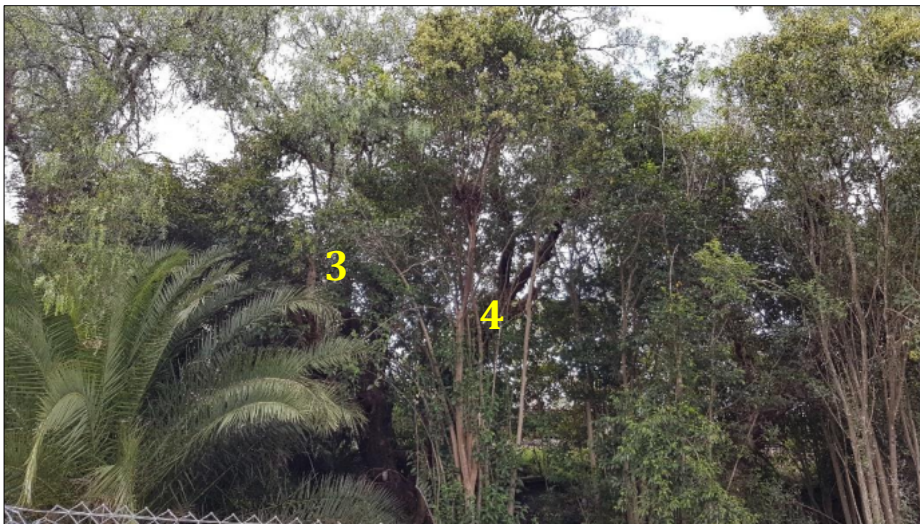
Photograph 2: Trees 3 and 4 *Schinus molle* (Peppercorn Tree) to be removed.

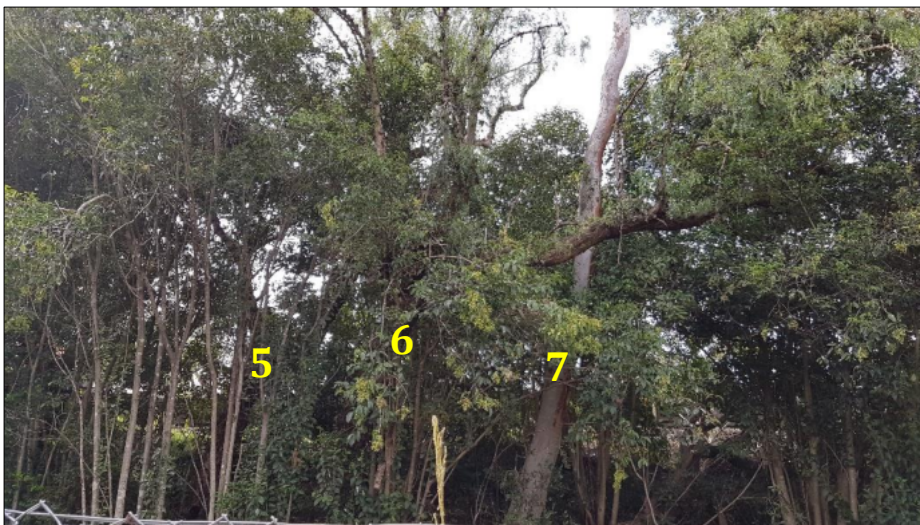
Photograph 3: Trees 5, 6 and 7 *Schinus molle* (Peppercorn Tree) to be removed.

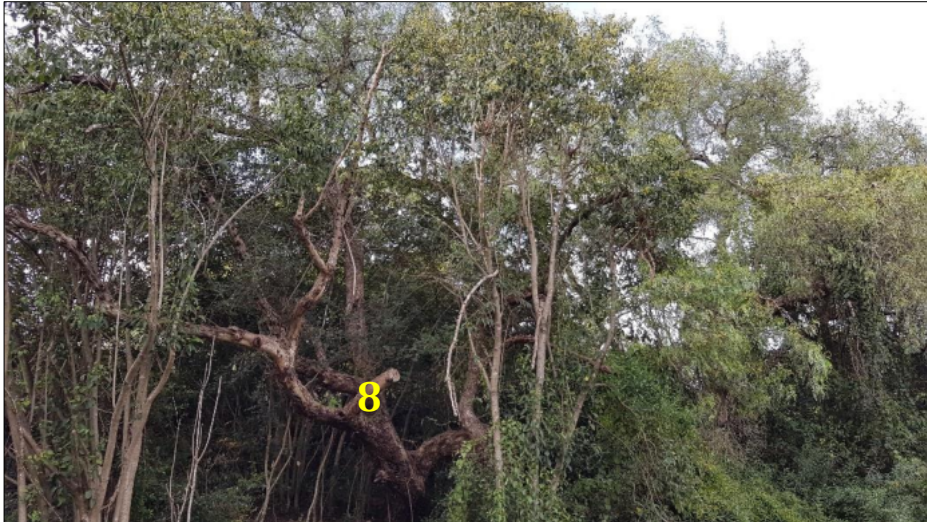
Photograph 4: Tree 8 *Schinus molle* (Peppercorn Tree) to be removed.

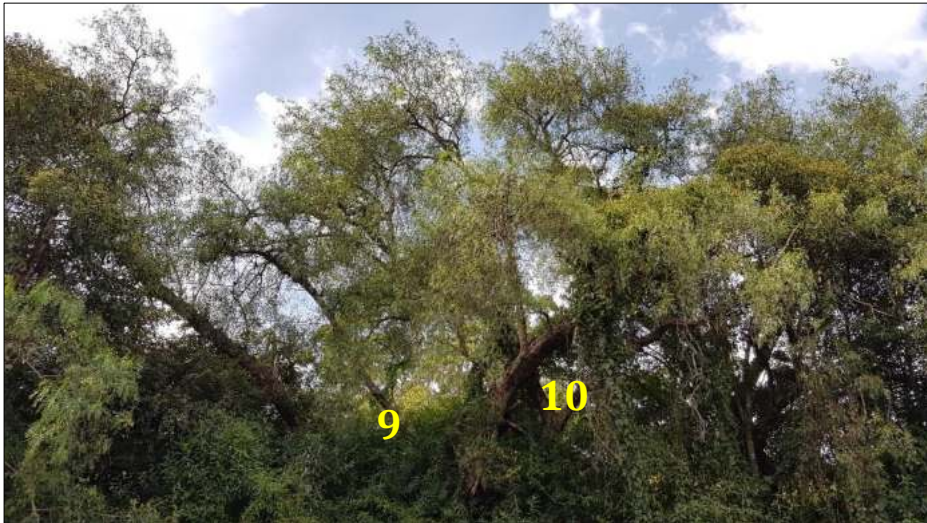
Photograph 5: Trees 9 and 10 *Schinus molle* (Peppercorn Tree) to be removed.

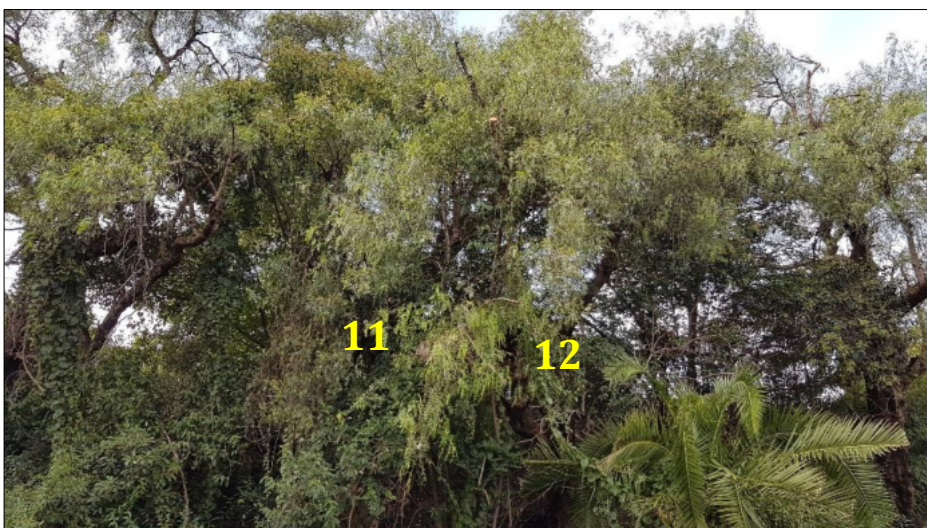
Photograph 6: Trees 11 and 12 *Schinus molle* (Peppercorn Tree) to be removed.

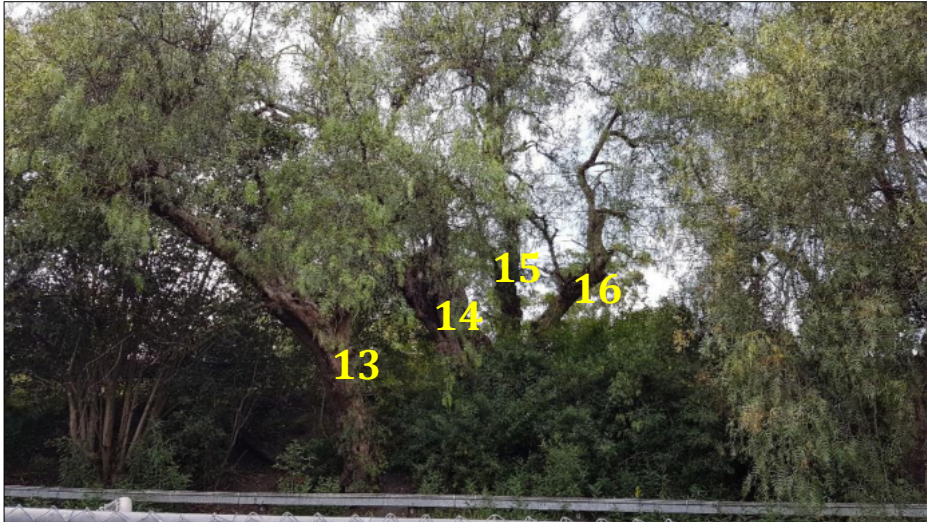
Photograph 7: Trees 13, 14, 15 and 16 *Schinus molle* (Peppercorn Tree) to be removed.

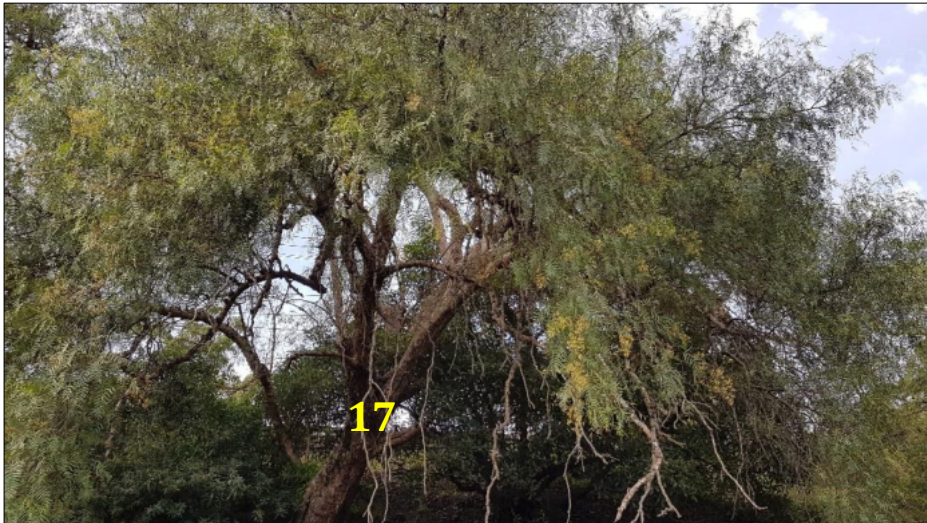
Photograph 8: Tree 17 *Schinus molle* (Peppercorn Tree) to be removed.

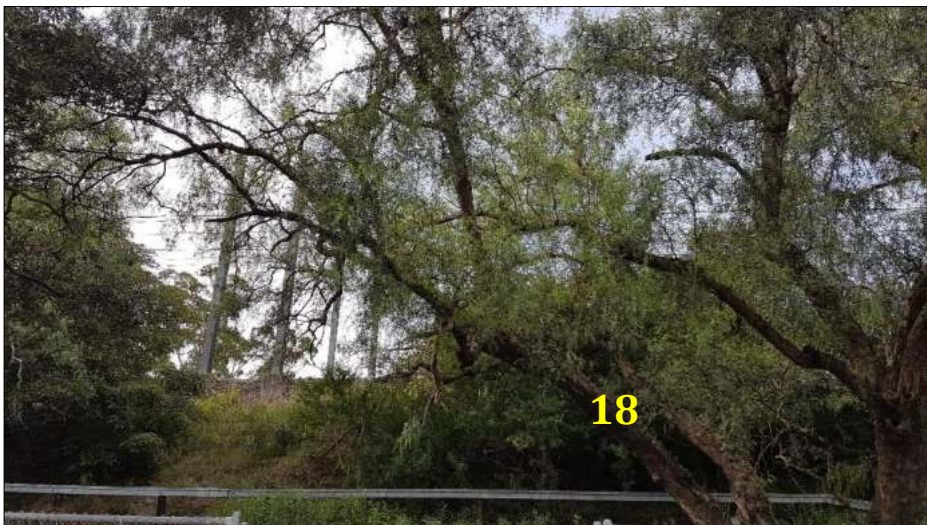
Photograph 9: Tree 18 *Schinus molle* (Peppercorn Tree) to be removed.

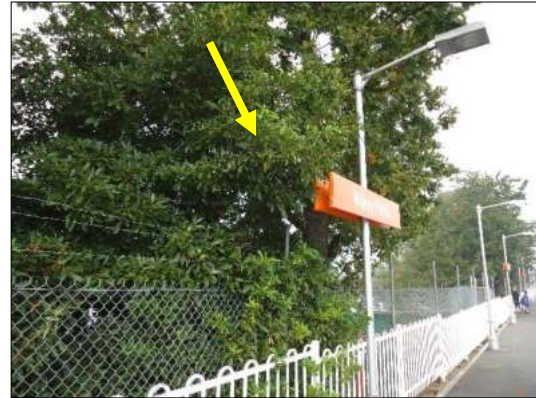
Photograph 1: Tree 1 *Pittosporum undulatum* (Sweet Pittosporum) identified for removal to accommodate Station Services Building adjacent platform 2.

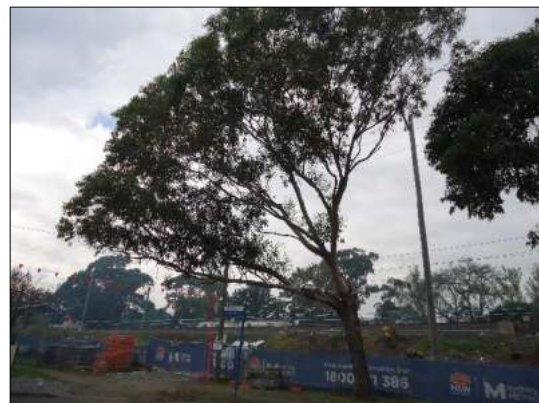
Photograph 3: Tree 3 *Eucalyptus robusta* (Swamp Mahogany) identified for removal to accommodate ULX and permanent fencing.

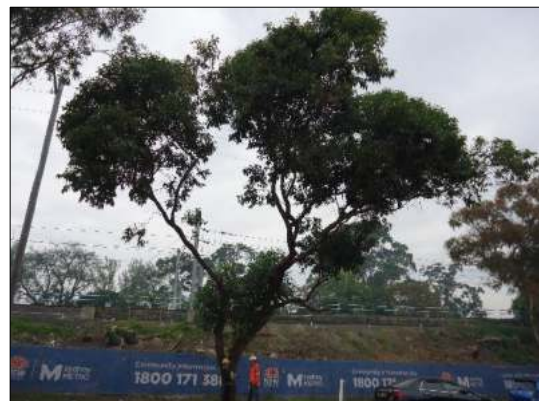
Photograph 4: Tree 4 *Eucalyptus scoparia* (Wallangarra White Gum) identified for removal to accommodate ULX and permanent fencing.

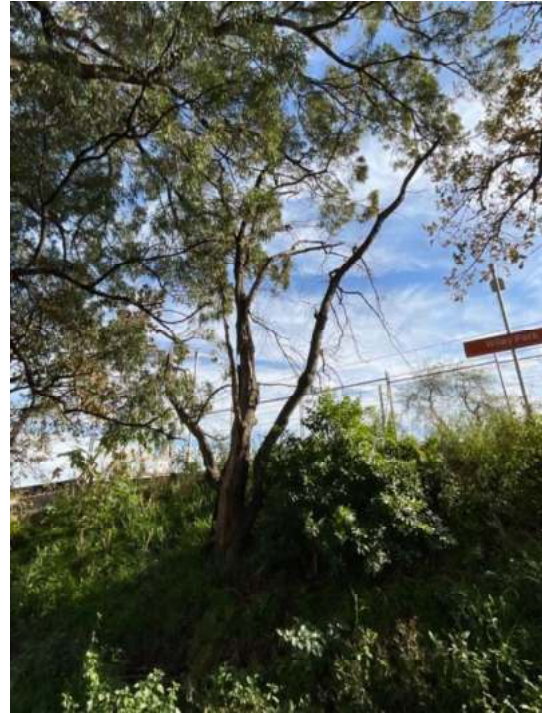
Figure 7. Tree 2 (Dead). (ArborScan, 2022)

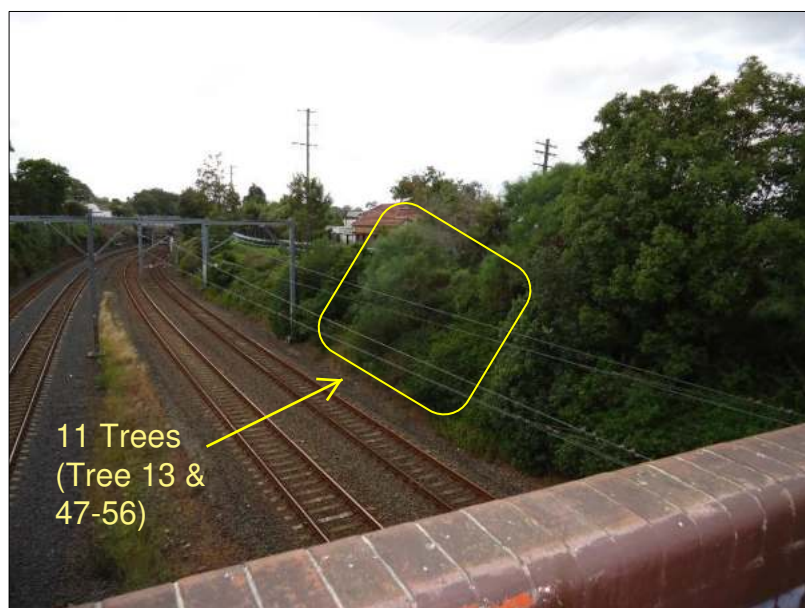
Woody vegetation located along the rail embankment was identified for removal to align the new GST. No access was gained to the rail corridor to assess the vegetation, but it has been confirmed in consultation with the project Ecologist to consist of; one *Pittosporum undulatum* (Sweet Pittosporum) tree 13, seven *Acacia saligna* (Golden Wreath Wattle) trees 47 to 53, one *Grevillea* sp (Grevillea), tree 54 and two *Yucca* sp (Yucca) trees 55 and 56. The vegetation is considered to have a short useful life expectancy and low landscape significance given its location within the rail corridor. Image 3 shows the approximate area to be cleared.

Image 3: Approximate area of woody vegetation along the rail embankment to be cleared to align the new GST.

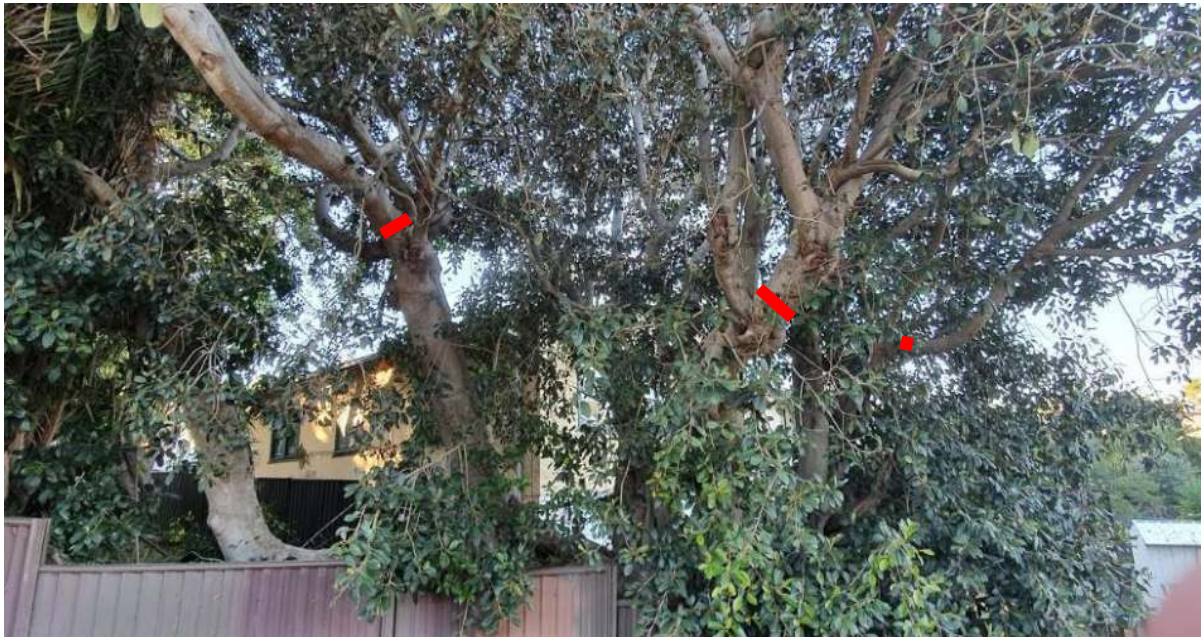
3.1 TREE 1 – MORTON BAY FIG (*FICUS MACROPHYLLA*) SEE FIGURE 2

Branch No #	Branch / Stem Height (Mts)	Branch / Stem Diameter (mm)	Branch Order	Pruning Class	Canopy Percentage
1	3	80	2 nd	7.2.4, Selective	3%
2	3	250	2 nd	7.2.4, Selective	13%
3	3.6	180	2 nd	7.2.4, Selective	7%

Figure 2: Cut locations of limbs to be pruned marked in red.

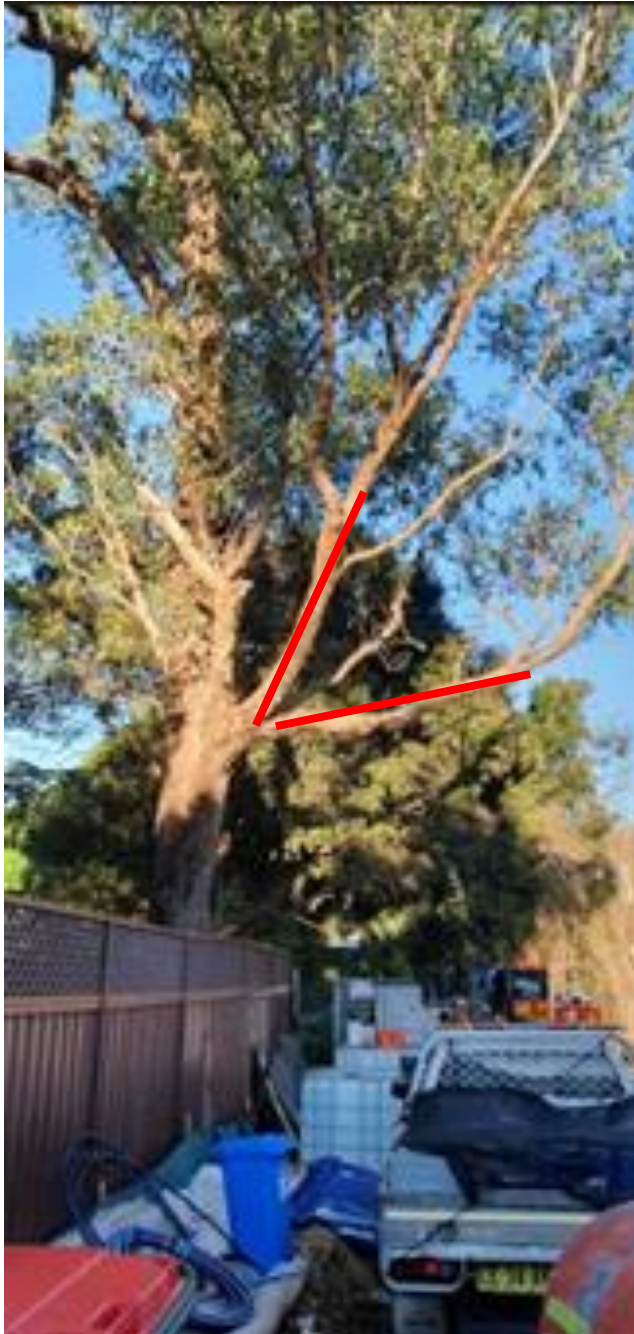
3.2 TREE 2 – GUM TREE (*UNIDENTIFIED EUCALYPTUS SP.*) SEE FIGURE 3

Branch No #	Branch / Stem Height	Branch / Stem Diameter	Branch Order	Pruning Class	Canopy Percentage
1	4.4m	180mm	2 nd	7.2.4, Selective	8%
2	4.5m	180mm	2 nd	7.2.4, Selective	9%

Figure 3: Limbs to be pruned marked in red.

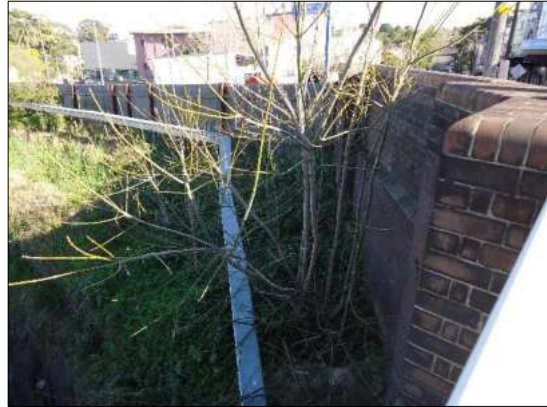
Tree 1 consists of a self-seeded multi-stemmed *Acer negundo* (Box Elder), refer Appendix 2 photograph 1. It has been assessed as having a short useful life expectancy and low landscape value. The wider Southwest Metro Package works require three 300mm diameter piles to be excavated at the location of the tree to

Photograph 1: Tree 1 *Acer negundo* (Box Elder) growing adjacent rail bridge wall on the northern side of the rail corridor.

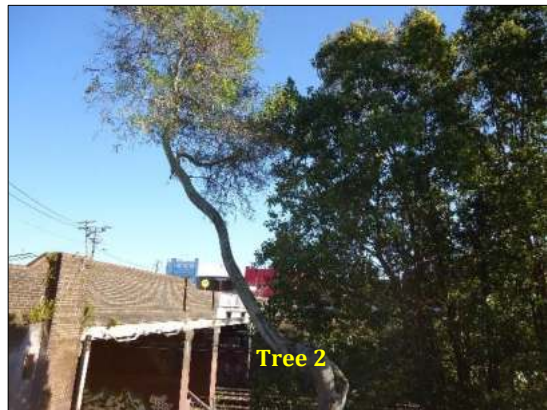
Photograph 2: Tree 2 *Acacia* sp (Wattle) growing on the southern side of the rail corridor atop of the embankment.

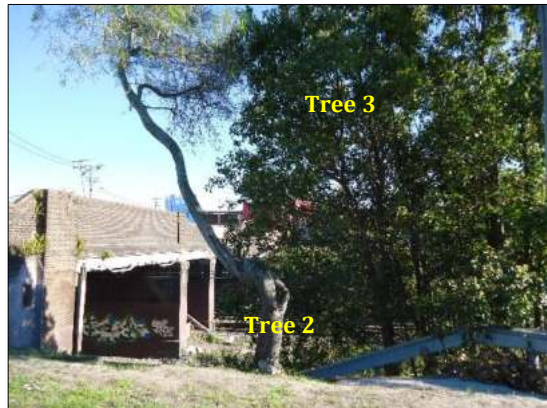
Photograph 3: Tree 3 *Cinnamomum camphora* (Camphor Laurel) growing on the southern side of the rail corridor atop of the embankment. Note the kink and cavity within the trunk of tree 2.

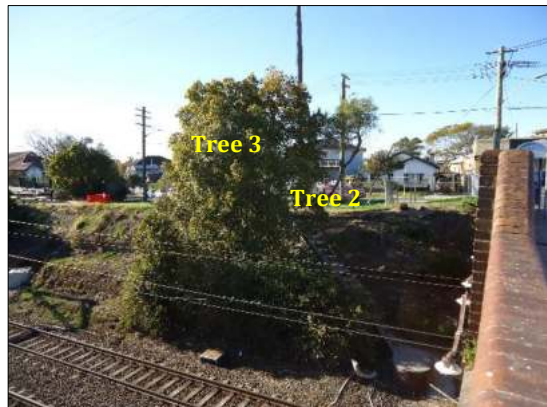
Photograph 4: Trees 2 and 3 as seen from the rail bridge.
