Tree Impact Assessment Report

City and Southwest Metro Station Upgrade Works Package 5 & 6

P5 Document No. SMCSWSW5-DEW-WEC-EM-REP-000542

P6 Document No. SMCSWSW6-DEW-WEC-EM-REP-000632

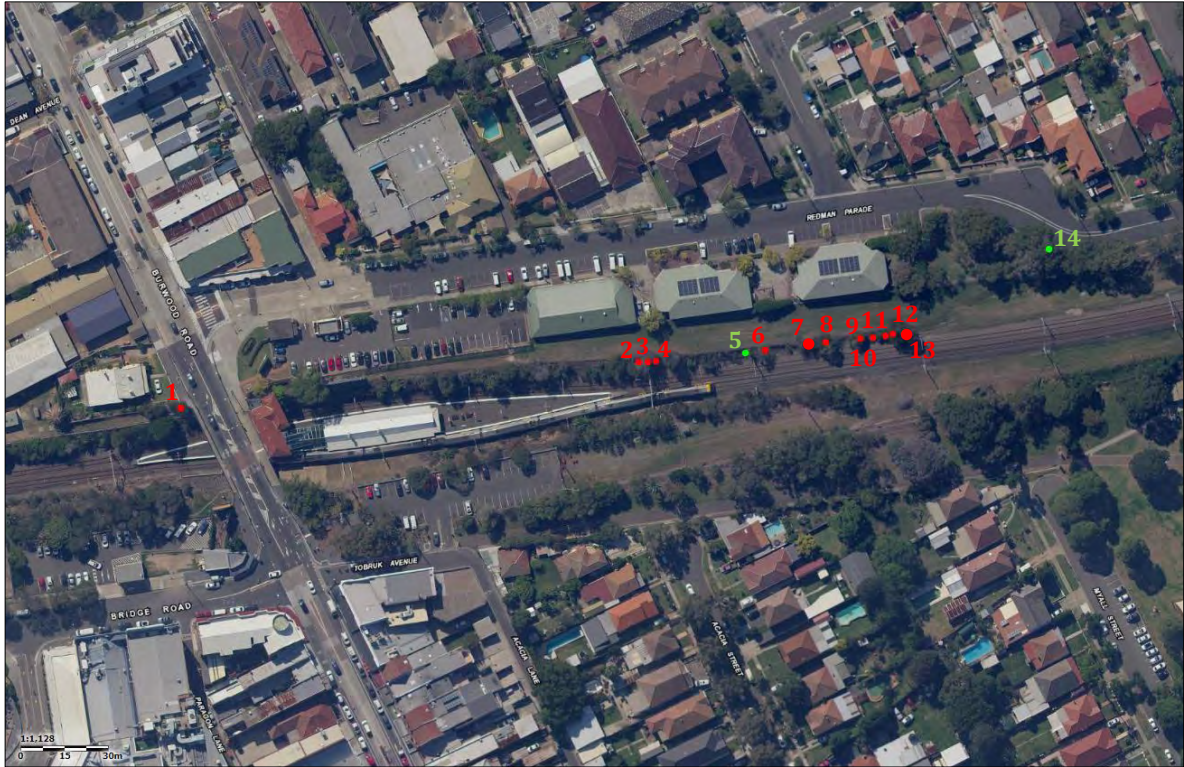
All appropriate approvals and consents are to be obtained prior to tree and vegetation removal works commencing. Given their size and location, it is felt that trees 2, 3, 4, 6, 7, 8, 9, 10, 11, 12 and 13 may be removed using an excavator without significant impact on tree 5.

Image 1: Aerial image of Belmore station showing approximate tree locations. Red dots indicate trees to be removed, green dots indicate trees to be pruned.

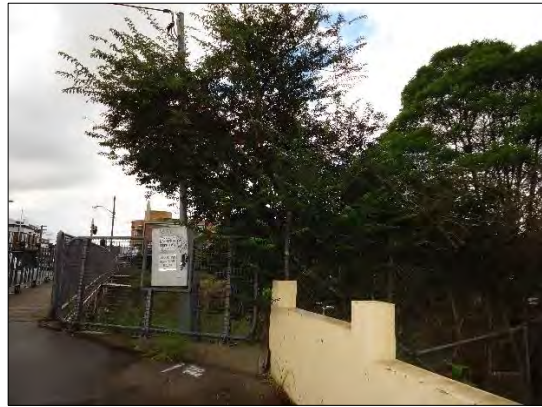
Photograph 1: Tree 1 *Ligustrum sinensis* (Small-leafed Privet) to be removed for pilling works adjacent rail bridge.

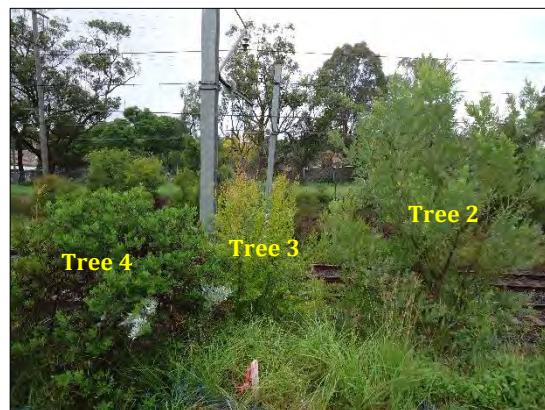
Photograph 2: Trees 2 *Acacia* sp (Wattle), 3 *Leptospermum* sp (Tee Tree) and 4 Unknown species to be removed for MSB works.

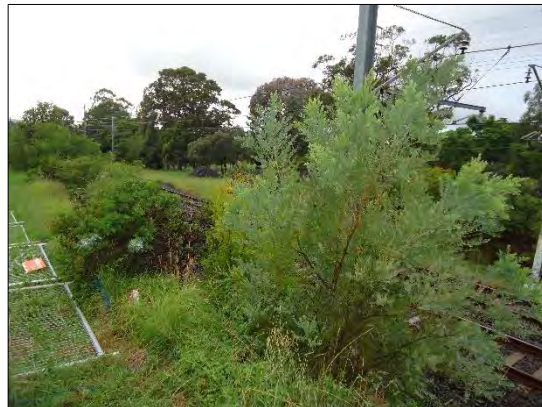
Photograph 3: Tree 5 *Acacia* sp (Wattle) to be selectively pruned for clearance along the embankment.

Tree 5 *Acacia* sp (Wattle) identified pruning involves the removal of approximately four branches up to 20mm in diameter and constitutes <10% of the total canopy volume. The pruning is not expected to have a significant impact upon the remaining stems.

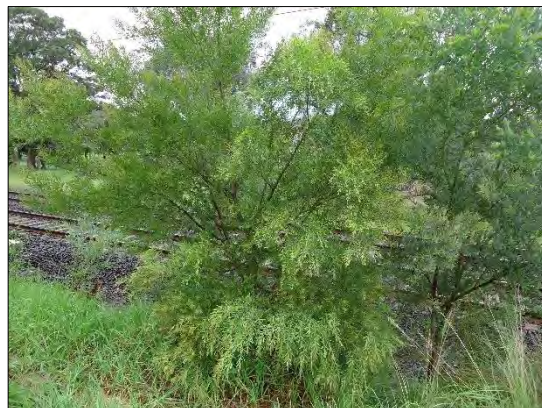
Photograph 4: Tree 6 *Acacia* sp (Wattle) to be removed for MSB works.

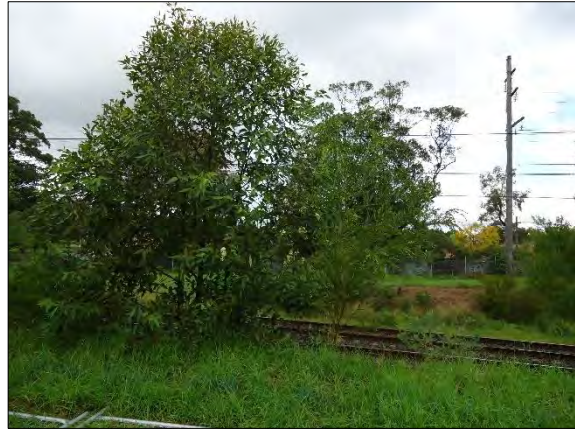
Photograph 5: Tree 7 *Eucalyptus robusta* (Swamp Mahogany) to be removed to accommodate the new GST alignment.

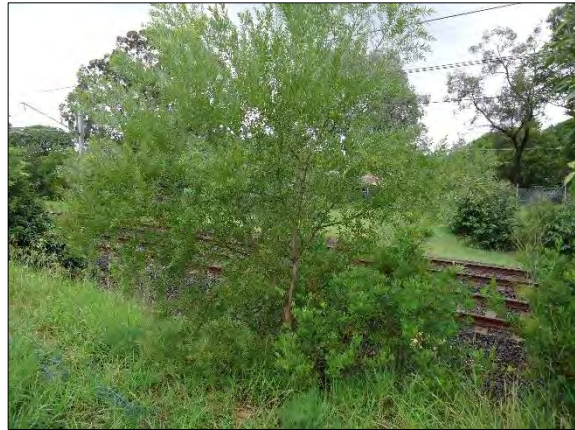
Photograph 6: Tree 8 *Acacia* sp (Wattle) to be removed for MSB works.

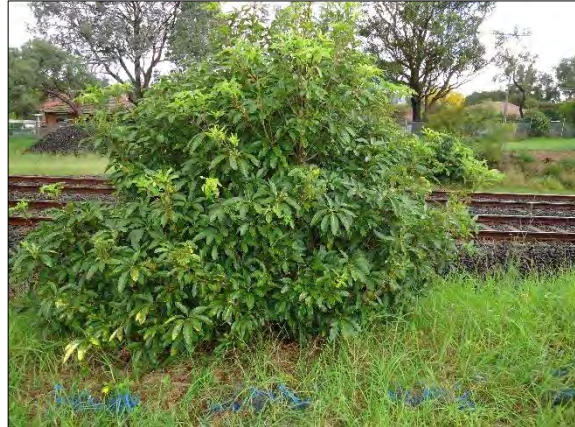
Photograph 7: Tree 9 *Pittorporum undulatum* (Sweet Pittosporum) to be removed for MSB works.

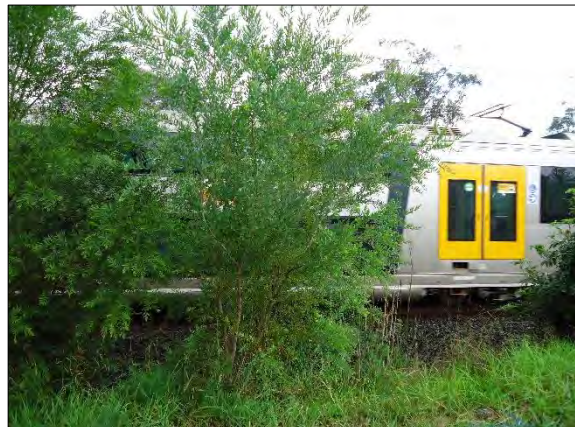
Photograph 8: Tree 10 *Acacia* sp (Wattle) to be removed for MSB works.

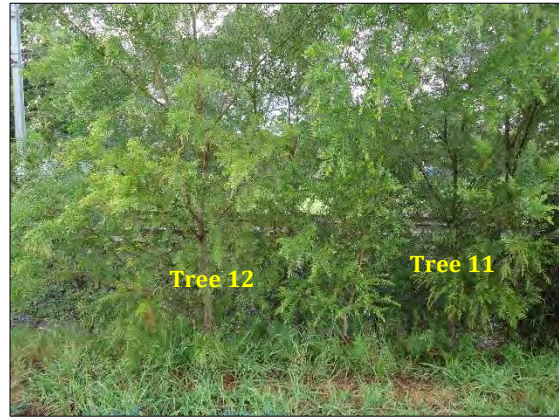
Photograph 9: Trees 11 and 12 *Acacia* sp (Wattle) to be removed for MSB works.

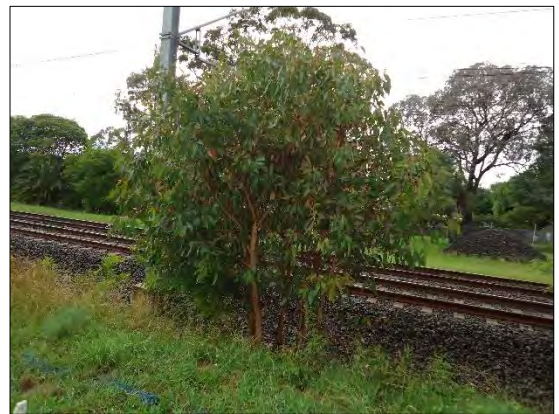
Photograph 10: Tree 13 *Eucalyptus robusta* (Swamp Mahogany) to be removed to accommodate the new sewer alignment.

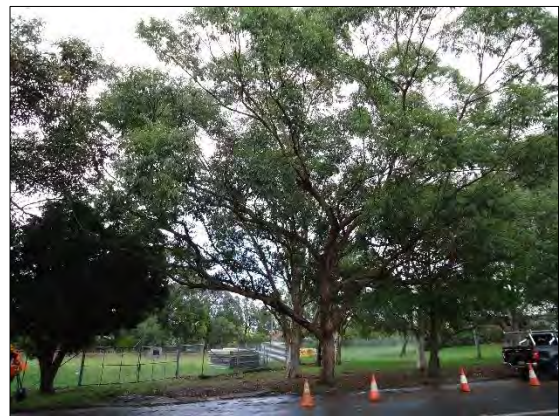
Photograph 11: Tree 14 *Eucalyptus robusta* (Swamp Mahogany) located within road reserve to be selectively pruned for site access clearances.

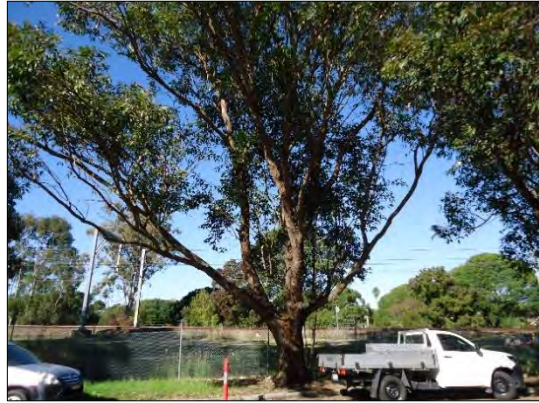
Photograph 1: Tree 1 *Eucalyptus robusta* (Swamp Mahogany) to be removed due to direct clash with permanent design access road to MSB.

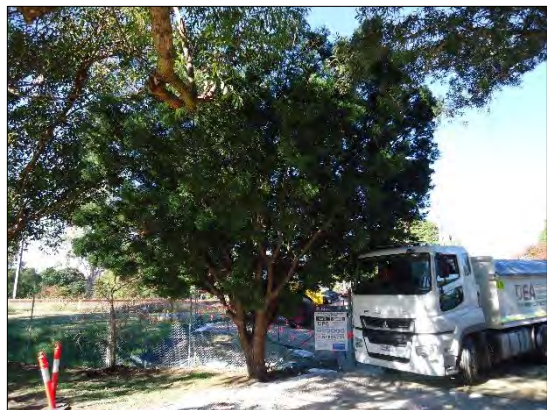
Photograph 2: Tree 2 *Podocarpus elatus* (Brown Pine) to be removed due to direct clash with permanent design access road to MSB.

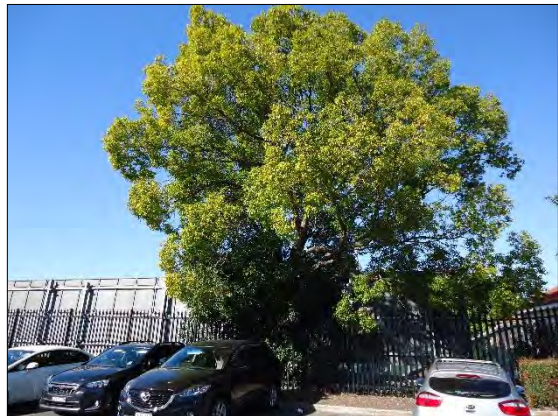
Photograph 3: Tree 3 *Cinnamomum camphora* (Camphor Laurel) within northern side of rail corridor.

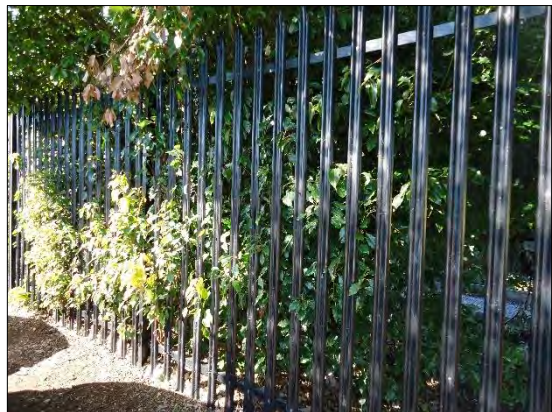
Photograph 4: Suckering around the base of tree 3 is to be removed to allow for the proposed alignment of the new GST.

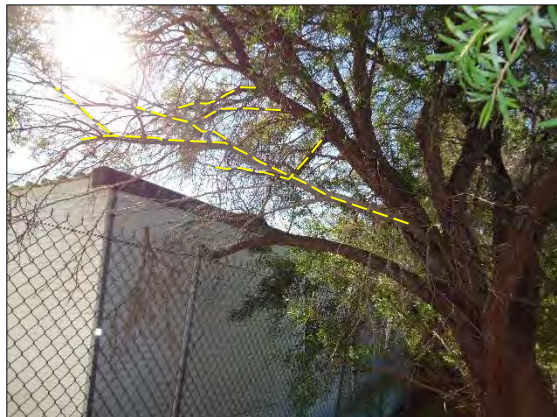
Photograph 7: Tree 6 *Leptospermum petersonii* (Lemon-scented Tee Tree) to be selectively pruned to clear site sheds.

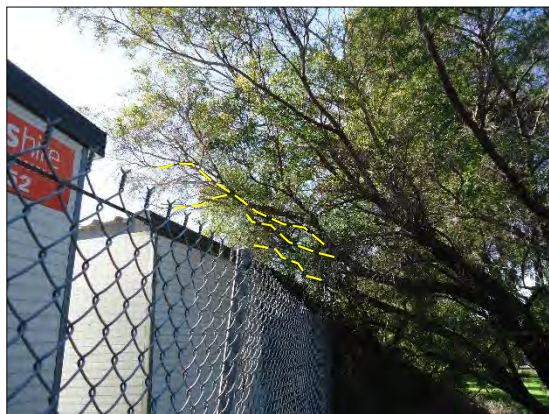
Photograph 8: Tree 7 *Leptospermum petersonii* (Lemon-scented Tee Tree) to be selectively pruned to clear site sheds. Additional pruning shall be required to provide clearances to new over head cabling.

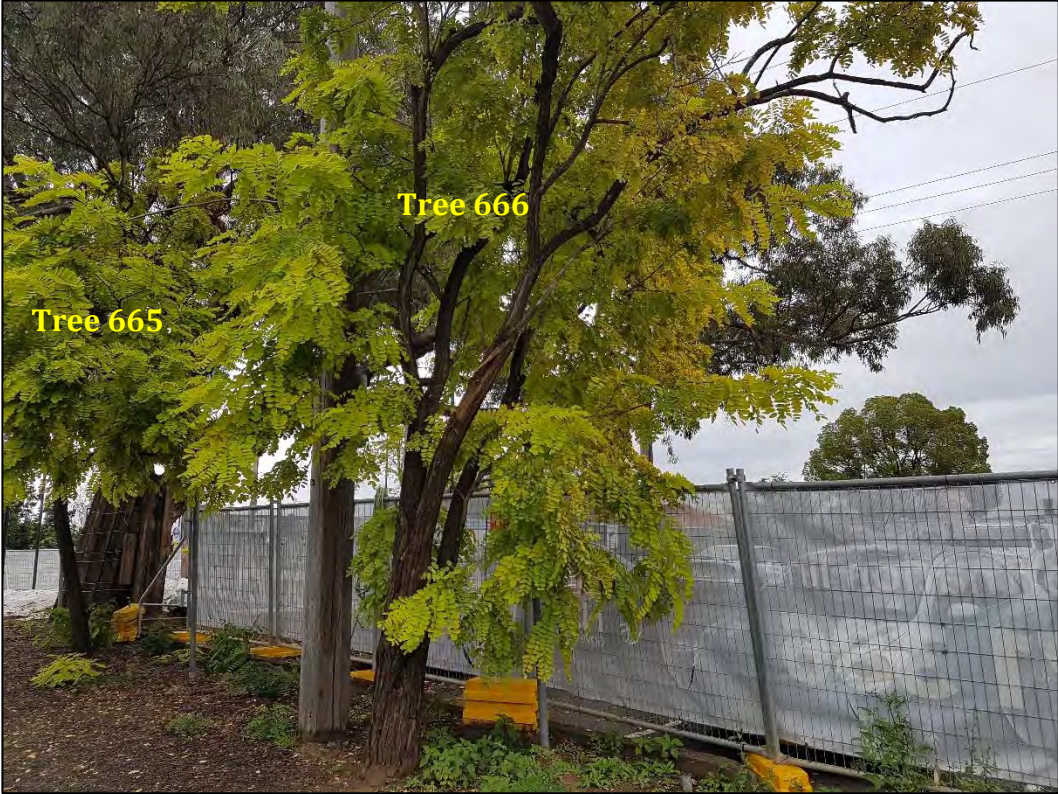
Photograph 1: Tree 665 and 666 as seen from within the site.

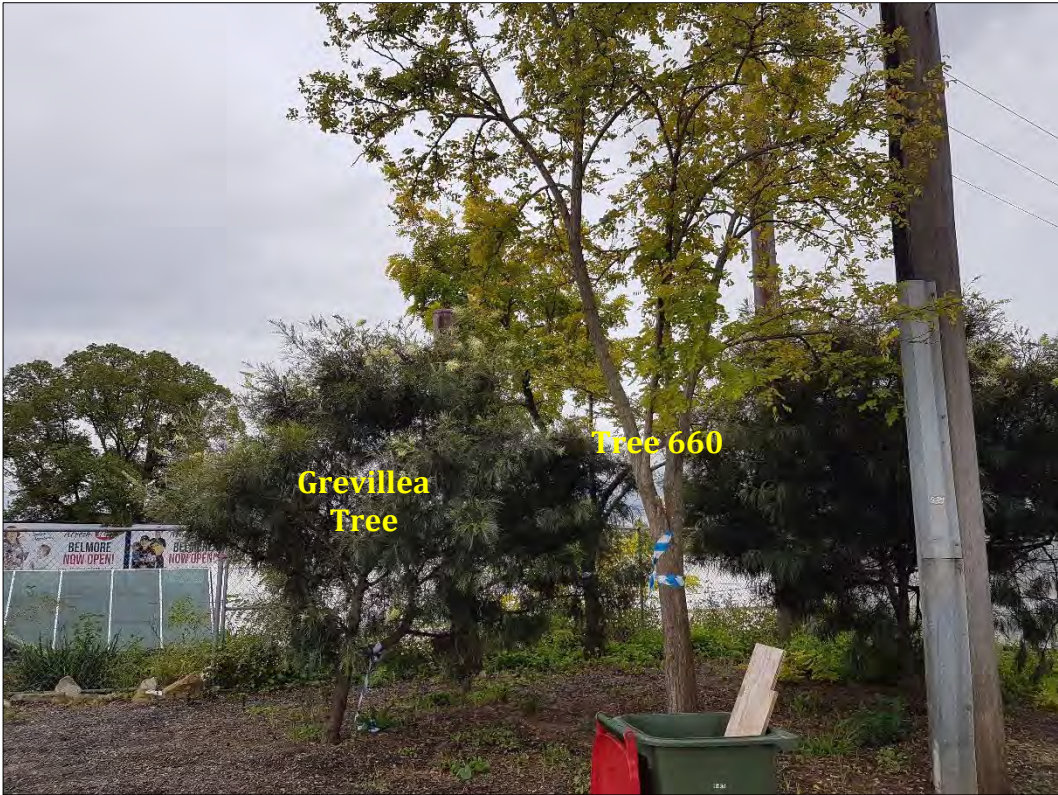
Photograph 2: Tree 660 and the Grevillea as seen from within the site.

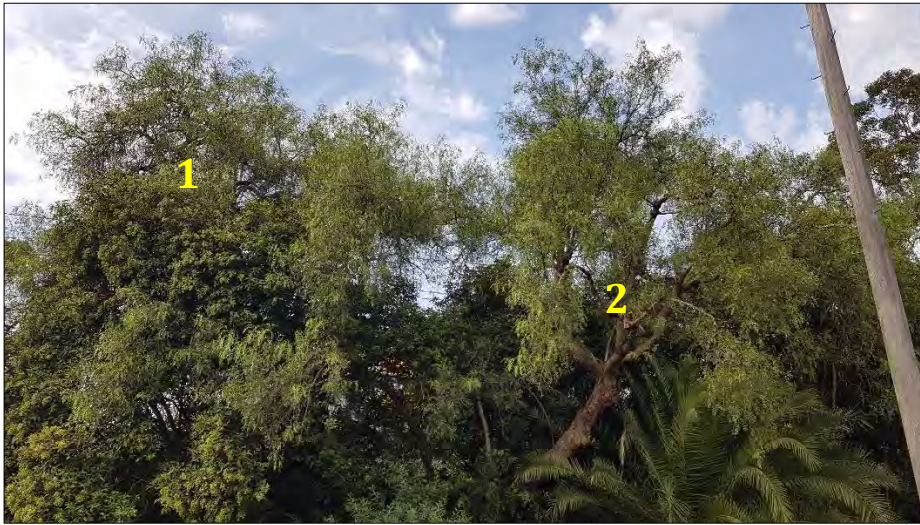
Photograph 1: Trees 1 and 2 *Schinus molle* (Peppercorn Tree) to be removed.

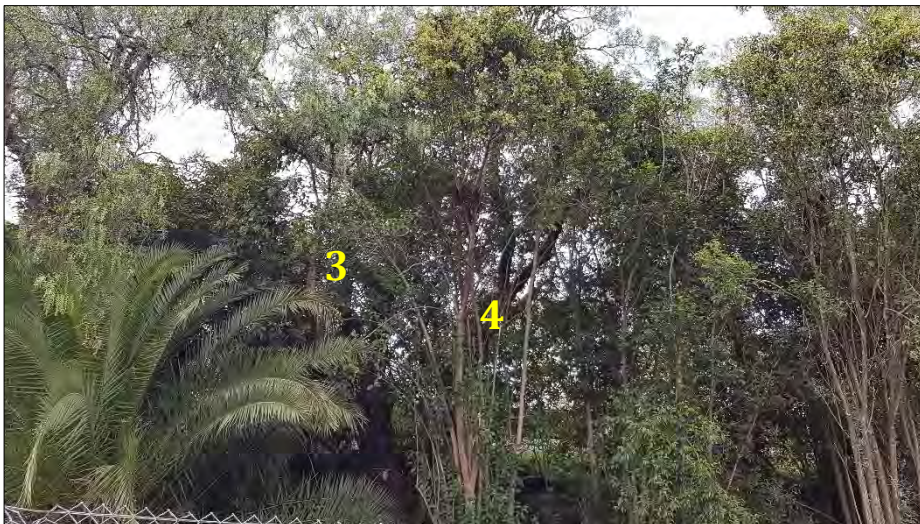
Photograph 2: Trees 3 and 4 *Schinus molle* (Peppercorn Tree) to be removed.

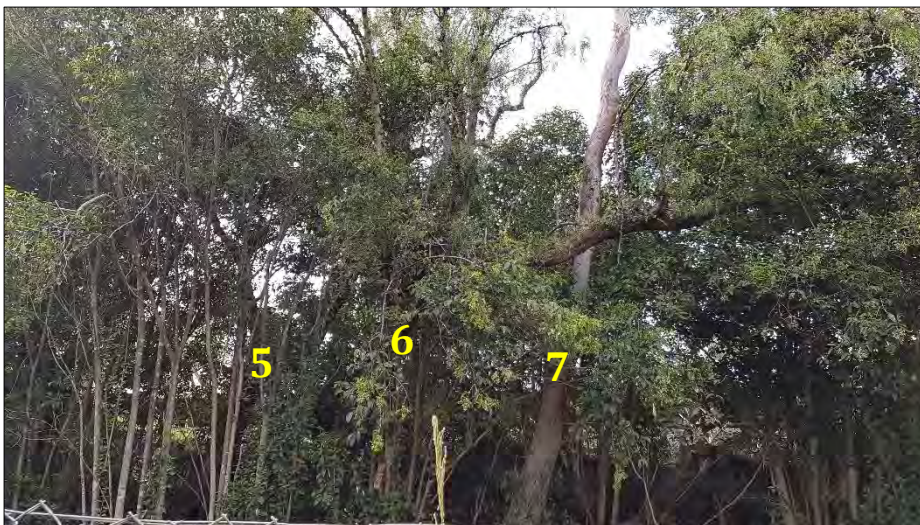
Photograph 3: Trees 5, 6 and 7 *Schinus molle* (Peppercorn Tree) to be removed.

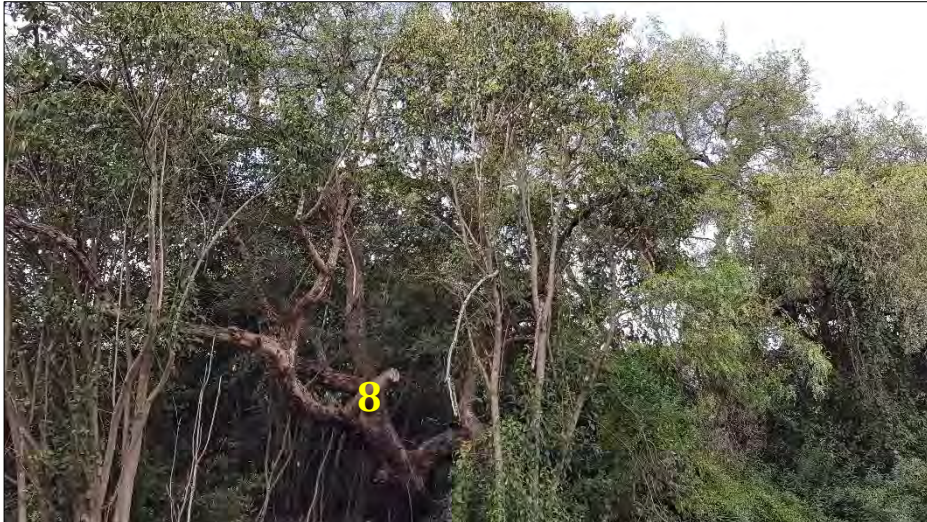
Photograph 4: Tree 8 *Schinus molle* (Peppercorn Tree) to be removed.

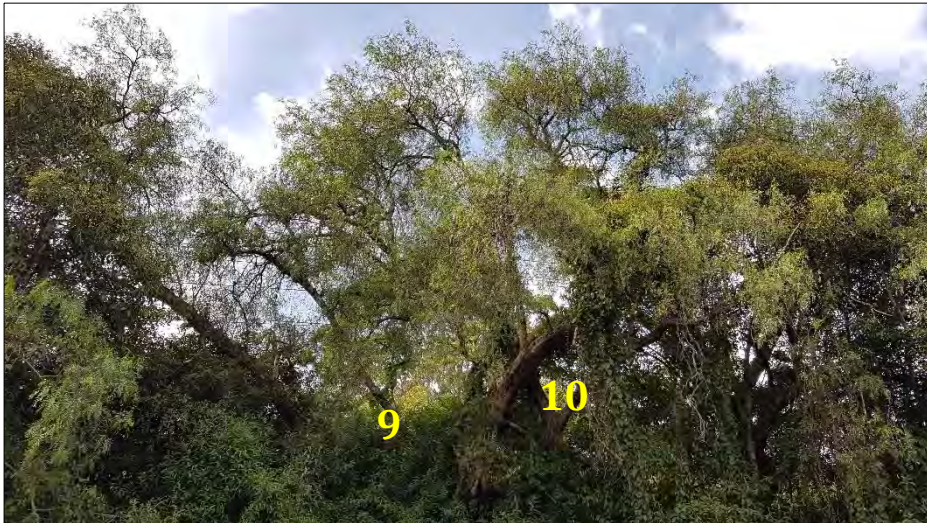
Photograph 5: Trees 9 and 10 *Schinus molle* (Peppercorn Tree) to be removed.

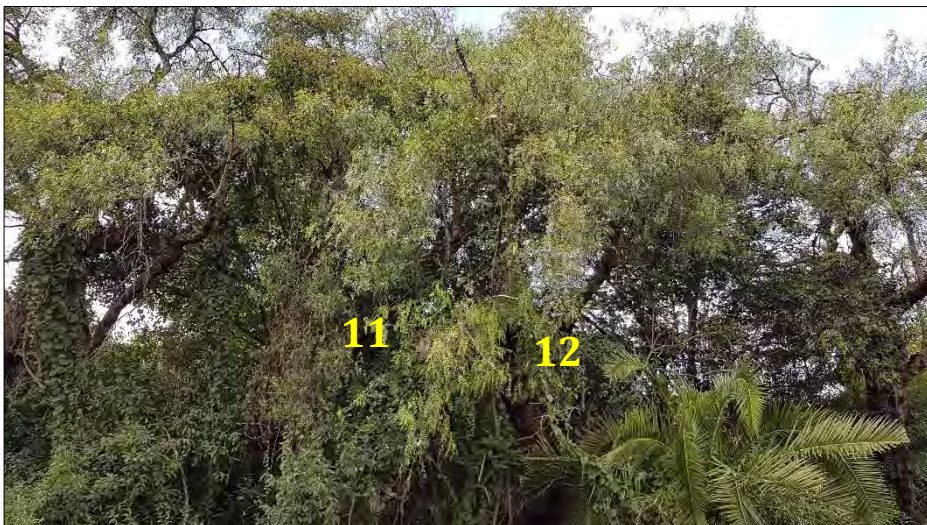
Photograph 6: Trees 11 and 12 *Schinus molle* (Peppercorn Tree) to be removed.

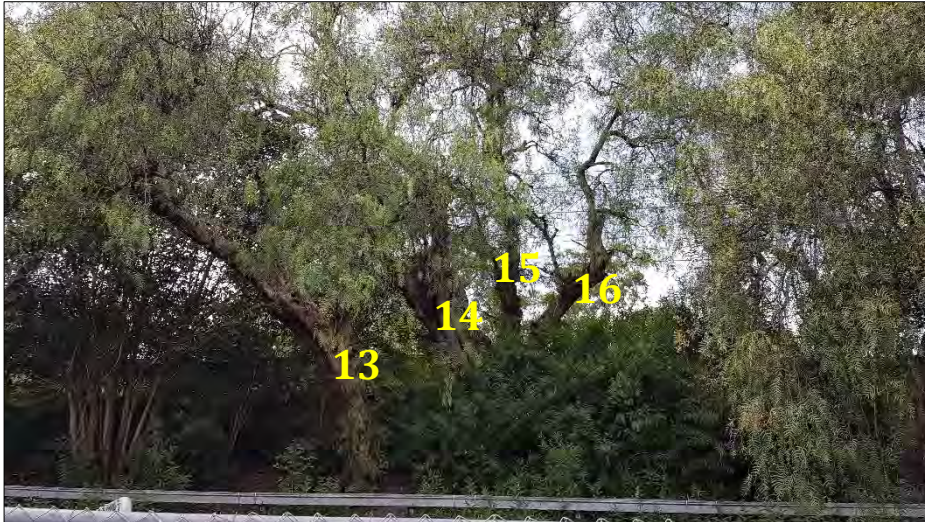
Photograph 7: Trees 13, 14, 15 and 16 *Schinus molle* (Peppercorn Tree) to be removed.

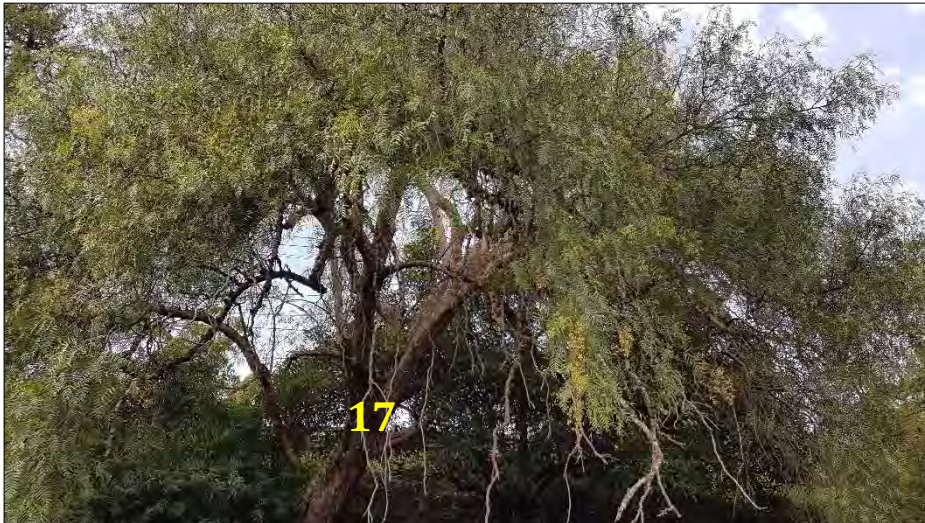
Photograph 8: Tree 17 *Schinus molle* (Peppercorn Tree) to be removed.

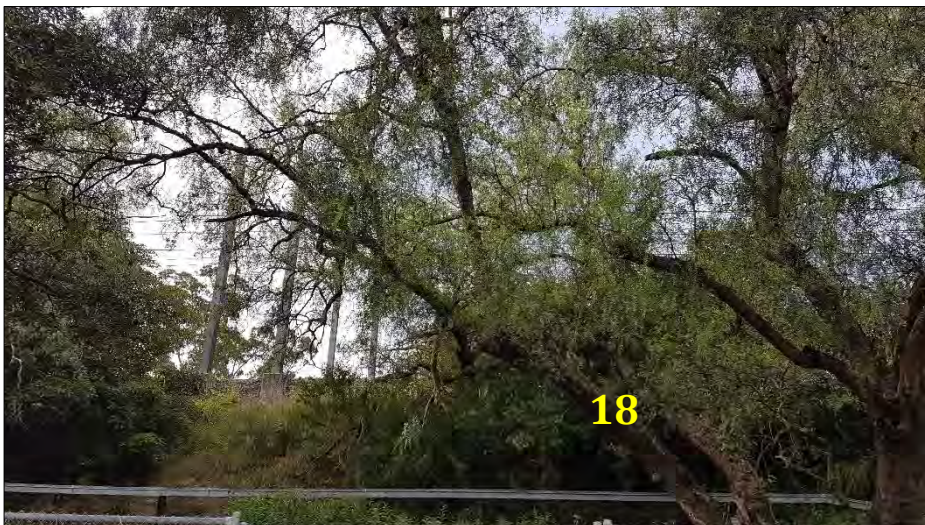
Photograph 9: Tree 18 *Schinus molle* (Peppercorn Tree) to be removed.

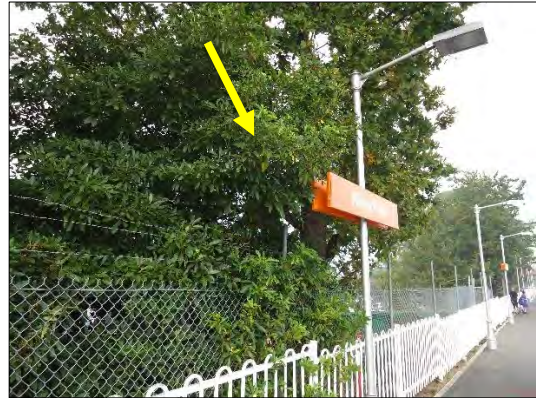
Photograph 2: Tree 2 *Eucalyptus pilularis* (Blackbutt) identified for removal to accommodate Metro services Building driveway and access.

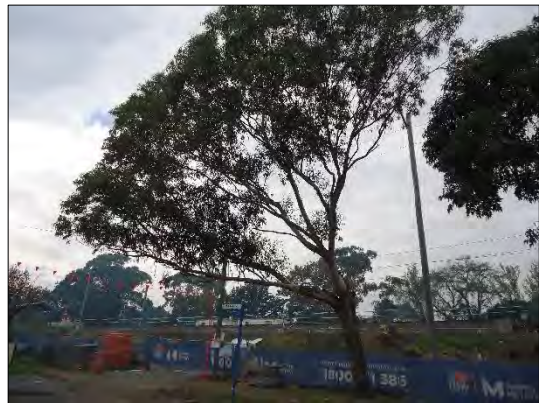
Photograph 3: Tree 3 *Eucalyptus robusta* (Swamp Mahogany) identified for removal to accommodate ULX and permanent fencing.

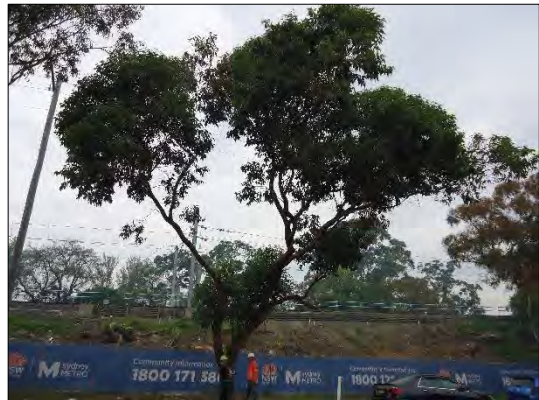
Photograph 4: Tree 4 *Eucalyptus scoparia* (Wallangarra White Gum) identified for removal to accommodate ULX and permanent fencing.

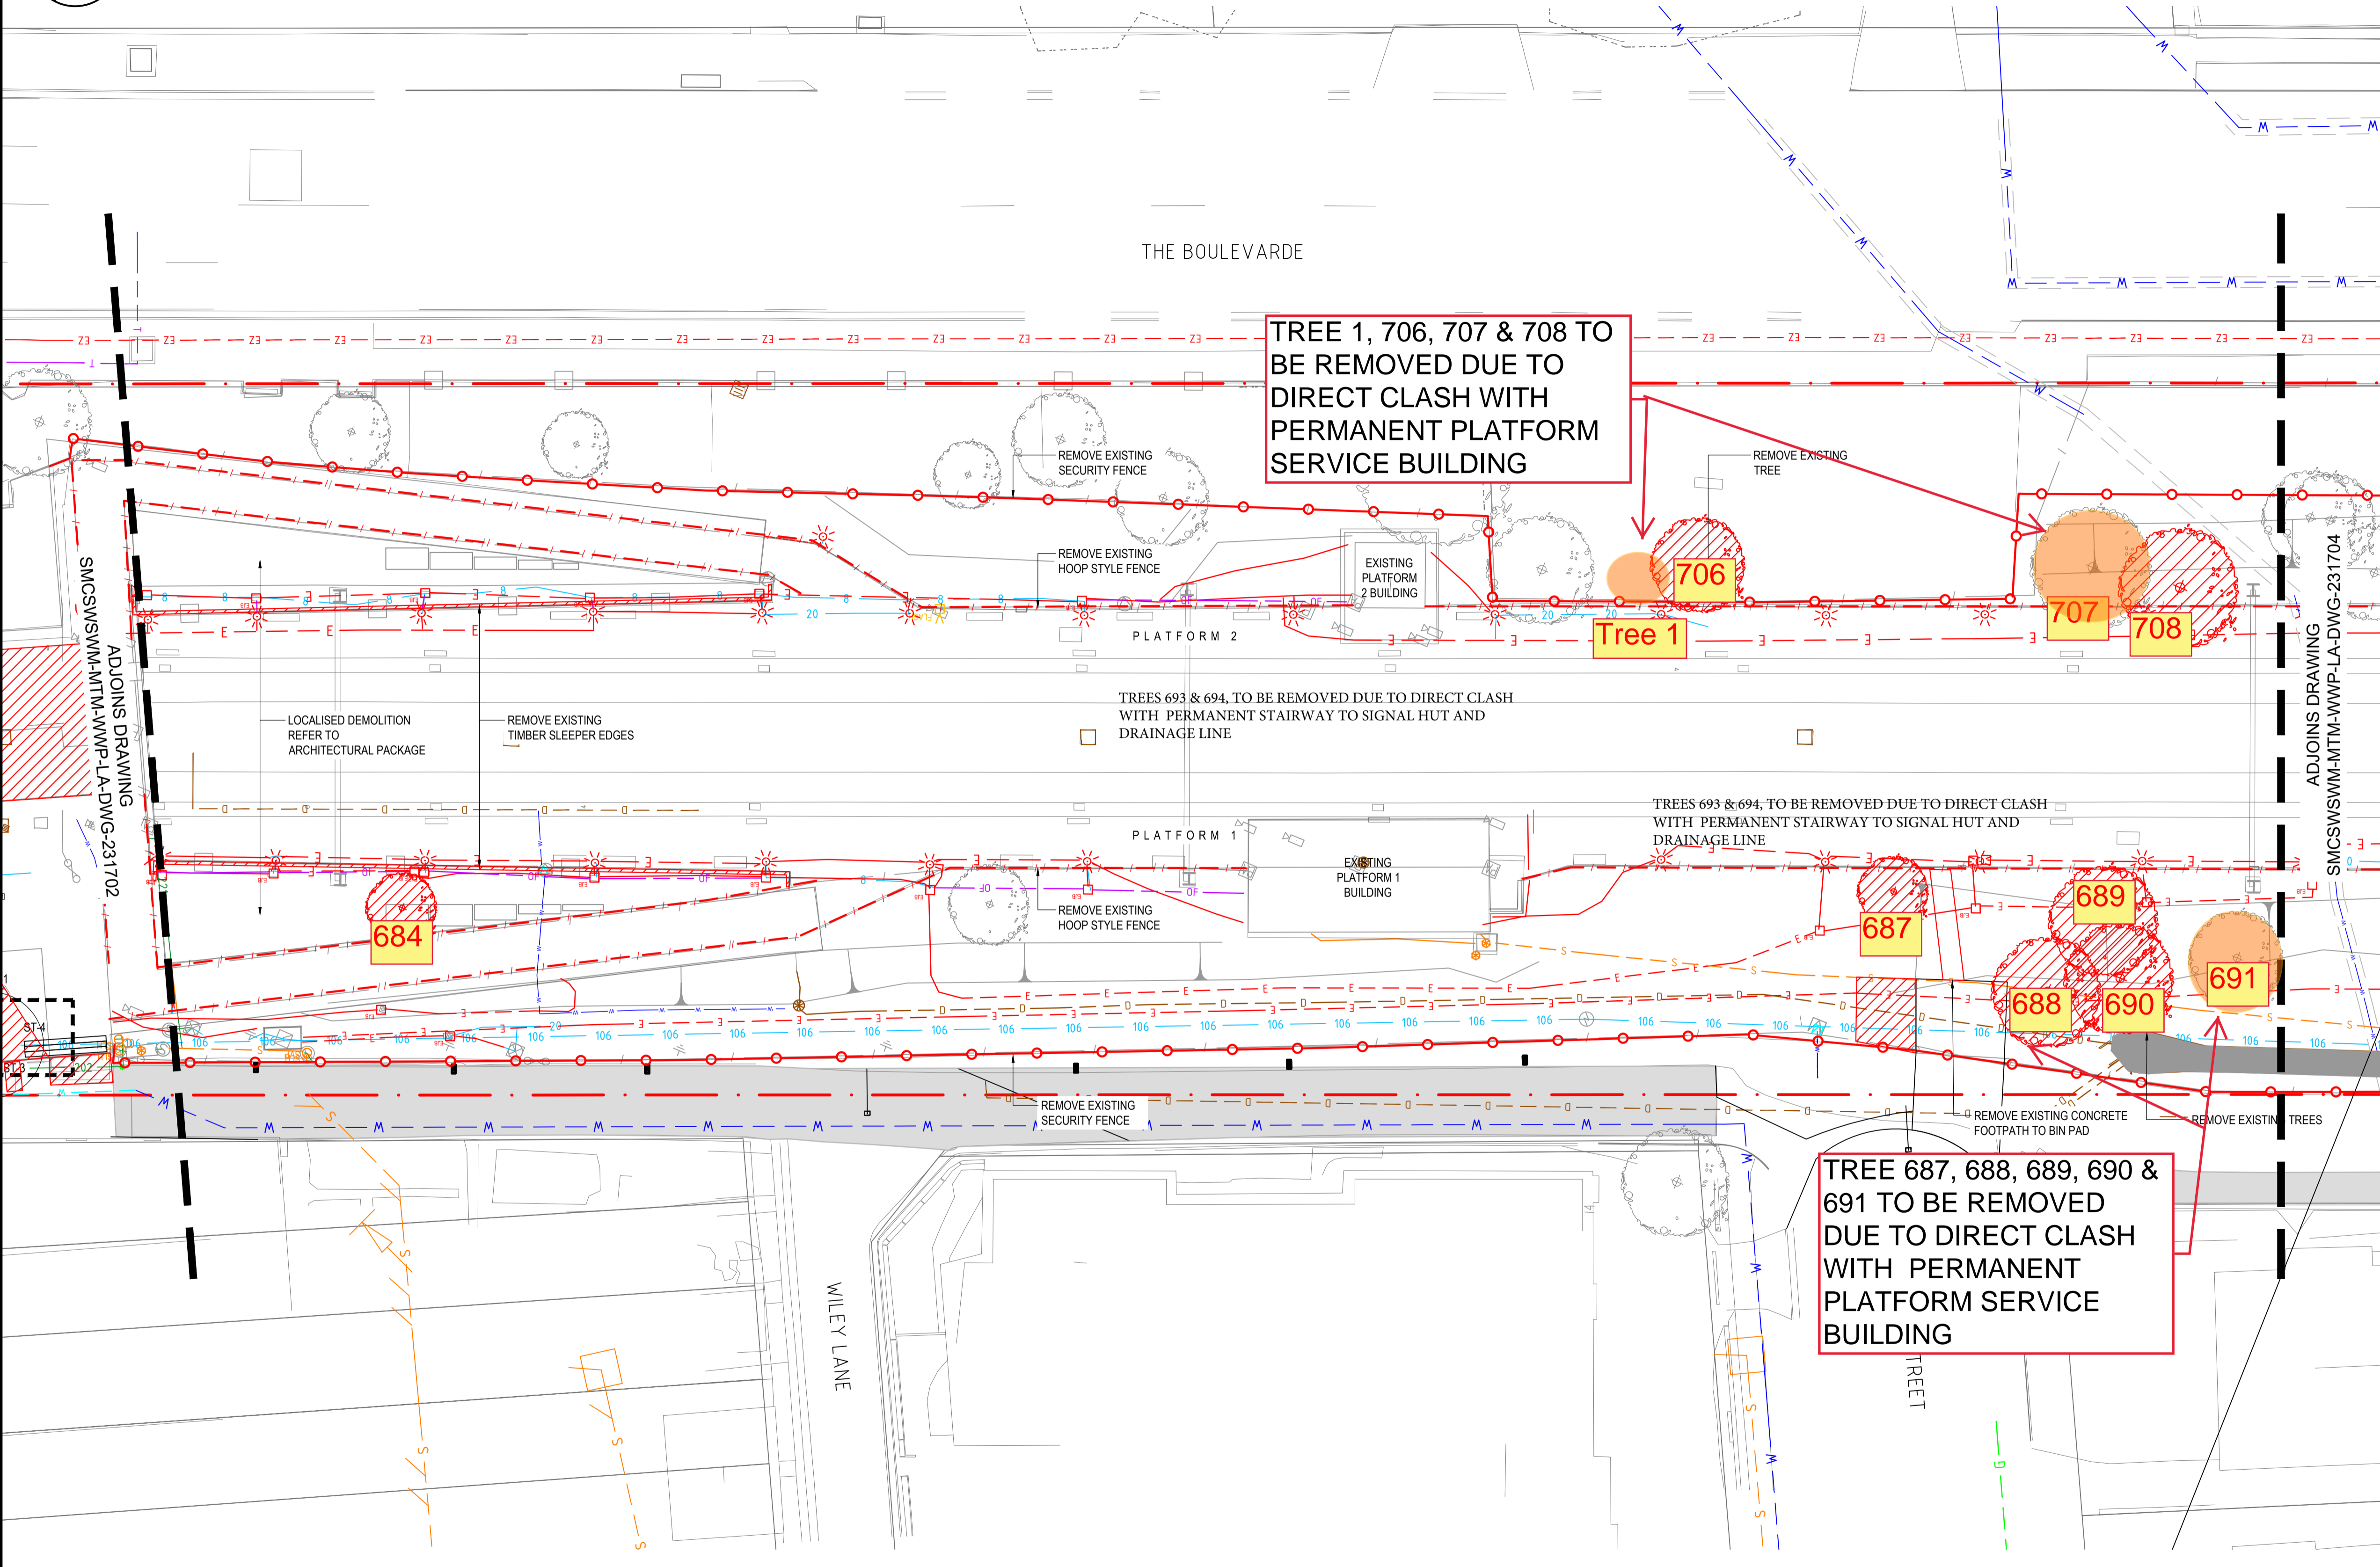
TREE 1, 706, 707 & 708 TO BE REMOVED DUE TO DIRECT CLASH WITH PERMANENT PLATFORM SERVICE BUILDING

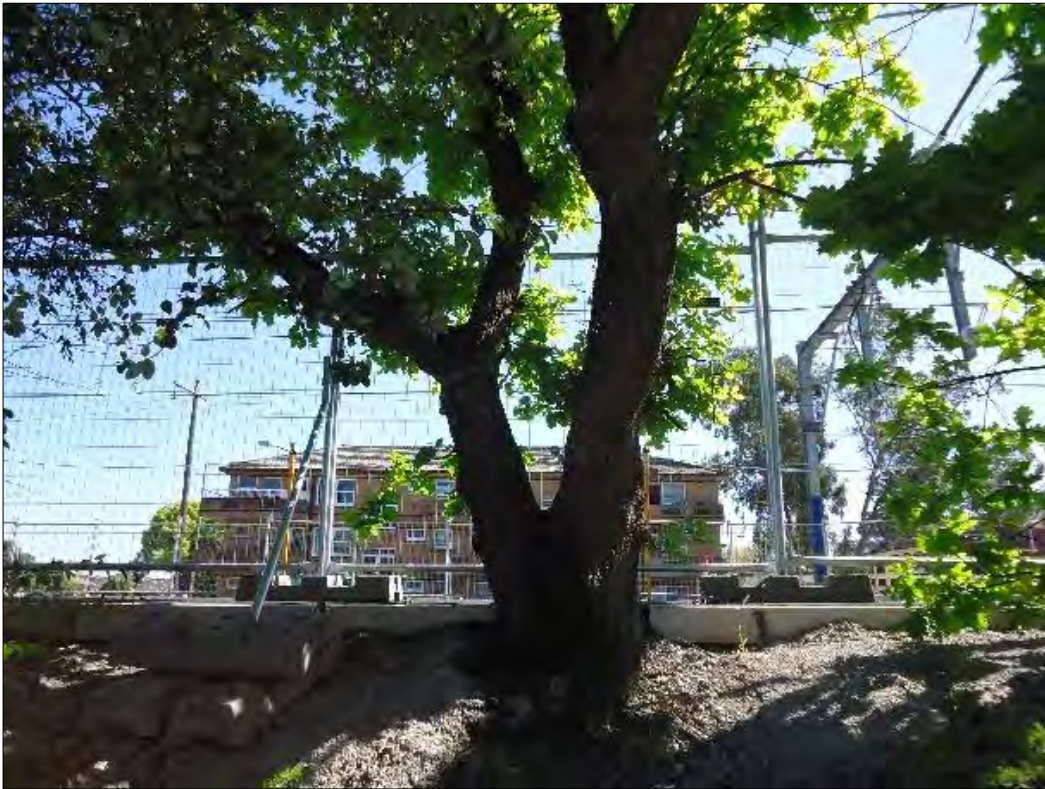
At the time of the inspection the trees were found to be in good health and condition, consistent with their species type, age class and growing environment.

Photograph 1: Tree 711 *Quercus robur* (Common Oak).

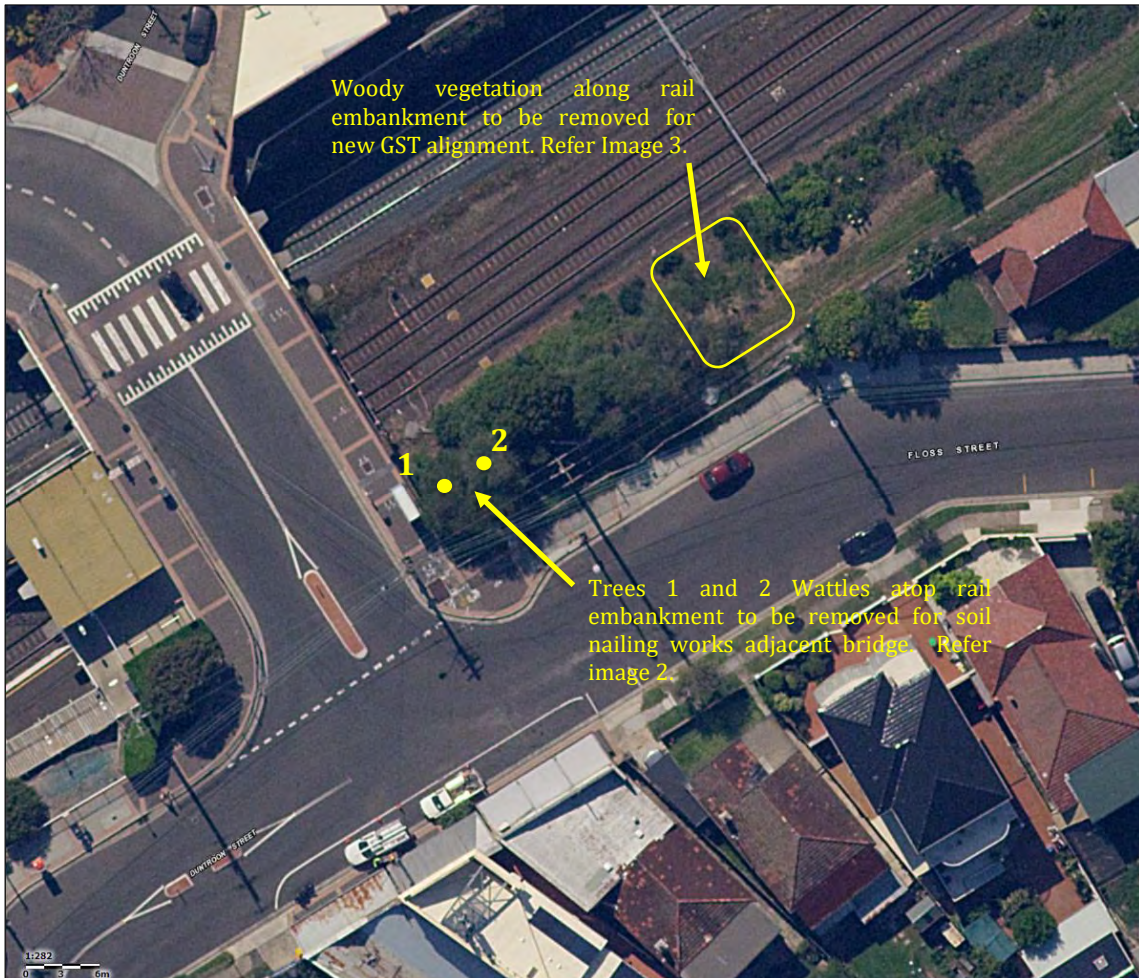
Additional tree and vegetation removal adjacent Floss Street involves two Wattles, trees 1 and 2, located adjacent the bridge and woody vegetation along the rail embankment. Image 1 shows their location.

Image 1: Aerial image of Hurlstone Park Station adjacent Floss Street showing additional tree and vegetation removal. (Source Six Maps accessed 10/03/2021).

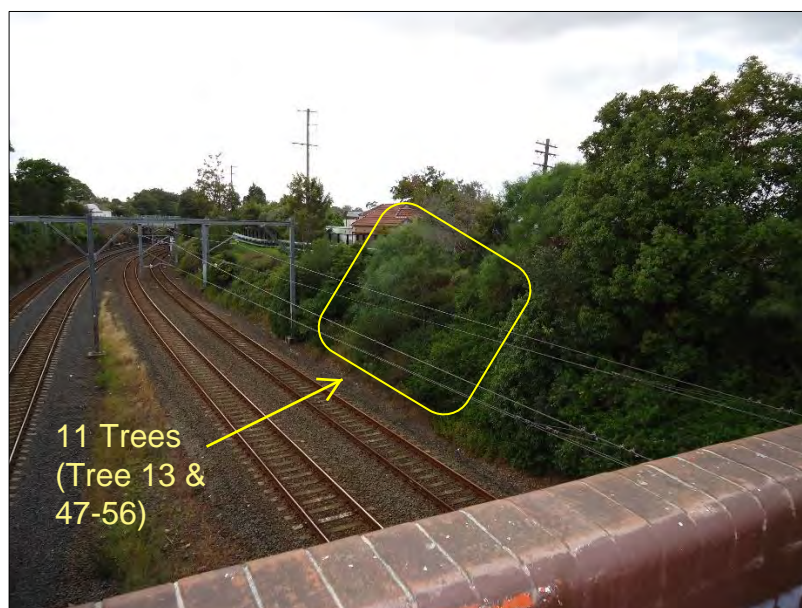
Woody vegetation located along the rail embankment was identified for removal to align the new GST. No access was gained to the rail corridor to assess the vegetation, but it has been confirmed in consultation with the project Ecologist to consist of; one *Pittosporum undulatum* (Sweet Pittosporum) tree 13, seven *Acacia saligna* (Golden Wreath Wattle) trees 47 to 53, one *Grevillea* sp (Grevillea), tree 54 and two *Yucca* sp (Yucca) trees 55 and 56. The vegetation is considered to have a short useful life expectancy and low landscape significance given its location within the rail corridor. Image 3 shows the approximate area to be cleared.

Image 3: Approximate area of woody vegetation along the rail embankment to be cleared to align the new GST.

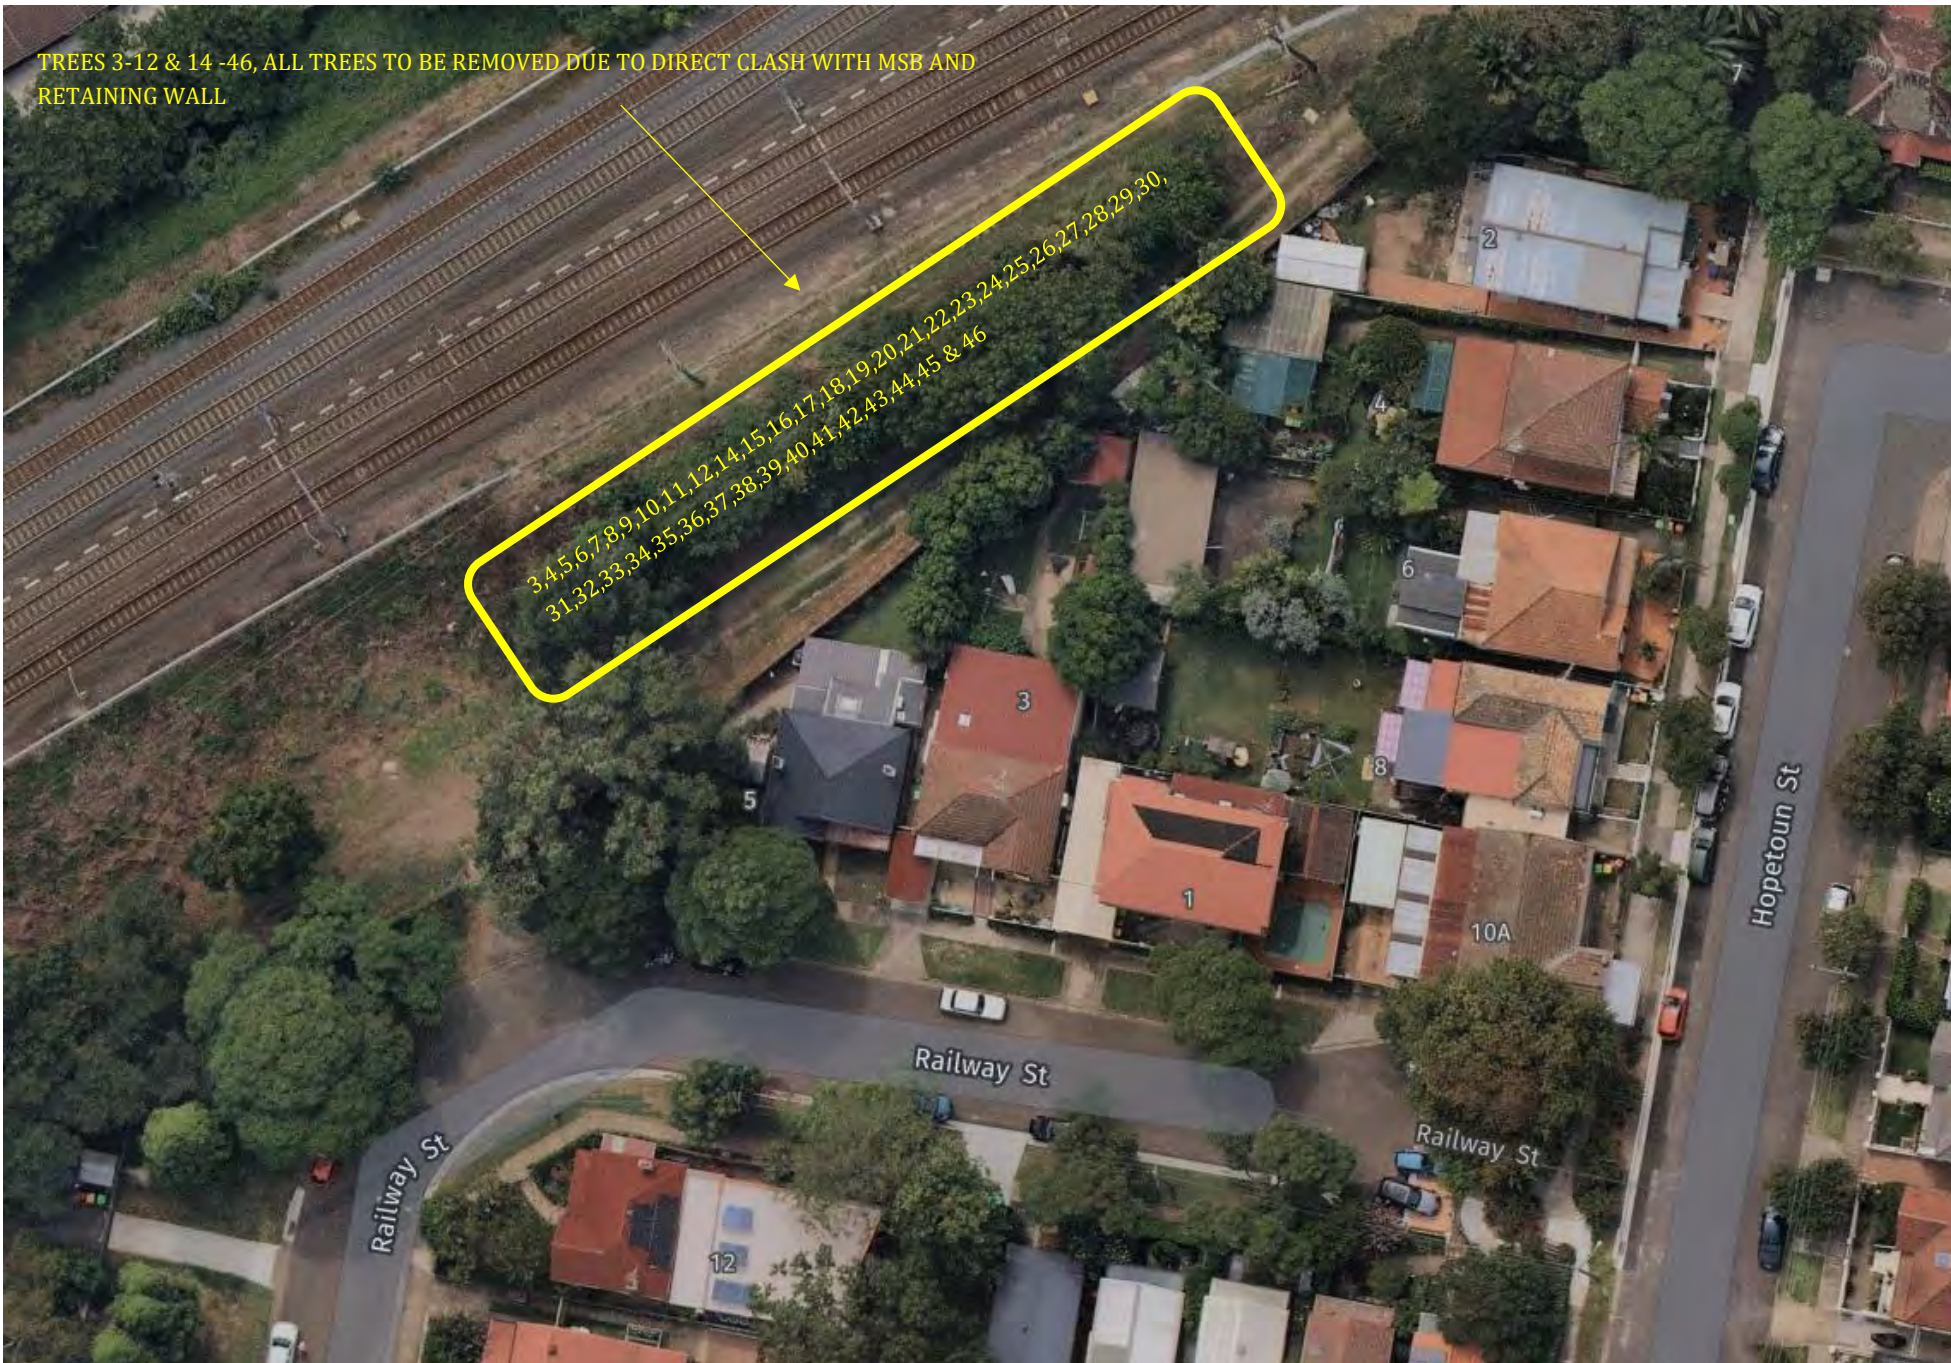
TREES 3-12 & 14-46, ALL TREES TO BE REMOVED DUE TO DIRECT CLASH WITH MSB AND RETAINING WALL

3,4,5,6,7,8,9,10,11,12,14,15,16,17,18,19,20,21,22,23,24,25,26,27,28,29,30,
31,32,33,34,35,36,37,38,39,40,41,42,43,44,45 & 46

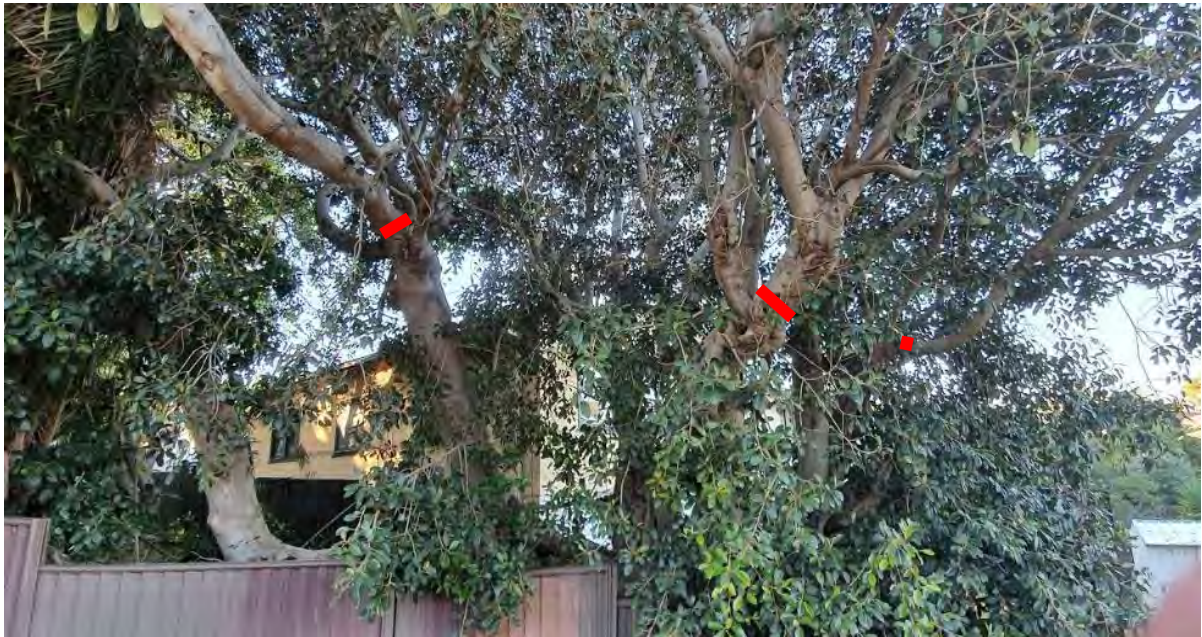
Figure 2: Cut locations of limbs to be pruned marked in red.

3.1 TREE 1 – MORTON BAY FIG (*FICUS MACROPHYLLA*) SEE FIGURE 2

Branch No #	Branch / Stem Height (Mts)	Branch / Stem Diameter (mm)	Branch Order	Pruning Class	Canopy Percentage
1	3	80	2 nd	7.2.4, Selective	3%
2	3	250	2 nd	7.2.4, Selective	13%
3	3.6	180	2 nd	7.2.4, Selective	7%
