Tree Impact Assessment Report

City and Southwest Metro Station Upgrade Works Package 5 & 6

P5 Document No. SMCSWSW5-DEW-WEC-EM-REP-000542

P6 Document No. SMCSWSW6-DEW-WEC-EM-REP-000632

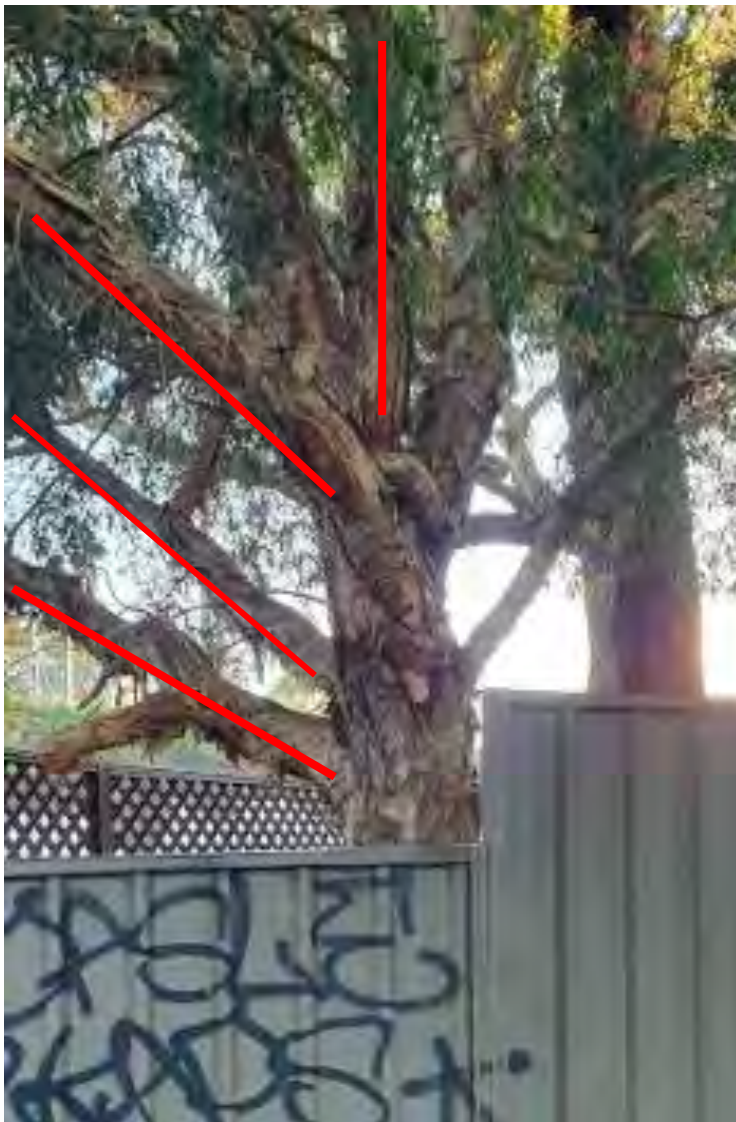
3.1 TREE 1 – WILLOW BOTTLE BRUSH (*CALLISTEMON SALIGNUS*) SEE FIGURE 2

Branch No #	Branch / Stem Height (Mts)	Branch / Stem Diameter (mm)	Branch Order	Pruning Class	Canopy Percentage
1	2	150	1st	7.2.4, Selective	4%
2	2.1	120	1st	7.2.4, Selective	4%
3	2.3	100	1st	7.2.4, Selective	4%
4	2.5	80	1st	7.2.4, Selective	3%

Figure 2:Limbs to be pruned marked in red.

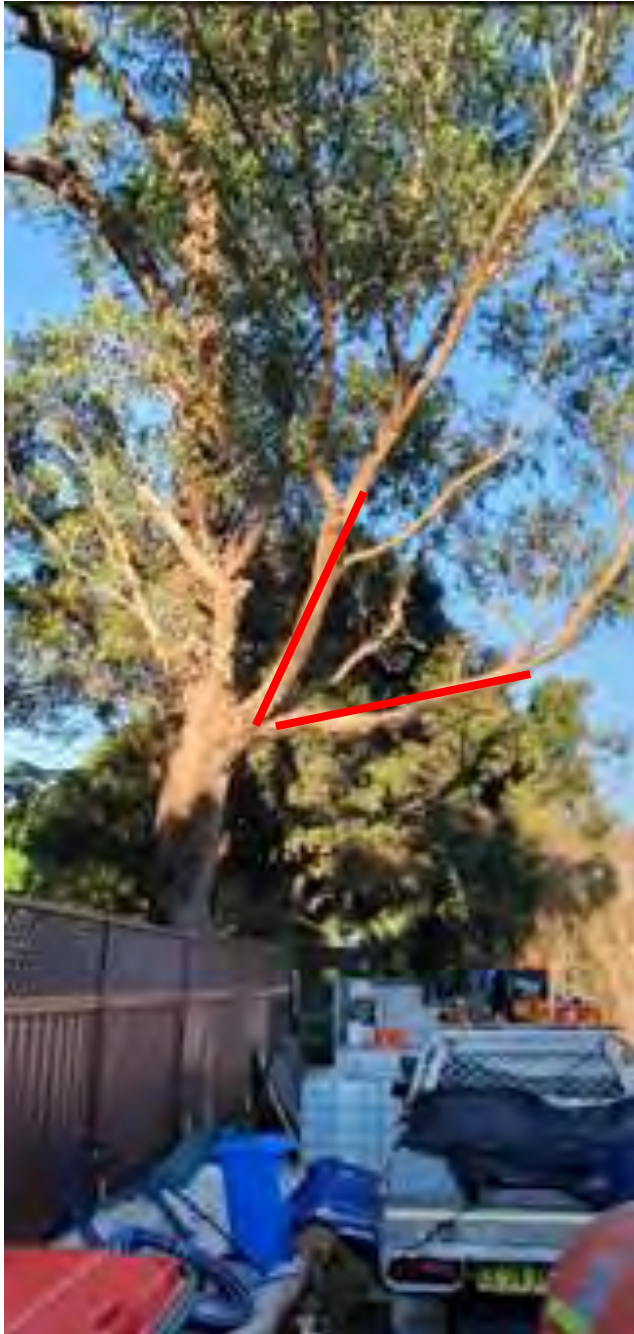
3.2 TREE 2 – GUM TREE (*UNIDENTIFIED EUCALYPTUS SP.*) SEE FIGURE 3

Branch No #	Branch / Stem Height	Branch / Stem Diameter	Branch Order	Pruning Class	Canopy Percentage
1	4.4m	180mm	2 nd	7.2.4, Selective	8%
2	4.5m	180mm	2 nd	7.2.4, Selective	9%

Figure 3: Limbs to be pruned marked in red.

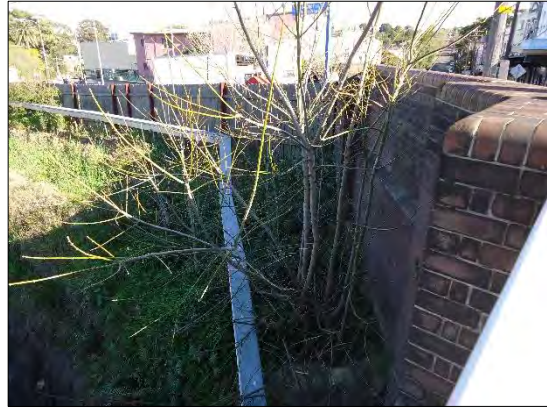
Tree 1 consists of a self-seeded multi-stemmed *Acer negundo* (Box Elder), refer Appendix 2 photograph 1. It has been assessed as having a short useful life expectancy and low landscape value. The wider Southwest Metro Package works require three 300mm diameter piles to be excavated at the location of the tree to

enable the construction of a materials throw screen. As such, the tree cannot be retained.

Photograph 1: Tree 1 *Acer negundo* (Box Elder) growing adjacent rail bridge wall on the northern side of the rail corridor.

Tree 1 is to be removed due to a clash with the permanent GST piling & security fencing footings within the footprint of the tree.

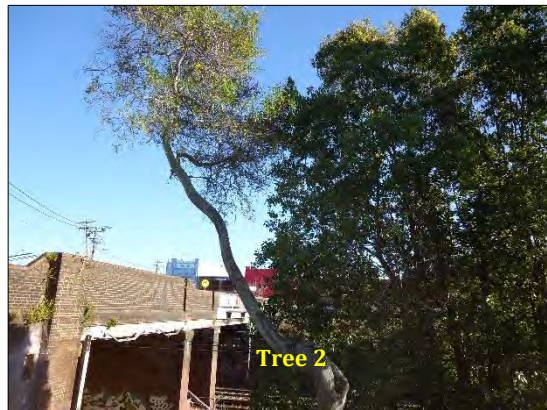
Photograph 2: Tree 2 *Acacia* sp (Wattle) growing on the southern side of the rail corridor atop of the embankment.

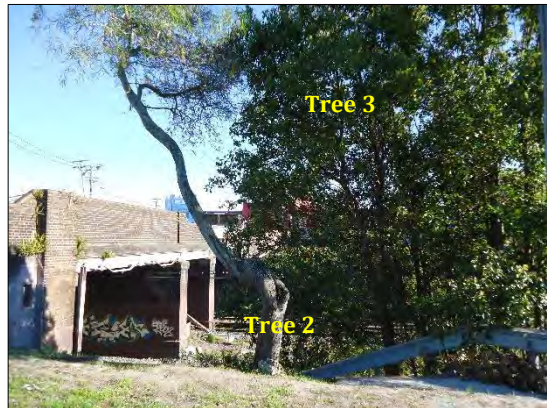
Photograph 3: Tree 3 *Cinnamomum camphora* (Camphor Laurel) growing on the southern side of the rail corridor atop of the embankment. Note the kink and cavity within the trunk of tree 2.

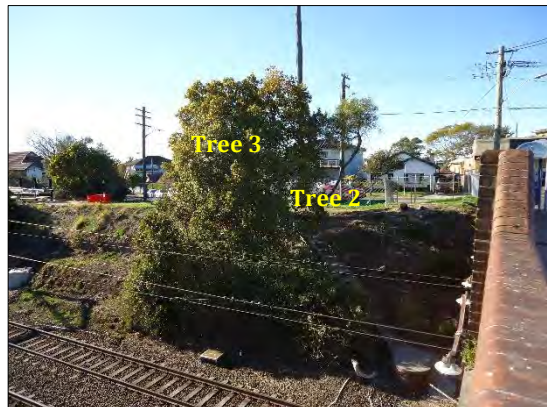
Photograph 4: Trees 2 and 3 as seen from the rail bridge.
