Tree Impact Assessment Report

City and Southwest Metro Station Upgrade Works Package 5 & 6

**Project wide: Hurlstone Park, Wiley Park, Belmore,
Campsie, Dulwich Hill and Punchbowl**

P5 Document No. SMCSWSW5-DEW-WEC-EM-REP-000542

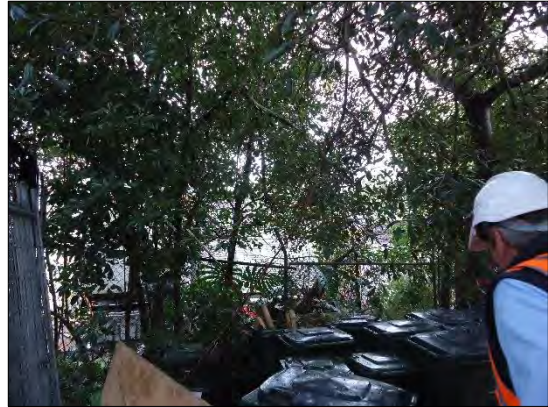
Photograph 1: Clump of vegetation consisting of approximately 14 individual stems of *Cinnamomum camphora* (Camphor Laurel) and a dead tree identified for removal.

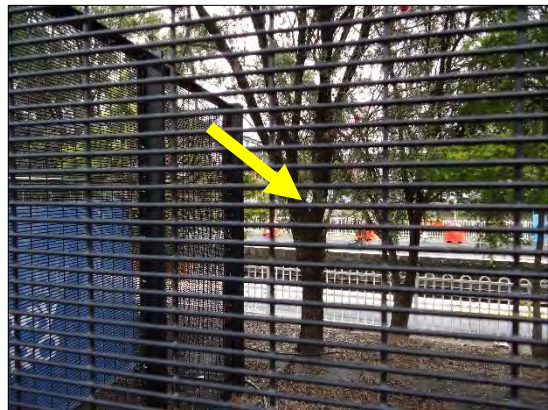
Photograph 2: Tree 632 *Callistemon viminalis* (Bottlebrush) identified for removal to accommodate the new GST alignment.

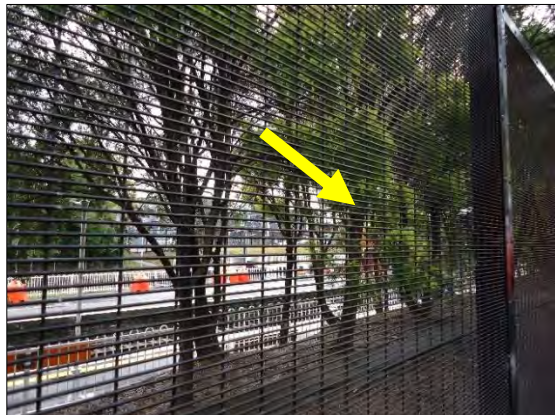
Photograph 3: Tree 627 *Leptospermum petersonii* (Lemon-scented Teatree) identified for selective pruning works create clearances to allow for the new GST alignment.

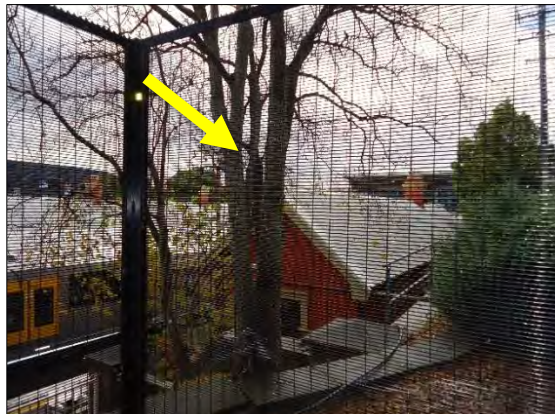
Photograph 4: Tree 614 *Sapium sebiferum* (Chinese Tallowwood) identified for removal to accommodate the new GST alignment.

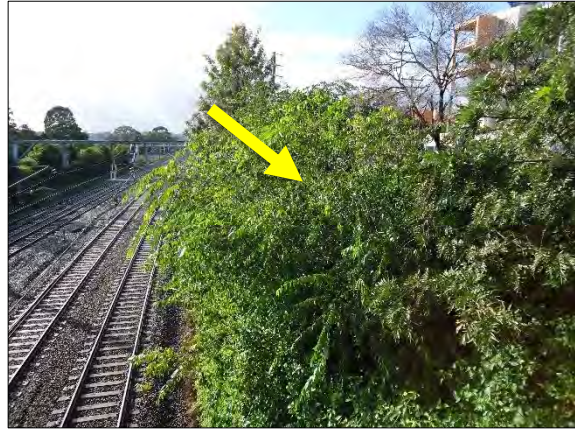
Photograph 5: Tree 6 *Celtis sinensis* (Hackberry) located within rail corridor. Tree to be removed to accommodate the new GST alignment. The surrounding Lantana along the rail embankment is also to be removed.

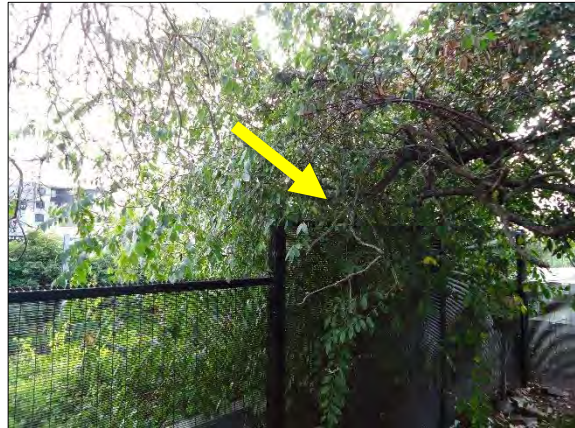
Photograph 6: Tree 7 *Celtis sinensis* (Hackberry) located within rail corridor. Tree to be removed to accommodate the new GST alignment.

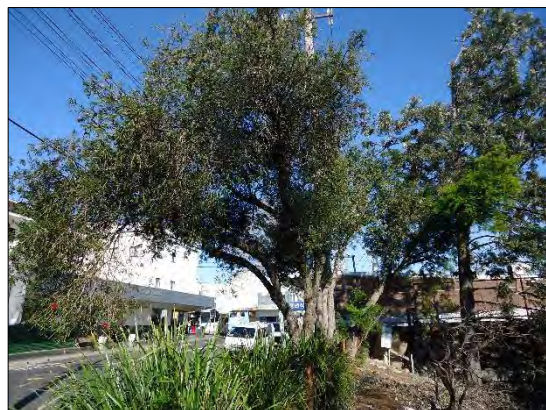
Photograph 4: Tree 519 *Callistemon viminalis* (Weeping Bottlebrush) located adjacent the northern side of South Parade.

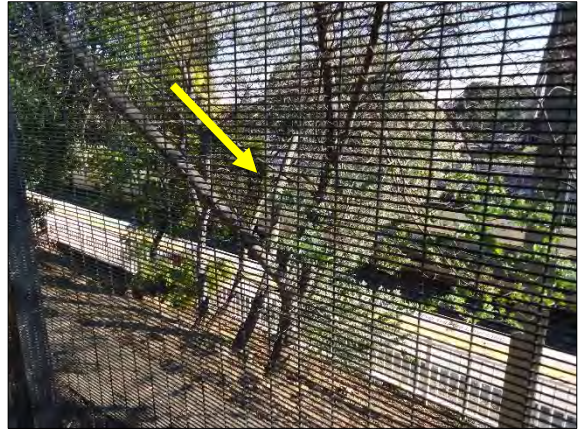
dead. Tree 615 was also found to be in a state of declining health and beyond reasonable attempts to remediate. The AIA report also identifies trees 615 and 620 as being exempt from local tree preservation controls. The additional trees to be removed are not representative of an endangered or threatened species or ecological community. Photographs of the assessed trees have been attached to the rear of this report as Appendix 2 Site Photographs.

Photograph 5: Tree 615 *Acacia podalyrifolia* (Queensland Silver Wattle) located adjacent Platform 2. The adjacent Queensland Silver Wattle's are near dead.

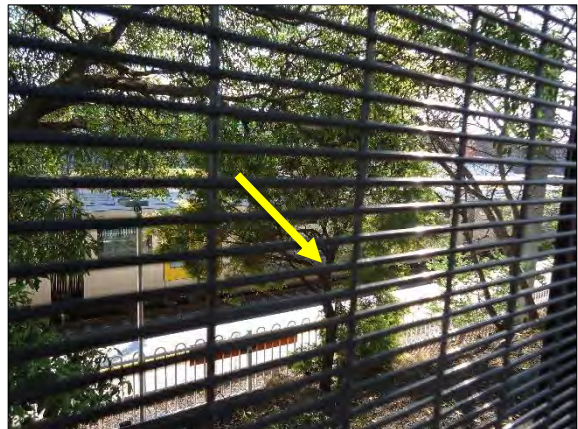
Photograph 6: Tree 5 *Melaleuca bracteata* (Black Teatree) located adjacent Platform 2.

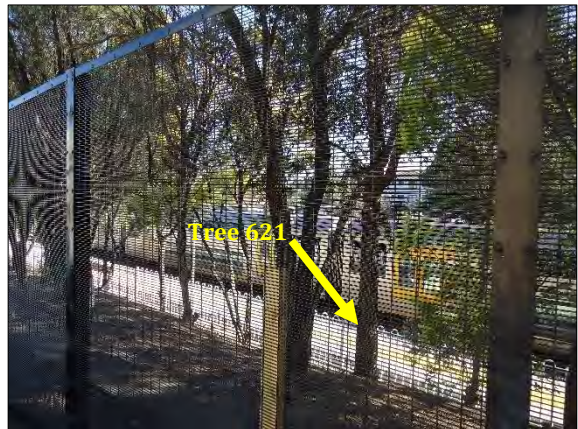
Photograph 7: Showing trees adjacent Platform 2. Tree 621 *Syncarpia glomulifera* (Turpentine) is shown for reference.

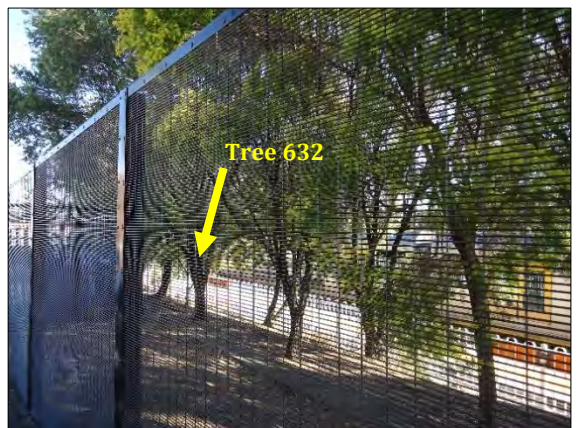
Photograph 8: Showing trees adjacent Platform 2. Tree 632 *Callistemon viminalis* (Weeping Bottlebrush) is shown for reference.

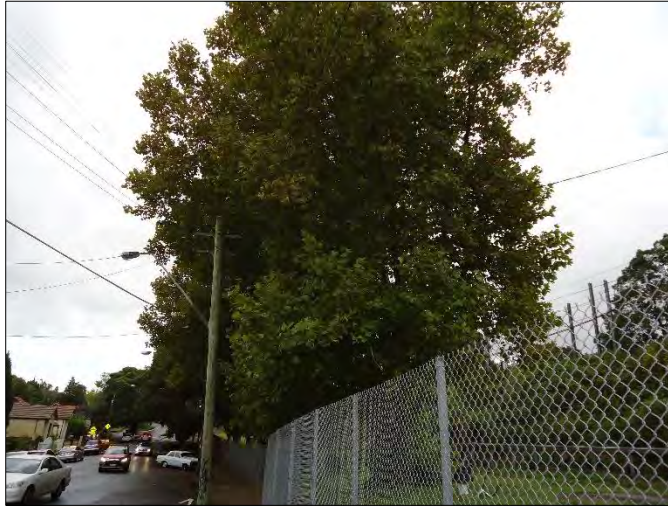
Photograph 1: Tree 1 *Platanus x acerifolia* (London Plane) to be removed.

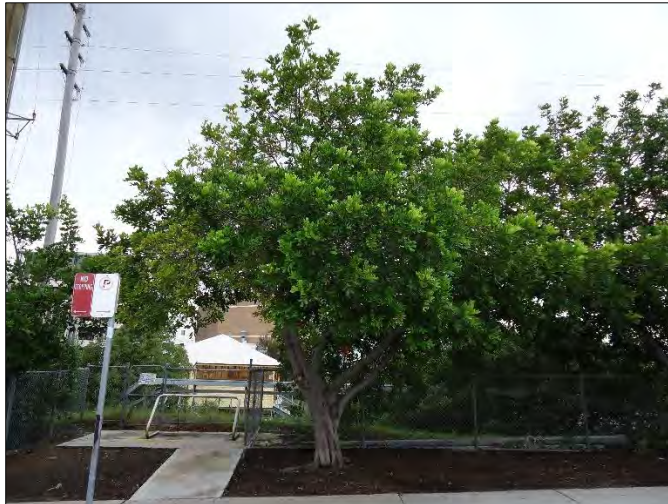
Photograph 2: Tree 2 *Cupaniopsis anacardioides* (Tuckeroo) to be removed.

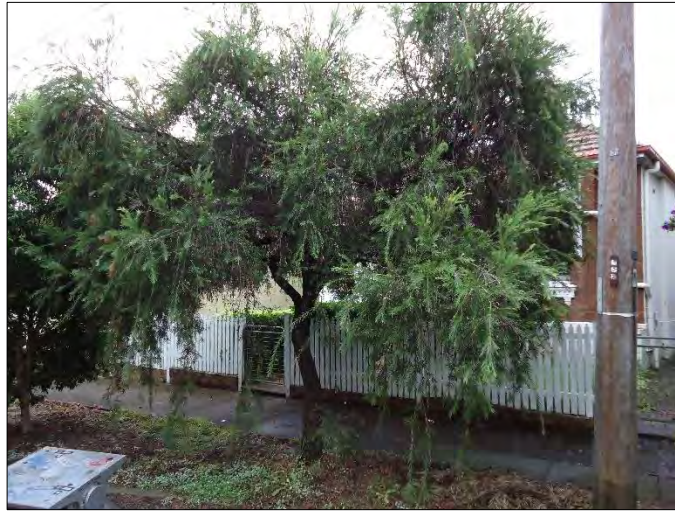
Photograph 4: Tree 4 *Calistemon viminalis* (Bottlebrush) to be removed.

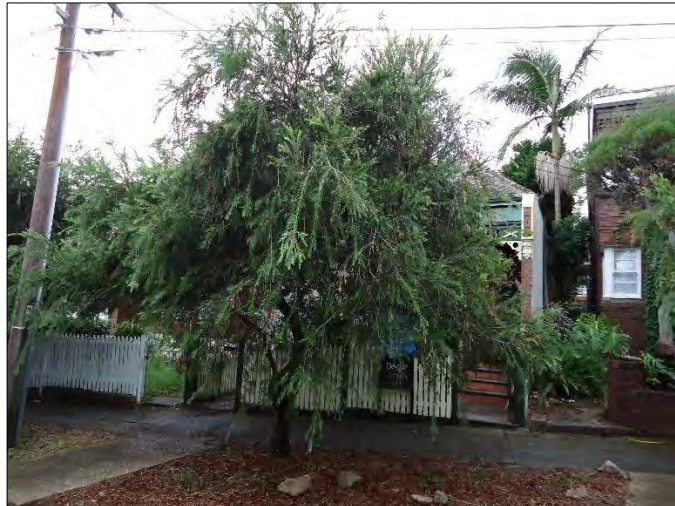
Photograph 5: Tree 5 *Calistemon viminalis* (Bottlebrush) to be removed.

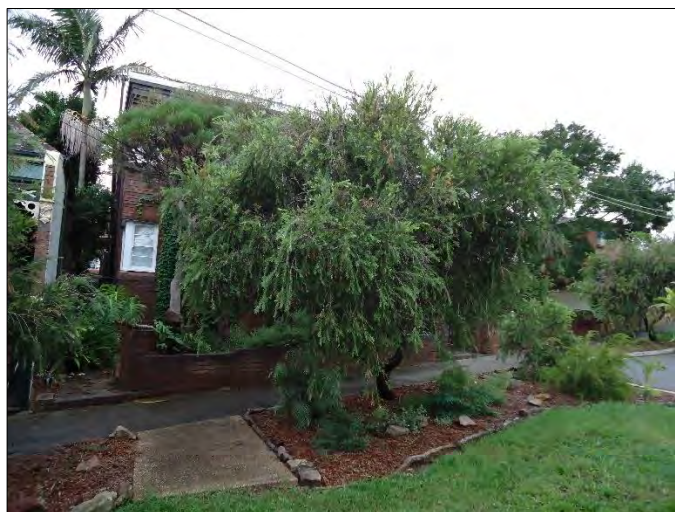
Photograph 6: Tree 6 *Calistemon viminalis* (Bottlebrush) to be removed.

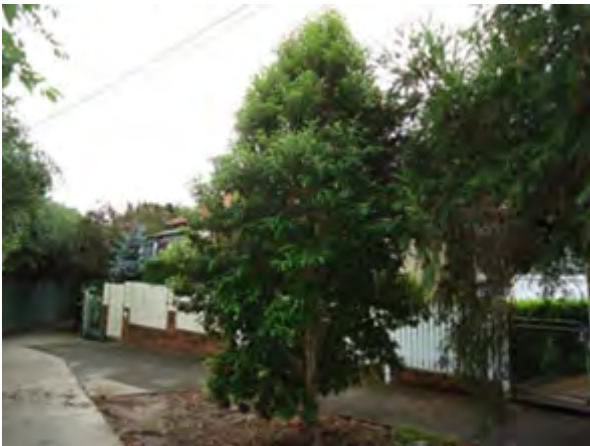
During the phone call with your colleague, it was noticed that the original photo was actually the wrong tree nominated to be relocated (refer to below correct image). Irrespective, the below correspondence is still relevant and we are seeking advise from Inner West Council whether they wish to retain the tree and transplant locally or shall the project add it to the tree offset planting requirements.

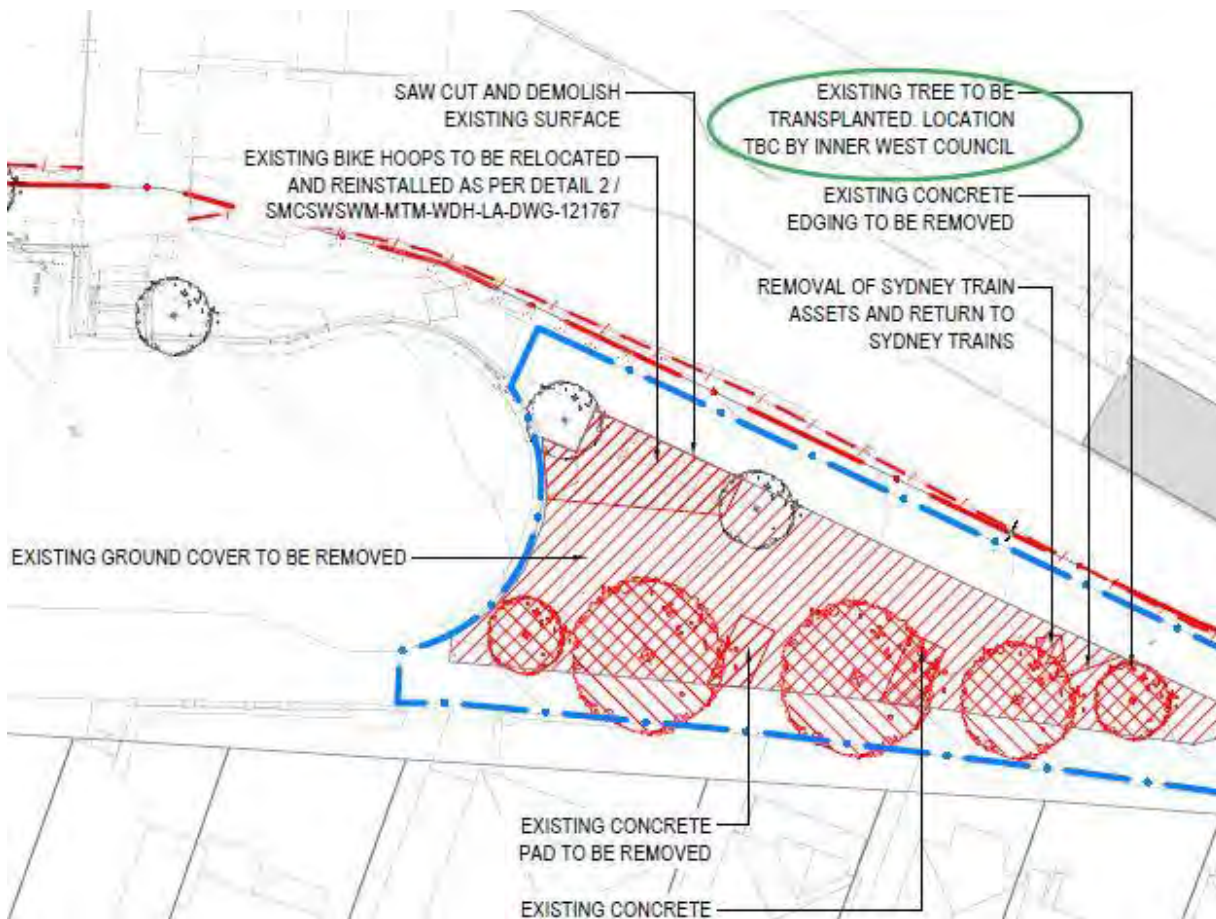
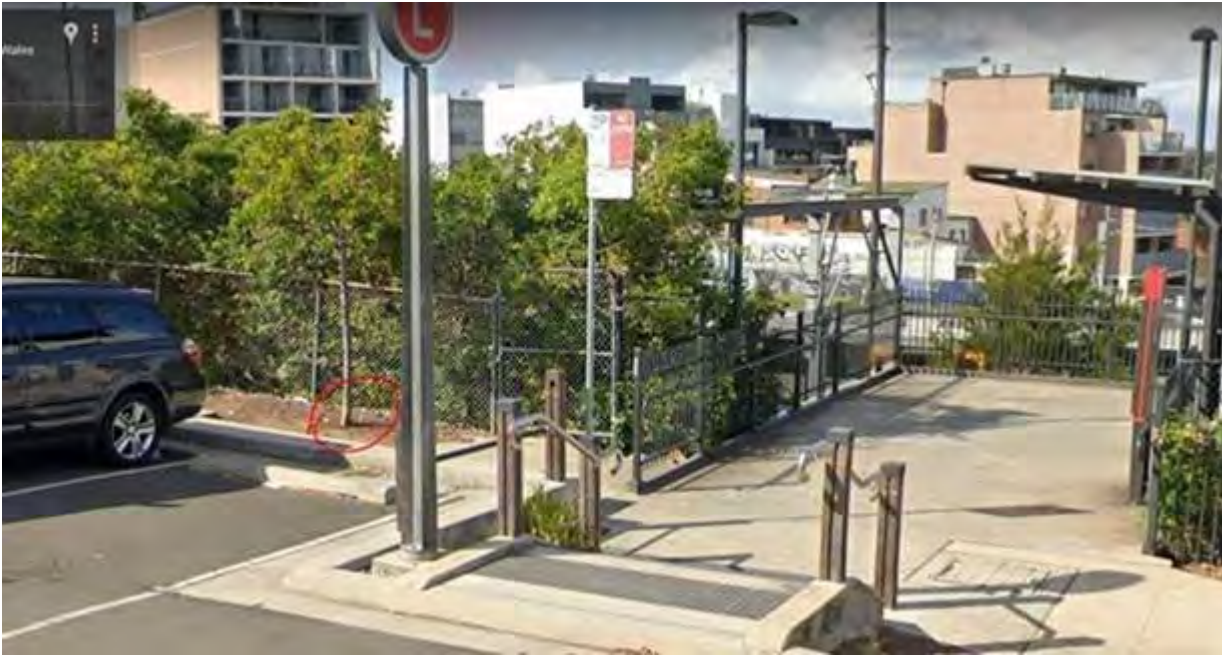
In short, the design has nominated a singular tree at Dulwich Hill Station to be relocated (see below design excerpt and street view image of tree circled in red). The tree is quite young and doesn't offer any significant value which leads me to ask whether IWC actually wish to retain the tree. Relocating the tree will pose a few logistical issues given that we (Downer) will need to remove the tree being in our PC and the transplant/ relocation works would need to be undertaken by IW Council given that the new location is likely to be outside of the project boundary.

The alternative to transplanting is for the project to remove the tree along with the remaining vegetation (separate tree clearance request) and add to the project tree offset planting. I believe this would be the most favourable option for both parties, however am seeking initial input from Inner West Council.

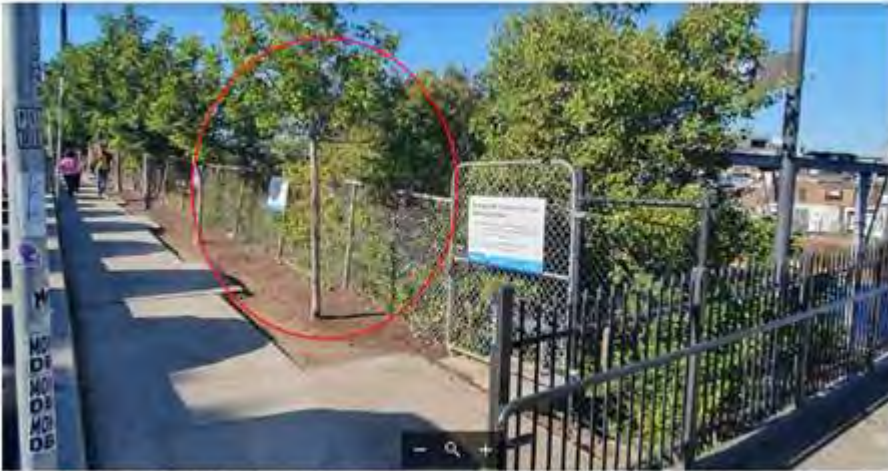
Tree A:

Image 2: Tree A circled in red.

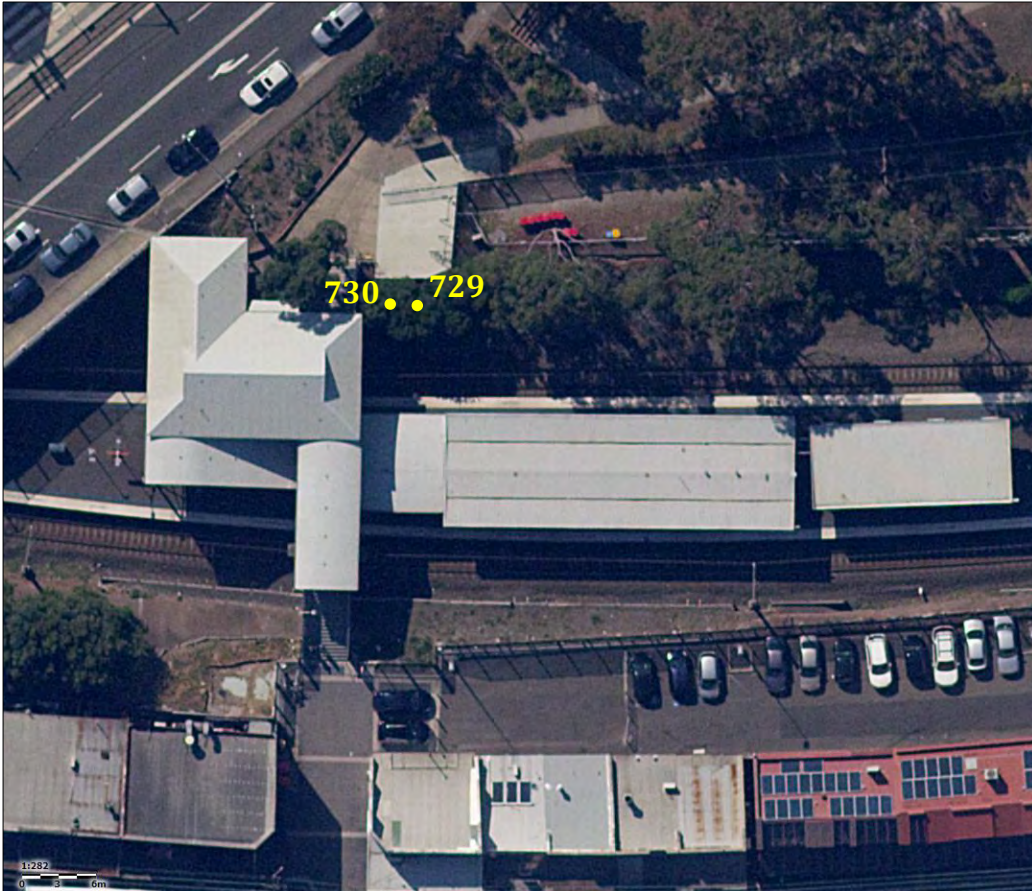
Image 1: Aerial image of Punchbowl Station showing the location of trees 729 and 730.

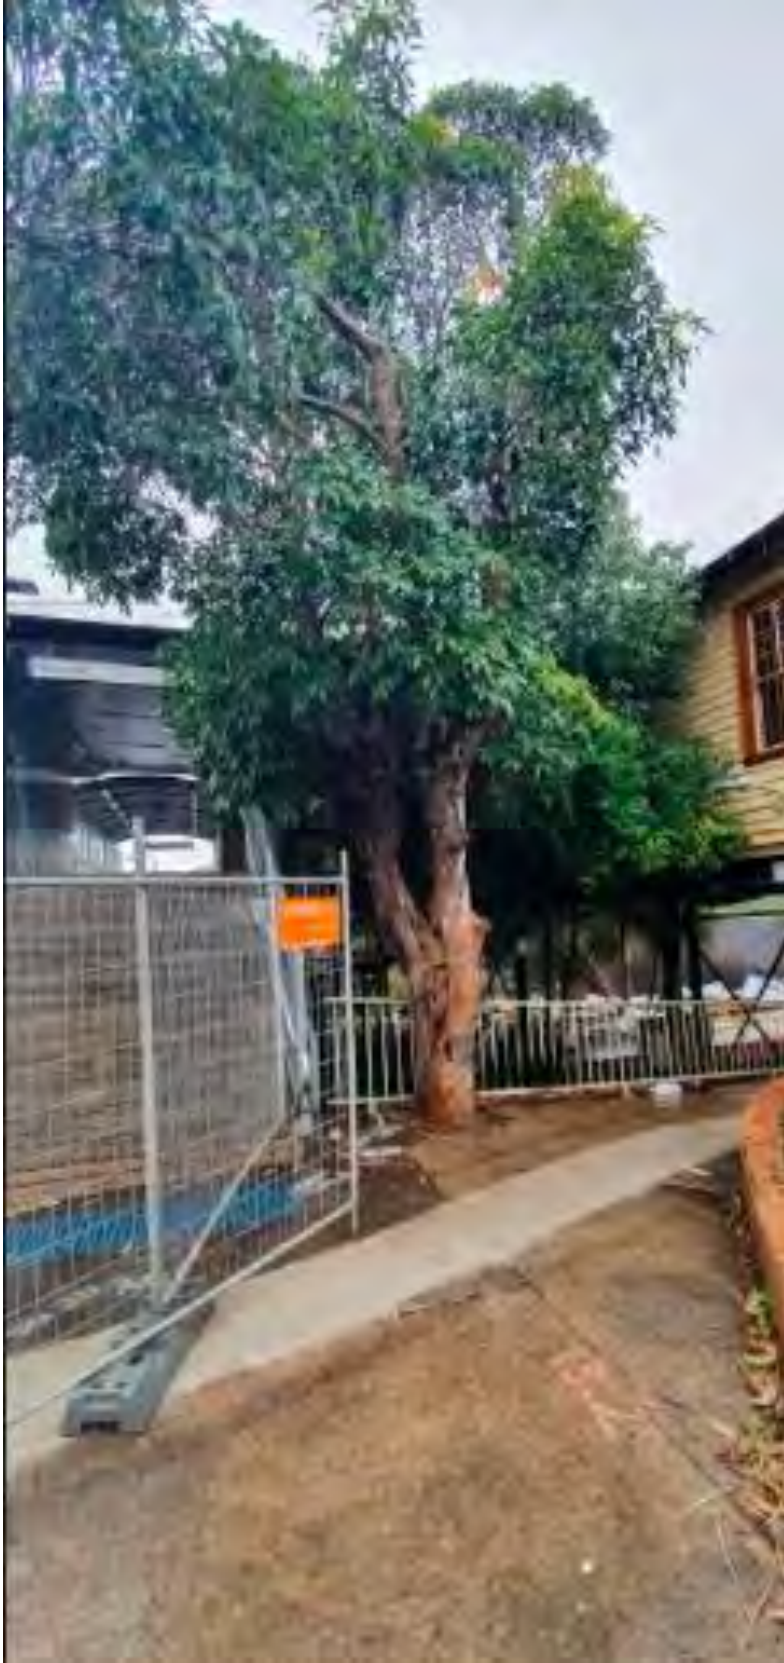
Image of the subject tree taken on the 29th June 2021.

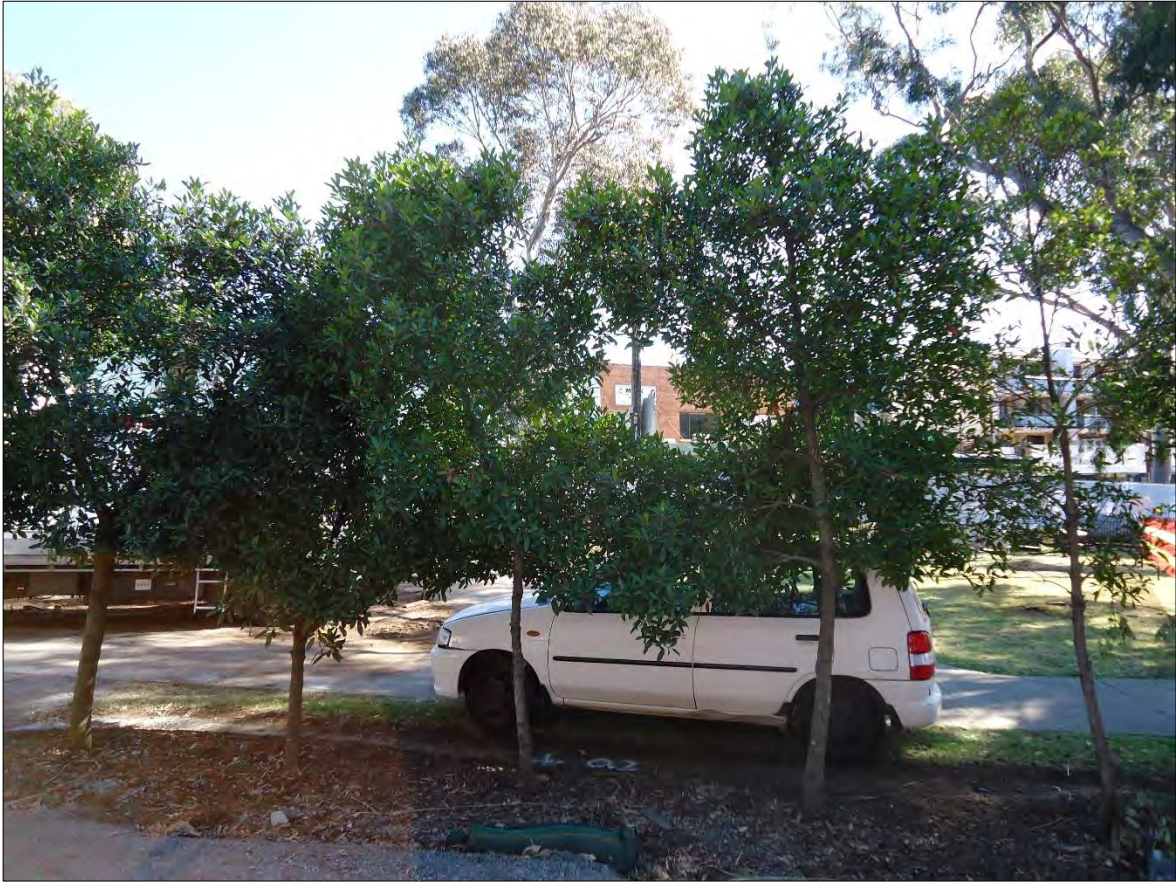
Photograph 1: Showing the five *Elaeocarpus reticulatus* (Blueberry Ash) to be removed.

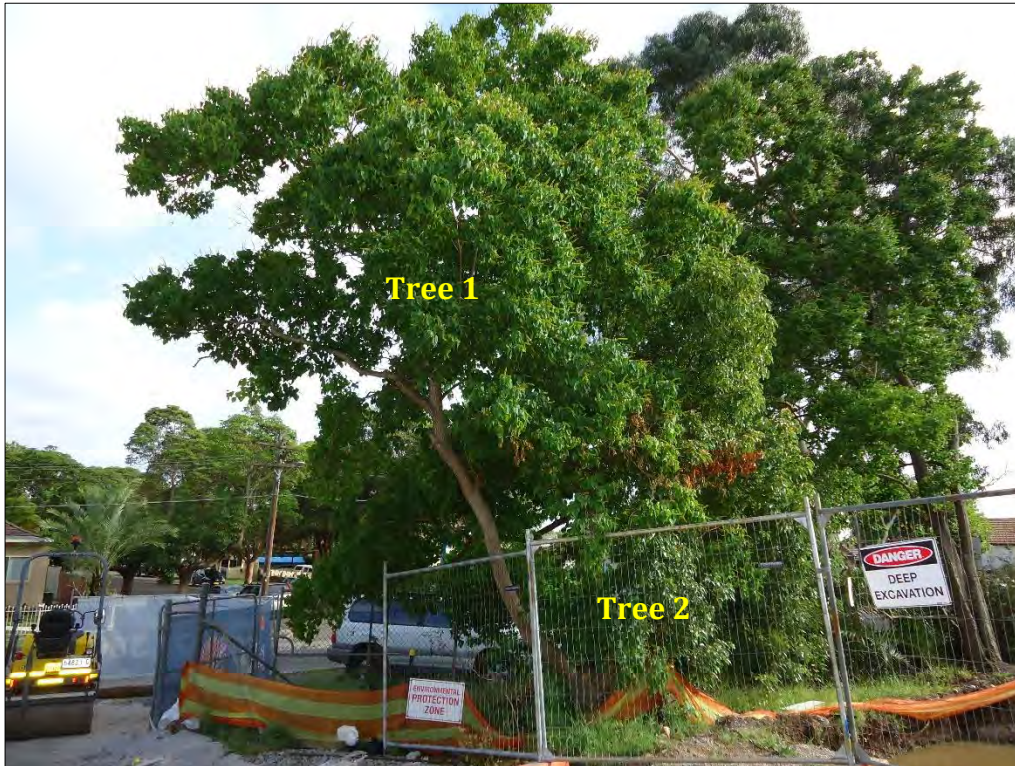
Photograph 1: The subject trees as seen from within the rail corridor. Tree 1 *Sapium sebiferum* (Chinese Tallowwood), tree 2 *Cinnamomum camphora* (Camphor Laurel).

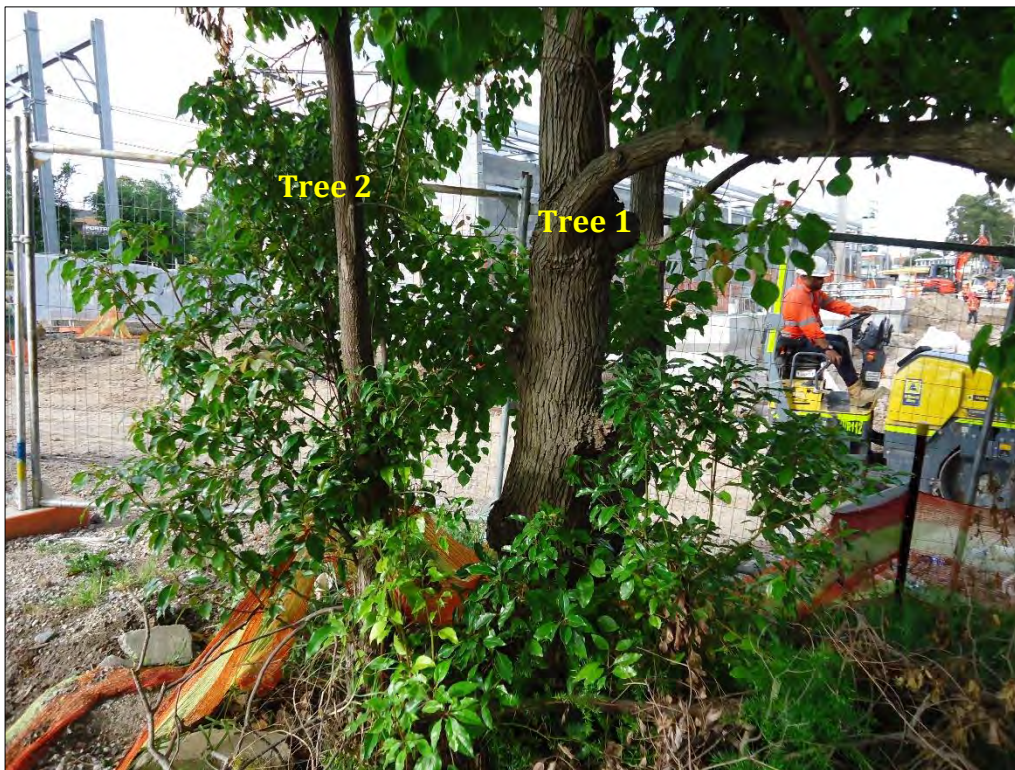
Photograph 1: Showing the individual trunks of the subject trees.
